# **RIVER CROSSINGS: RIVER DIVERSION THROUGH THE RIGHT-OF-WAY**

MARTIN CARNICERO  
TRANSPORTADORA DE GAS DEL NORTE  
ARGENTINA

## RIVER CROSSINGS: RIVER DIVERSION THROUGH THE RIGHT-OF- WAY

**Martín Carnicero**  
Transportadora de Gas del Norte  
Buenos Aires, Argentina

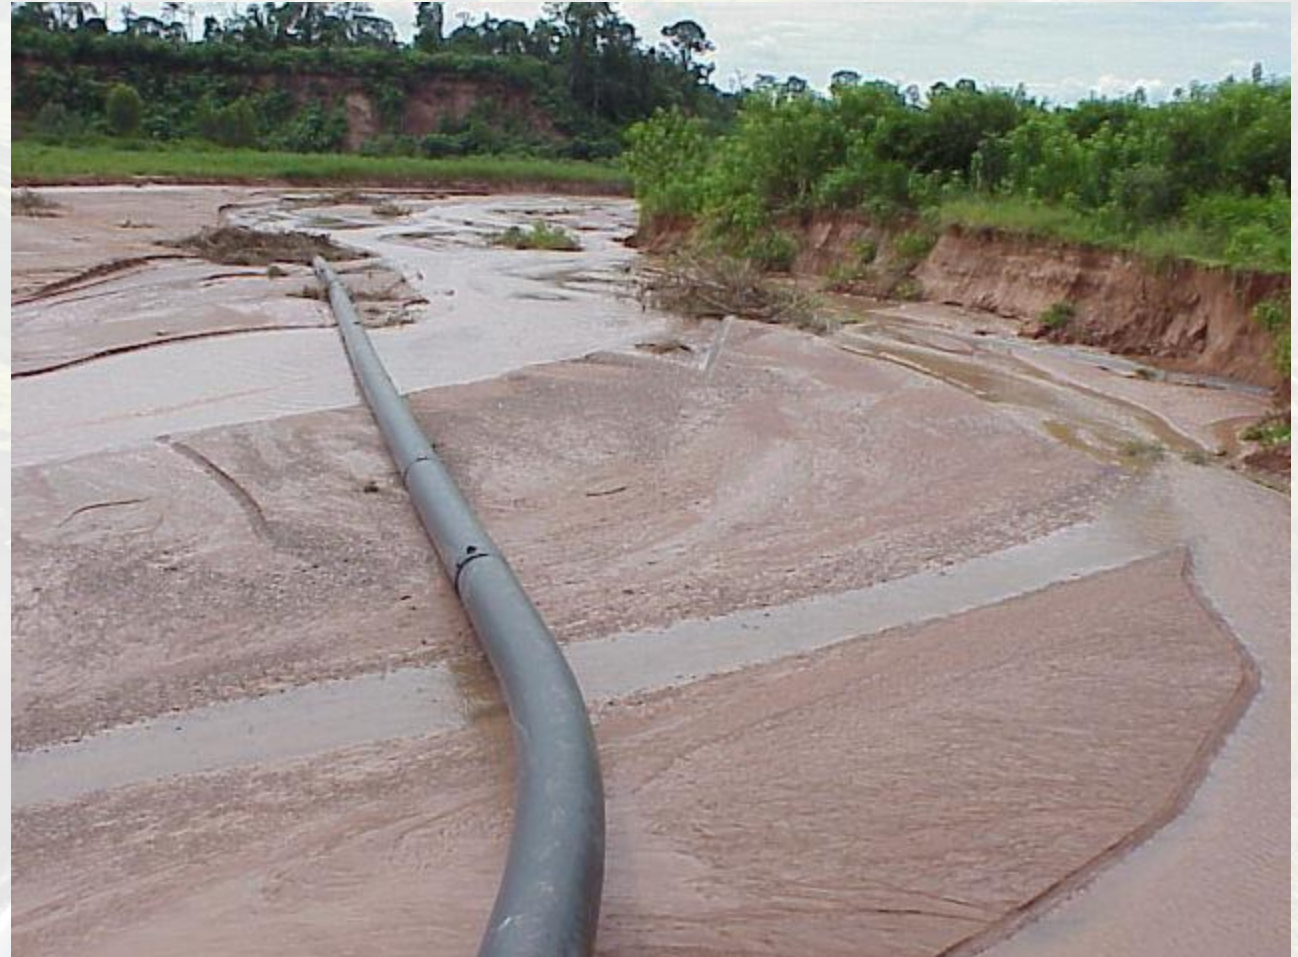
## EXPOSED SEGMENT:

- OUTSIDE ORIGINAL CROSSING
- NO BUOYANCY CONTROL
- NO GREATER WALL THICKNESS

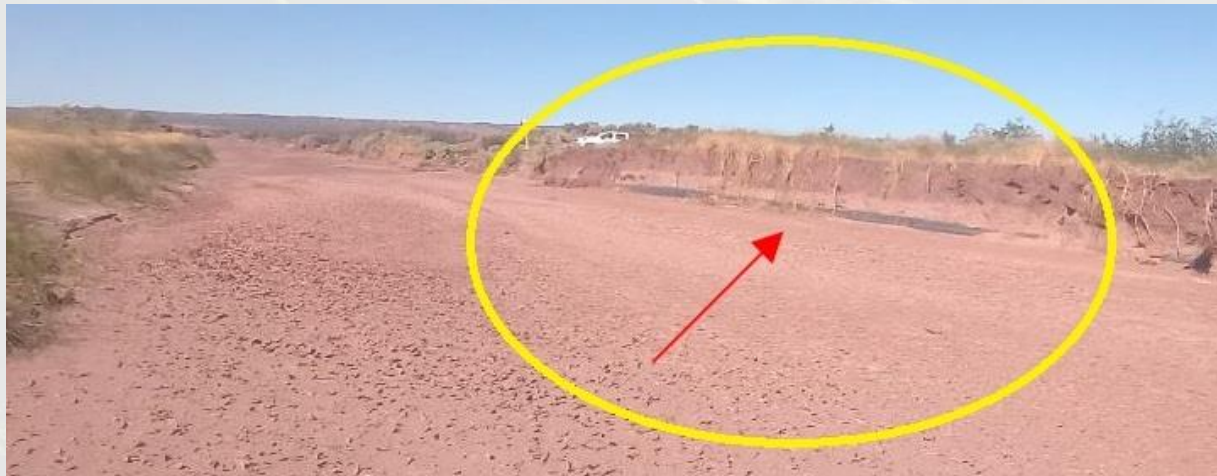
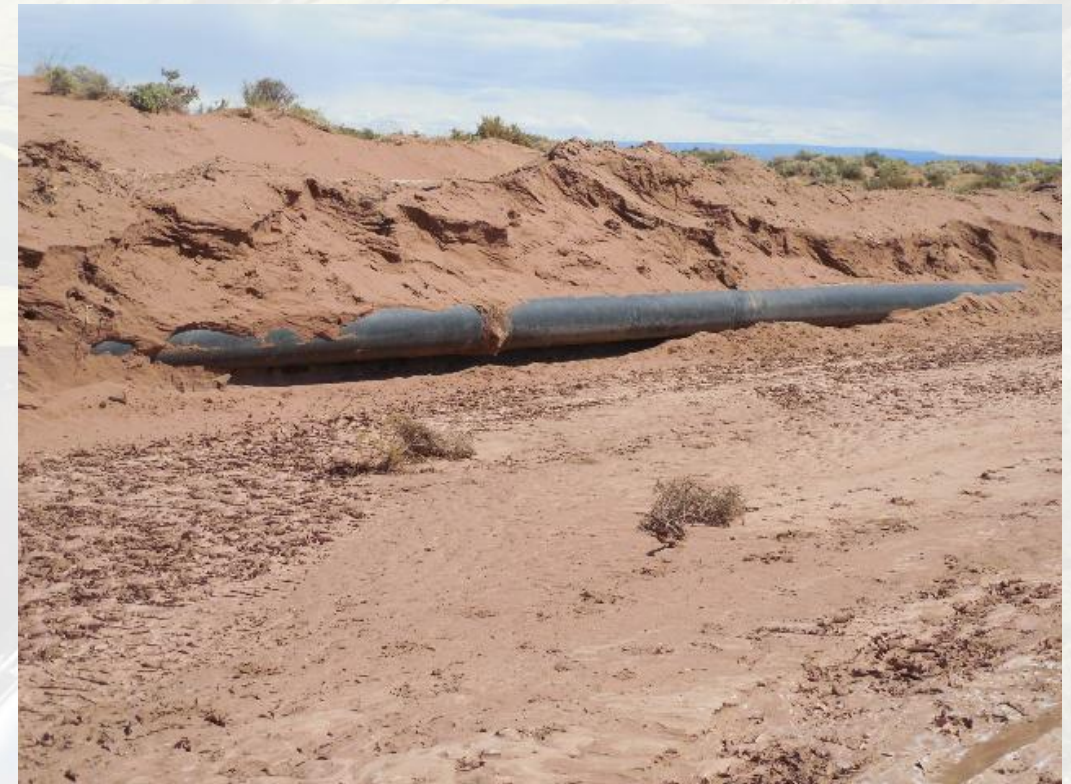
## **AFTER DIVERSION THROUGH ROW PIPELINE EXPOSURE ALONG ROW**

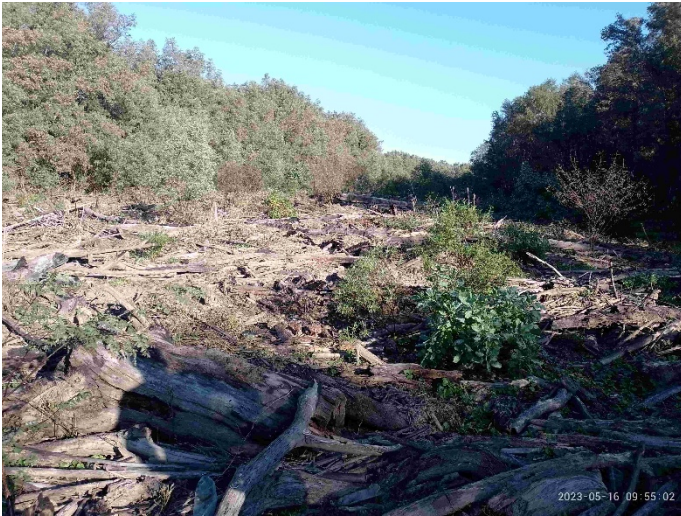
**FIGURE 5:** BLOCKED RIVER BRANCH WITH DEBRIS AND FINE SEDIMENTS

Given the 50-year flow (1,268 m<sup>3</sup>/sec), the small dimensions of the river cross section and a mild slope, flooding of a huge area becomes apparent. The river responds to this combination of factors by dividing its course into many branches which after a while are blocked with debris and sediments, before opening a new branch. Also, every rural road within the floodplain becomes a water course, changing the flow pattern with time and, thus, the amount of water and the location where water enters the ROW. **Figures 5 and 6** are representative of this situation [4].

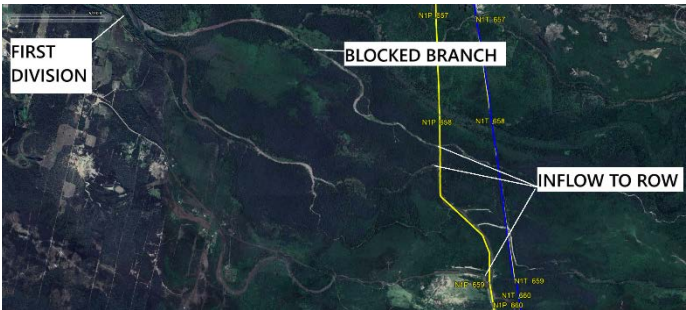
**FIGURE 6:** POINTS OF WATER INFLOW INTO THE ROW

In successive years after construction water entered the ROW first at the main river course, then after it was blocked, using old meanders and low zones, finding other three points of entrance.

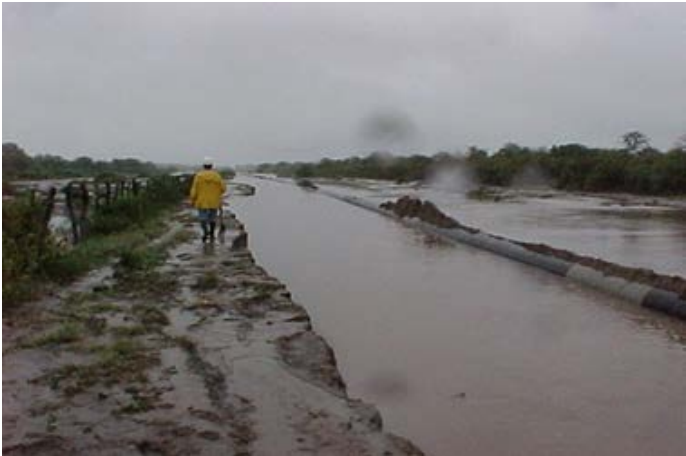
**FIGURE 7:** BUOYANCY OF 24" LINE AFTER YEAR 2000 FLOODING

This process took place on both natural gas lines ending in their exposure after extreme flood events; one in 2000 and the other in the summer of 2016. As seen in **Figures 7 and 8**, two long segments (of approximately 60 meters) of pipeline without buoyancy control weights were exposed. They coincided with locations where the pipeline was laid down at a slightly higher elevation and then buried.

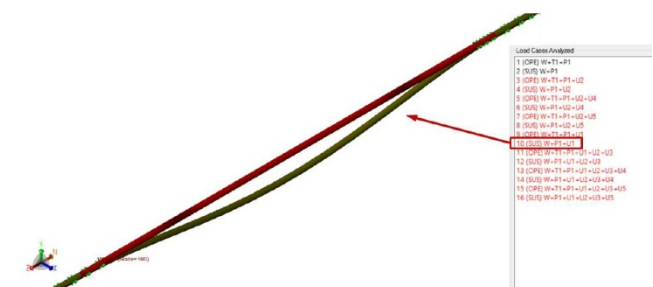
**FIGURE 12: MAXIMUM DOWNWARD DISPLACEMENT FOR A DRY RIVER WITH WEIGHTS SCENARIO**

Results presented in **Table 1** reflect this up and down behavior (negative meaning down movement and positive meaning upwards), while exceeding the allowable stress in all cases under hydrostatic conditions. **Figure 12** shows the maximum downward flexion under the worst-case scenario, which is a dry river with buoyancy control weights on the pipeline.

CONDITION	SCENARIO	LOAD	DISPLACEMENT [MM]	COMPUTED STRESS [MPa]	ALLOWABLE STRESS [MPa]	RATIO
WITHOUT WEIGHTS	NO WATER	OWN WEIGHT	-339.47	347.42	347.51	1.00
	FLOODED	BUOYANCY	550.21	418.83	347.51	1.21
WITH WEIGHTS	NO WATER	WEIGHTS	-3356.31	1502.84	347.51	4.32
	FLOODED	WEIGHTS+ BUOYANCY	-568.75	427.33	347.51	1.23

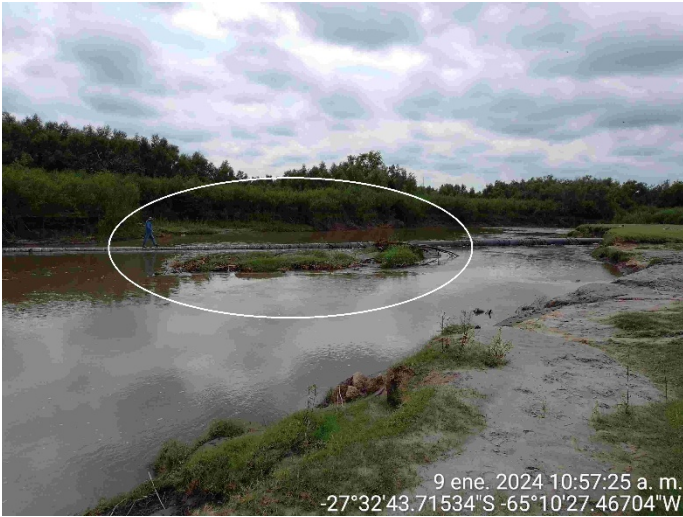
**FIGURE 13:** FIELD CONDITIONS SHOWING THE PIPELINE SUPPORTED BY A SMALL ISLAND

The first step followed when the stress analysis results were obtained was to conduct a field survey when the water level dropped, with focus on the underwater support conditions. Luckily, a small island formed by sediments and branches was located at the central segment of the exposed pipeline, as shown in **Figures 13 y 14**.

The finite-element model was run again representing field condition and the intermediate support. All scenarios showed the computed stresses where less than the allowable one. No further temporary remediation works were executed and field surveys of the stability of the island were performed periodically.

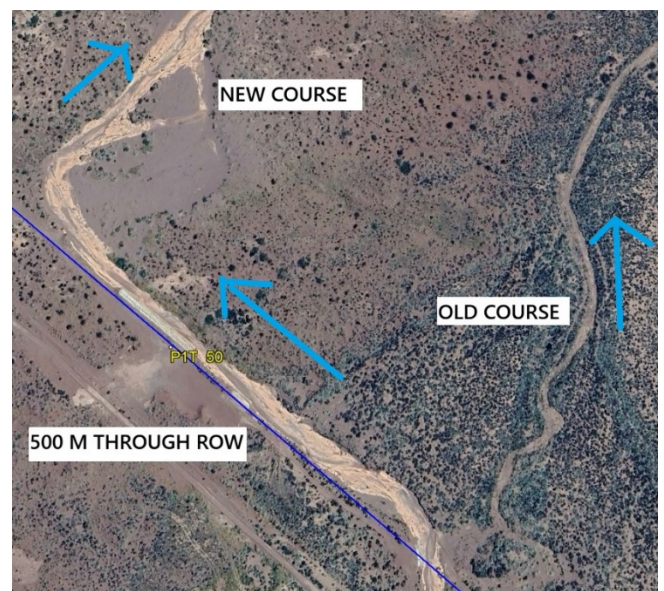
**FIGURE 21:** DIVERSION THROUGH THE ROW IN 2014

This situation didn't experience any substantial change until approximately 2014. During that year, the river changed its course and started to flow through the ROW for approximately 500 meters (see **Figures 21** and **22**). Among the possible reasons for this change are the lack of significant floods from 2004 to 2014, which may have caused the deposition of sediments on the

original river course, plus the fact that the ROW offered a preferential path during high flows.

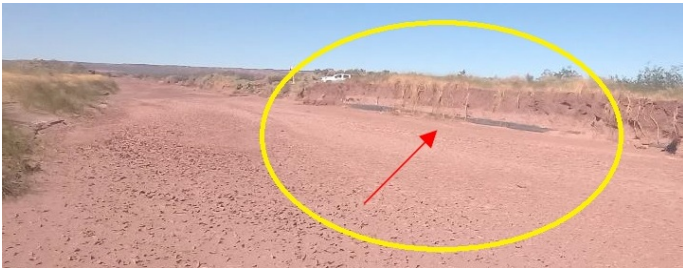
**FIGURE 23:** EXPOSED PIPELINE ALONG LEFT BANK

This new situation presented a completely different hydrotechnical threat to pipeline integrity since instead of localized exposures, a 500-meters stretch of pipeline was affected on its left new bank. The original pipeline design contemplated as buoyancy control a continuous concrete coating of only 24 m long, located at the original 20 m wide crossing. Under these new conditions, the pipeline was not prepared to account for buoyancy or any other tresses induced by water flows in case of exposure. This was the case after the 2014 flood where new segments along the river had minimum lateral soil cover, which was now the focus of further monitoring surveys. Initially, temporary remediation works were implemented to restore flow through the original river course by blocking the entrance to the ROW. Given the fact that floods are not common due to the annual precipitation regime, this scheme proved suitable for a while. In January 2022, a new storm took place, exposing approximately 35 m of pipeline, as shown in **Figures 23** and **24**.

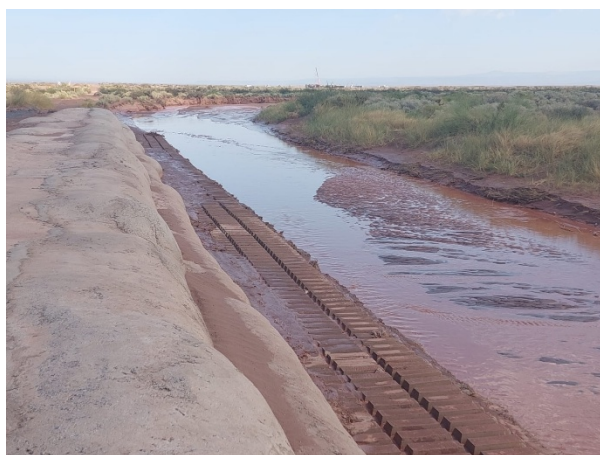
**FIGURE 28:** PERFORMANCE AFTER A FLOOD IN 2022

protections are harder to get within a reasonable distance. They are filled with local soil and covered in their exposed surface with a thin layer of cement mortar to protect them from scratches from debris, especially bushes and thorns. An additional flexible protection made from flexible concrete mats was placed at its foot to avoid scouring and sliding of the geotubes, as shown in **Figures 26** and **27**. Soon after construction, a flood took place verifying a suitable performance of temporary works (see **Figure 28**).

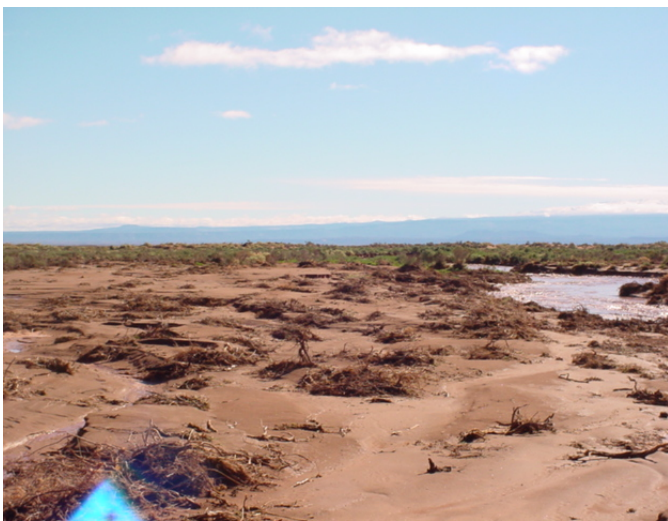
**FIGURE 32:** FIELD SURVEY AFTER A FLOOD

- The extent of the flooded area is massive. As shown in **Figure 32**, the dimensions of the cross section of the original river course (22 m wide and banks of 1.5 m) could only cope with minor flows. Flood conditions will develop as soon as a strong storm takes place, a fact that was corroborated by a field visit after a flood in April 2004.

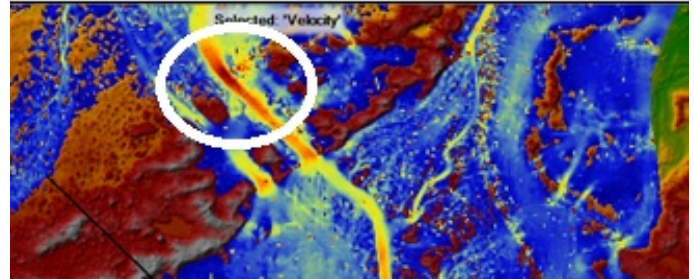
**FIGURE 33:** DETAILED VELOCITY MAP AT THE ROW

- After diversion through the ROW, exposed segments of pipelines are congruent with zones of highest velocities, as values reached in that area were in the order of 3 to 4 m/sec (see **Figure 33**).
