GEOTECHNICAL PIPELINE RISK MANAGEMENT IN THE CHALLENGING ANDEAN AREA

A CASE STUDY OF THE KM 235 IN OCENSA PIPELINE, COLOMBIA

06 de Noviembre de 2025

GEOTECHNICAL PIPELINE RISK MANAGEMENT IN THE CHALLENGING ANDEAN AREA: A CASE STUDY OF THE KM 235 IN OCENSA PIPELINE, COLOMBIA

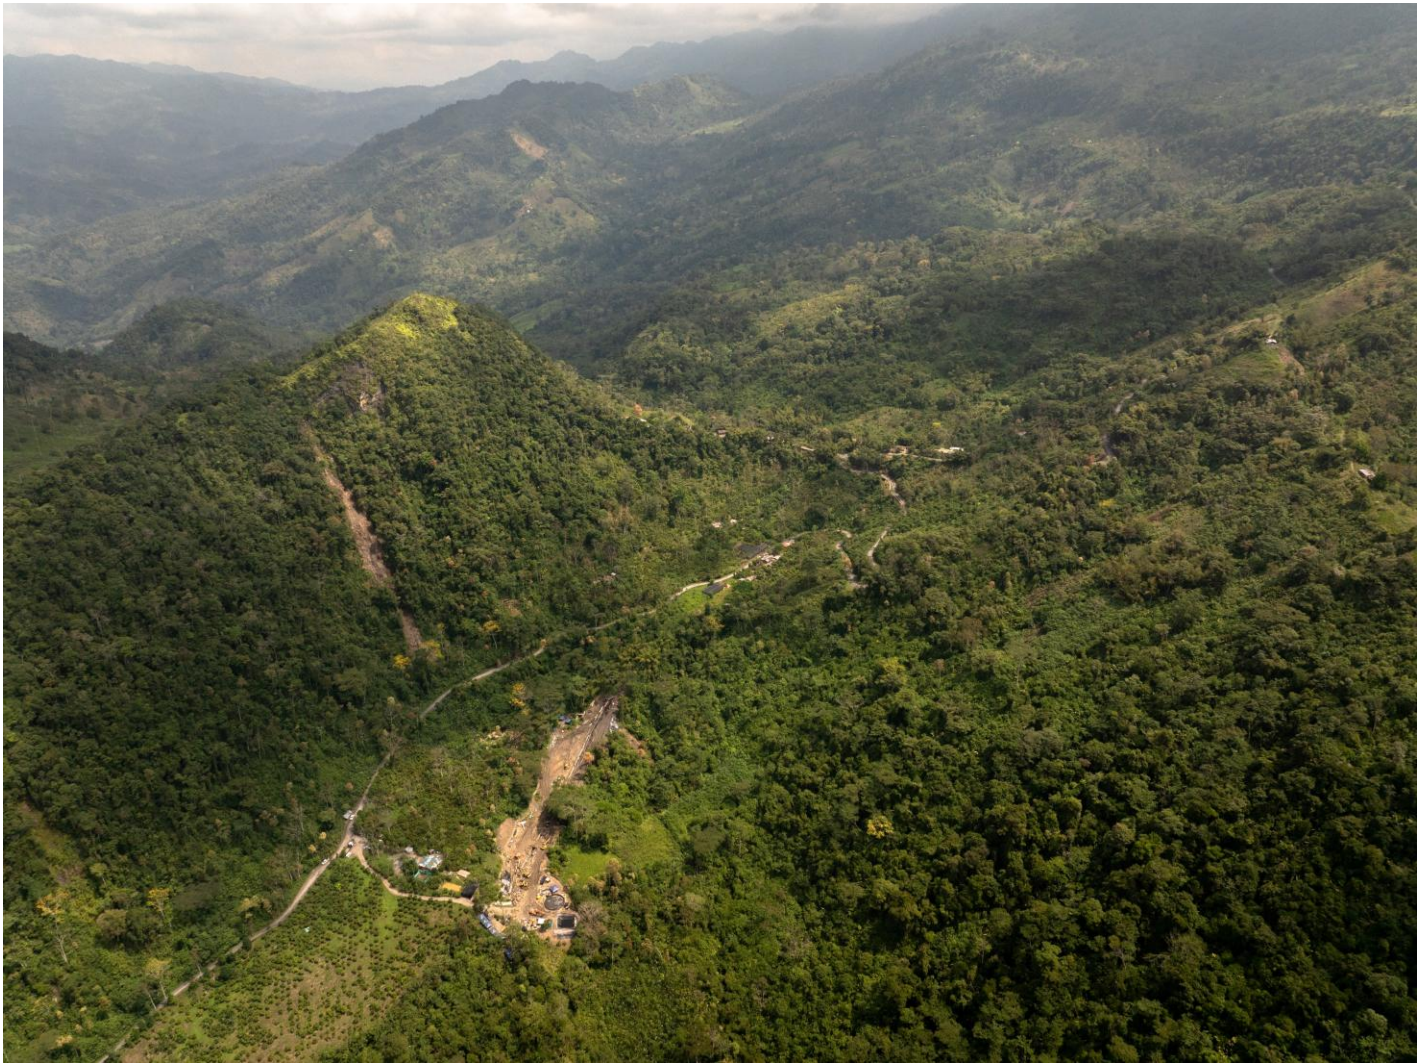
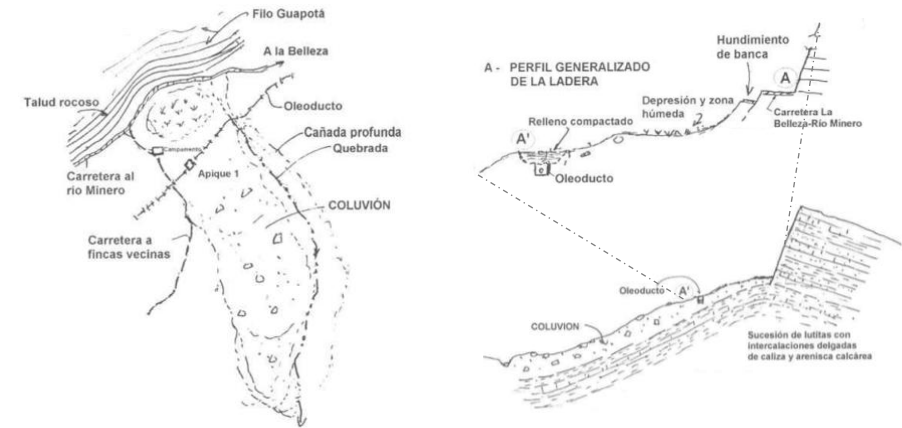
The pipeline runs through a **geologically and geomorphologically** intricate terrain. The slope experiences a **creeping movement** that exerts loads on the pipeline.

Left. Plan view of the instability process affecting the oil pipeline. Right. Profile view of the instability process affecting the oil pipeline.

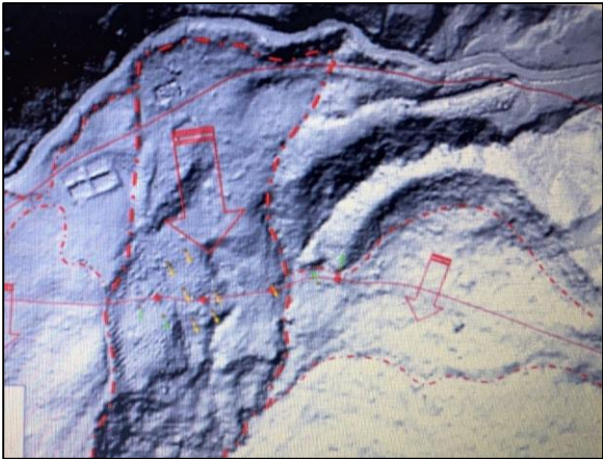
Plan view of the instability process in a lidar survey.

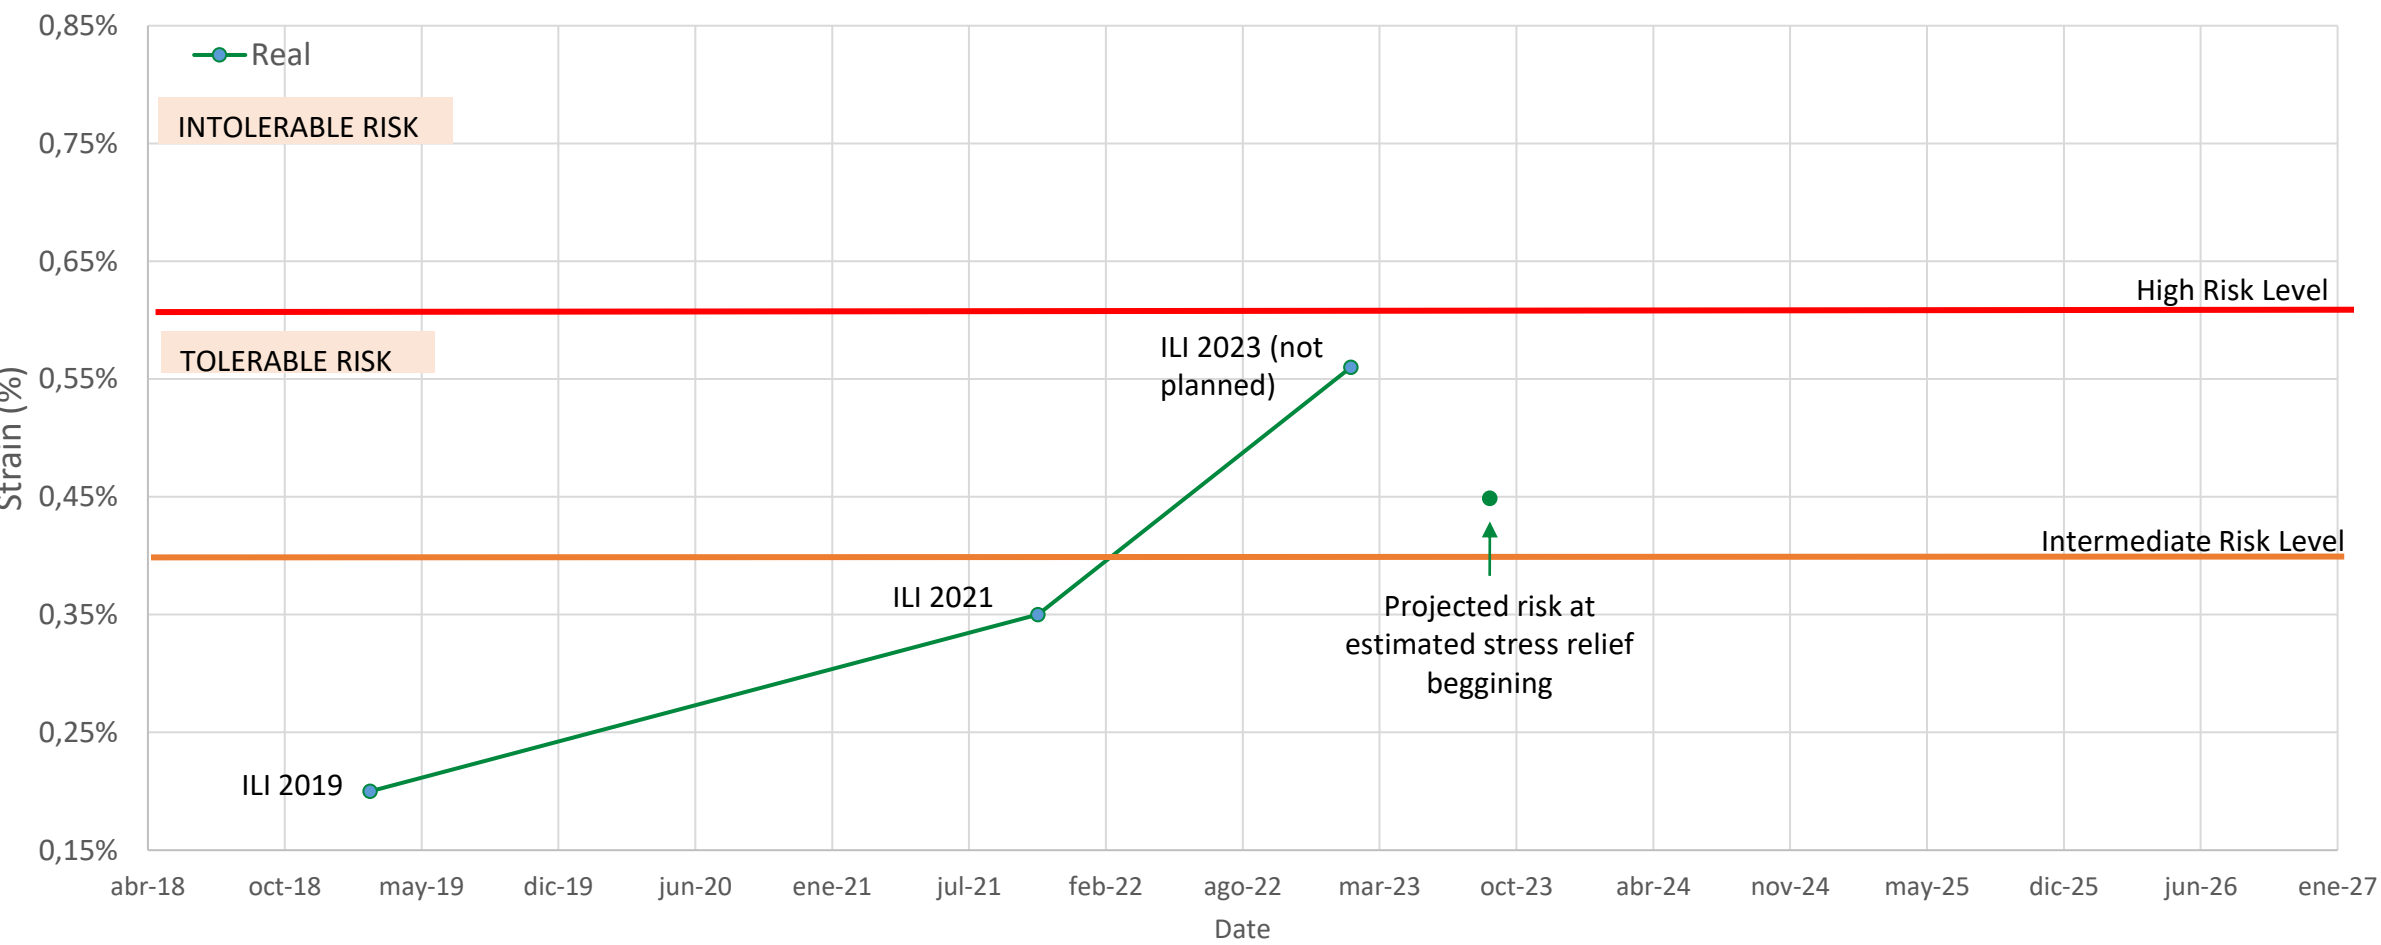
Risk behaviour between 2019 and 2024 and projections to 2025

By the end of the **third quarter of 2023**, strain exceeded projections by 36%, making stress relief a key priority.

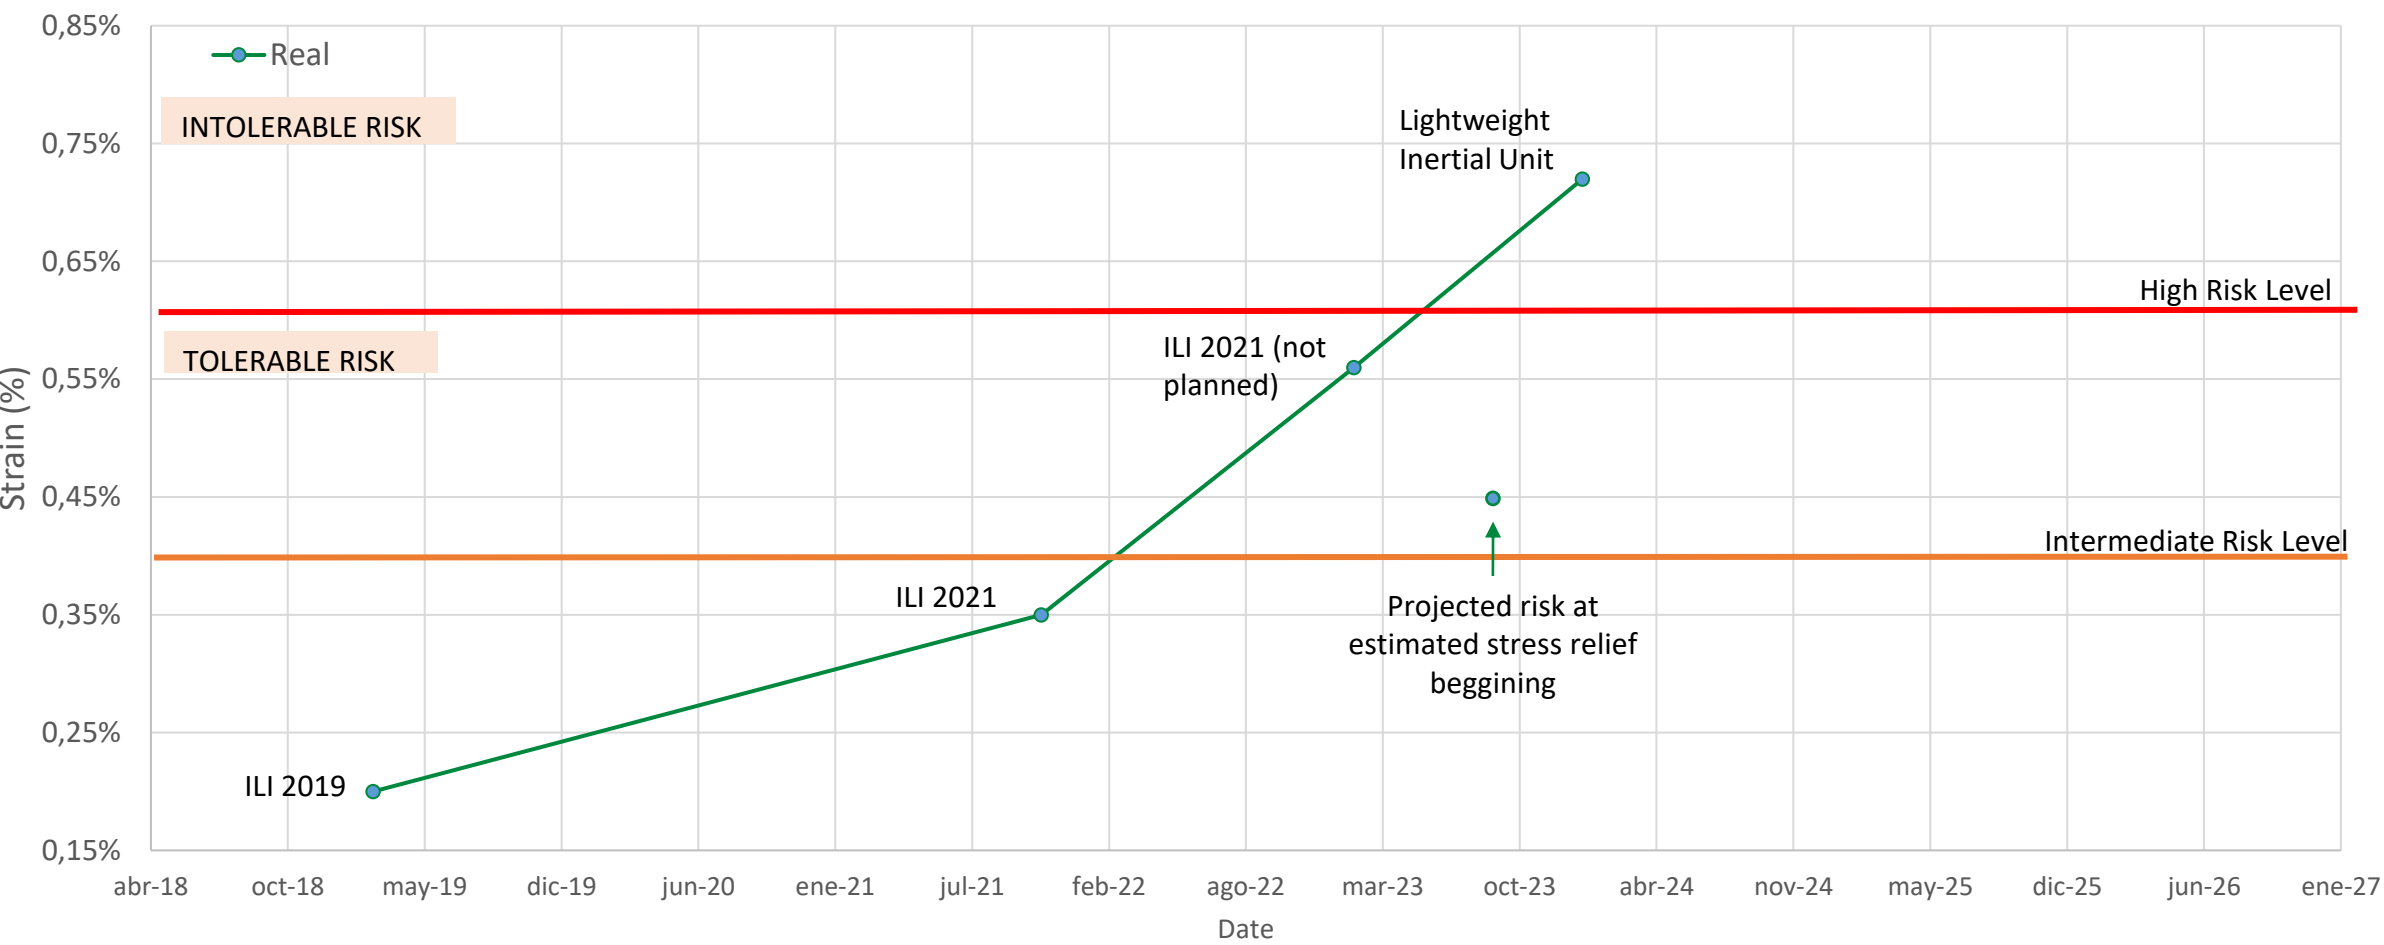
Risk behaviour between 2019 and 2024 and projections to 2025

Lightweight Inertial Unit confirmed strain continued to increase at the same rate and was close to the Very High risk zone by the beginning of 2024

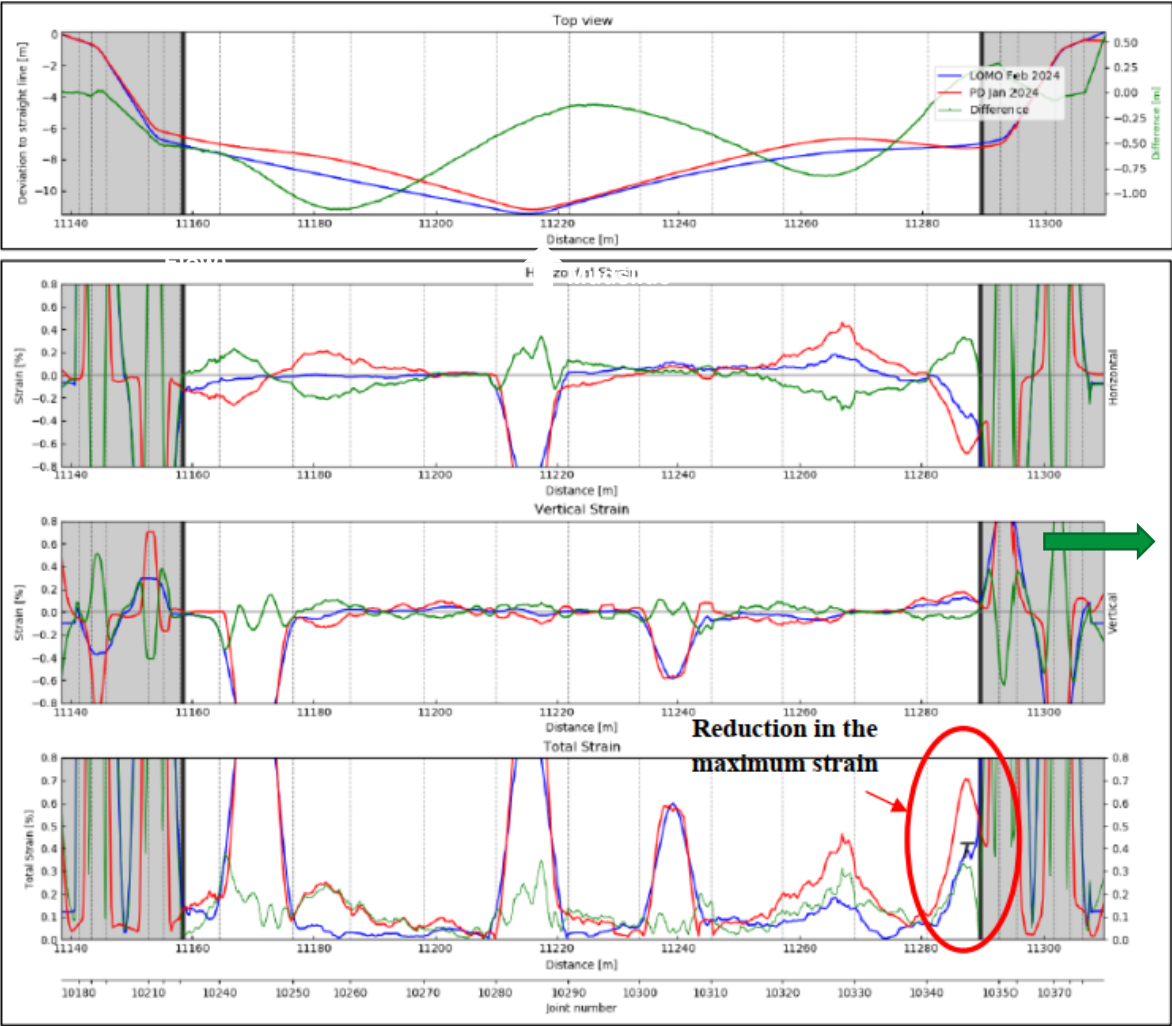
Bending strain decreased throughout the entire section, with section 3 showing a partial recovery attributed to plastic deformation.

Previous of Relief (ILI 2024)	After Relief (Topographic Survey 2024)
0.26 %	0.08 %
0.48 %	0.20 %
0.72 %	0.43 %

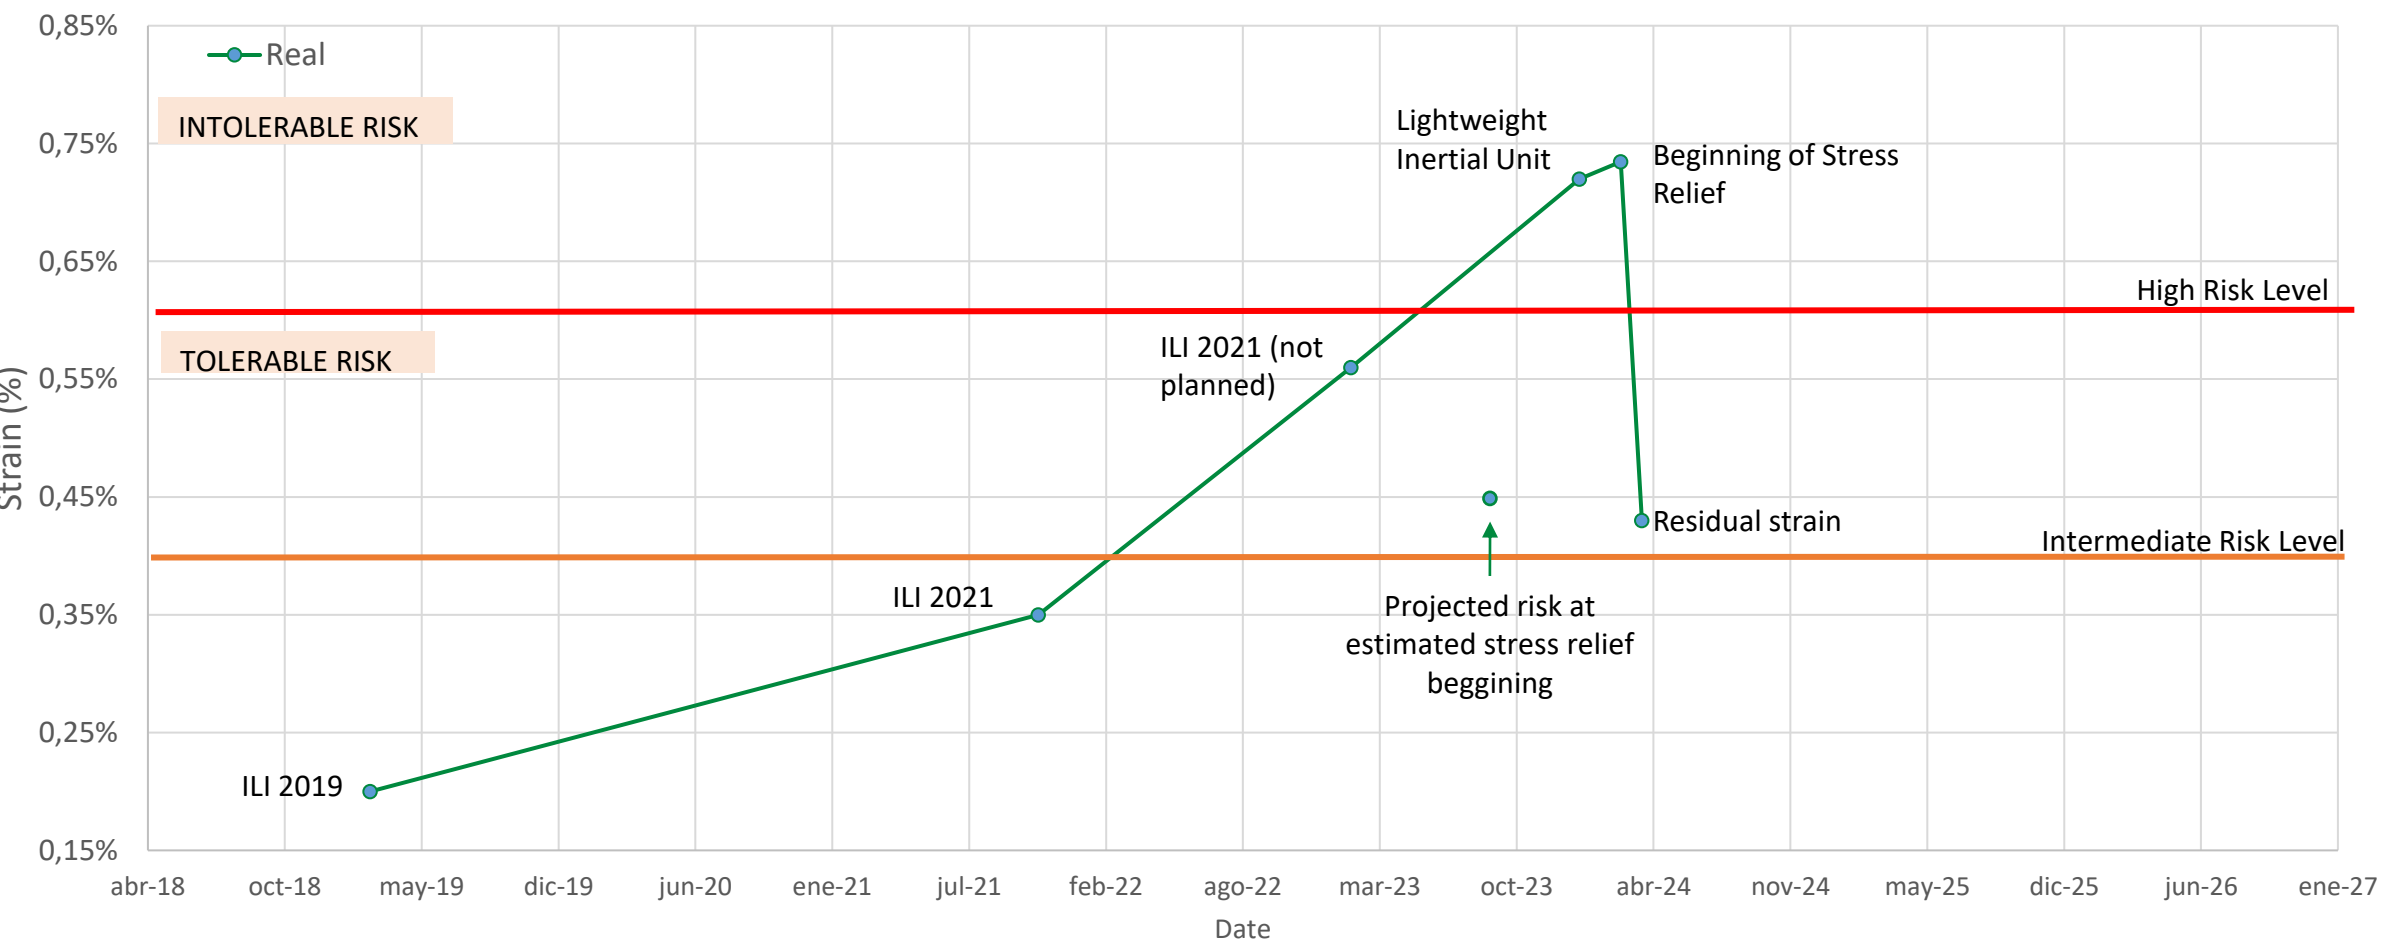
Risk behaviour between 2019 and 2024 and projections to 2025

Bending strain decreased throughout the entire section, with **section 3** showing a **partial recovery** attributed to plastic deformation.

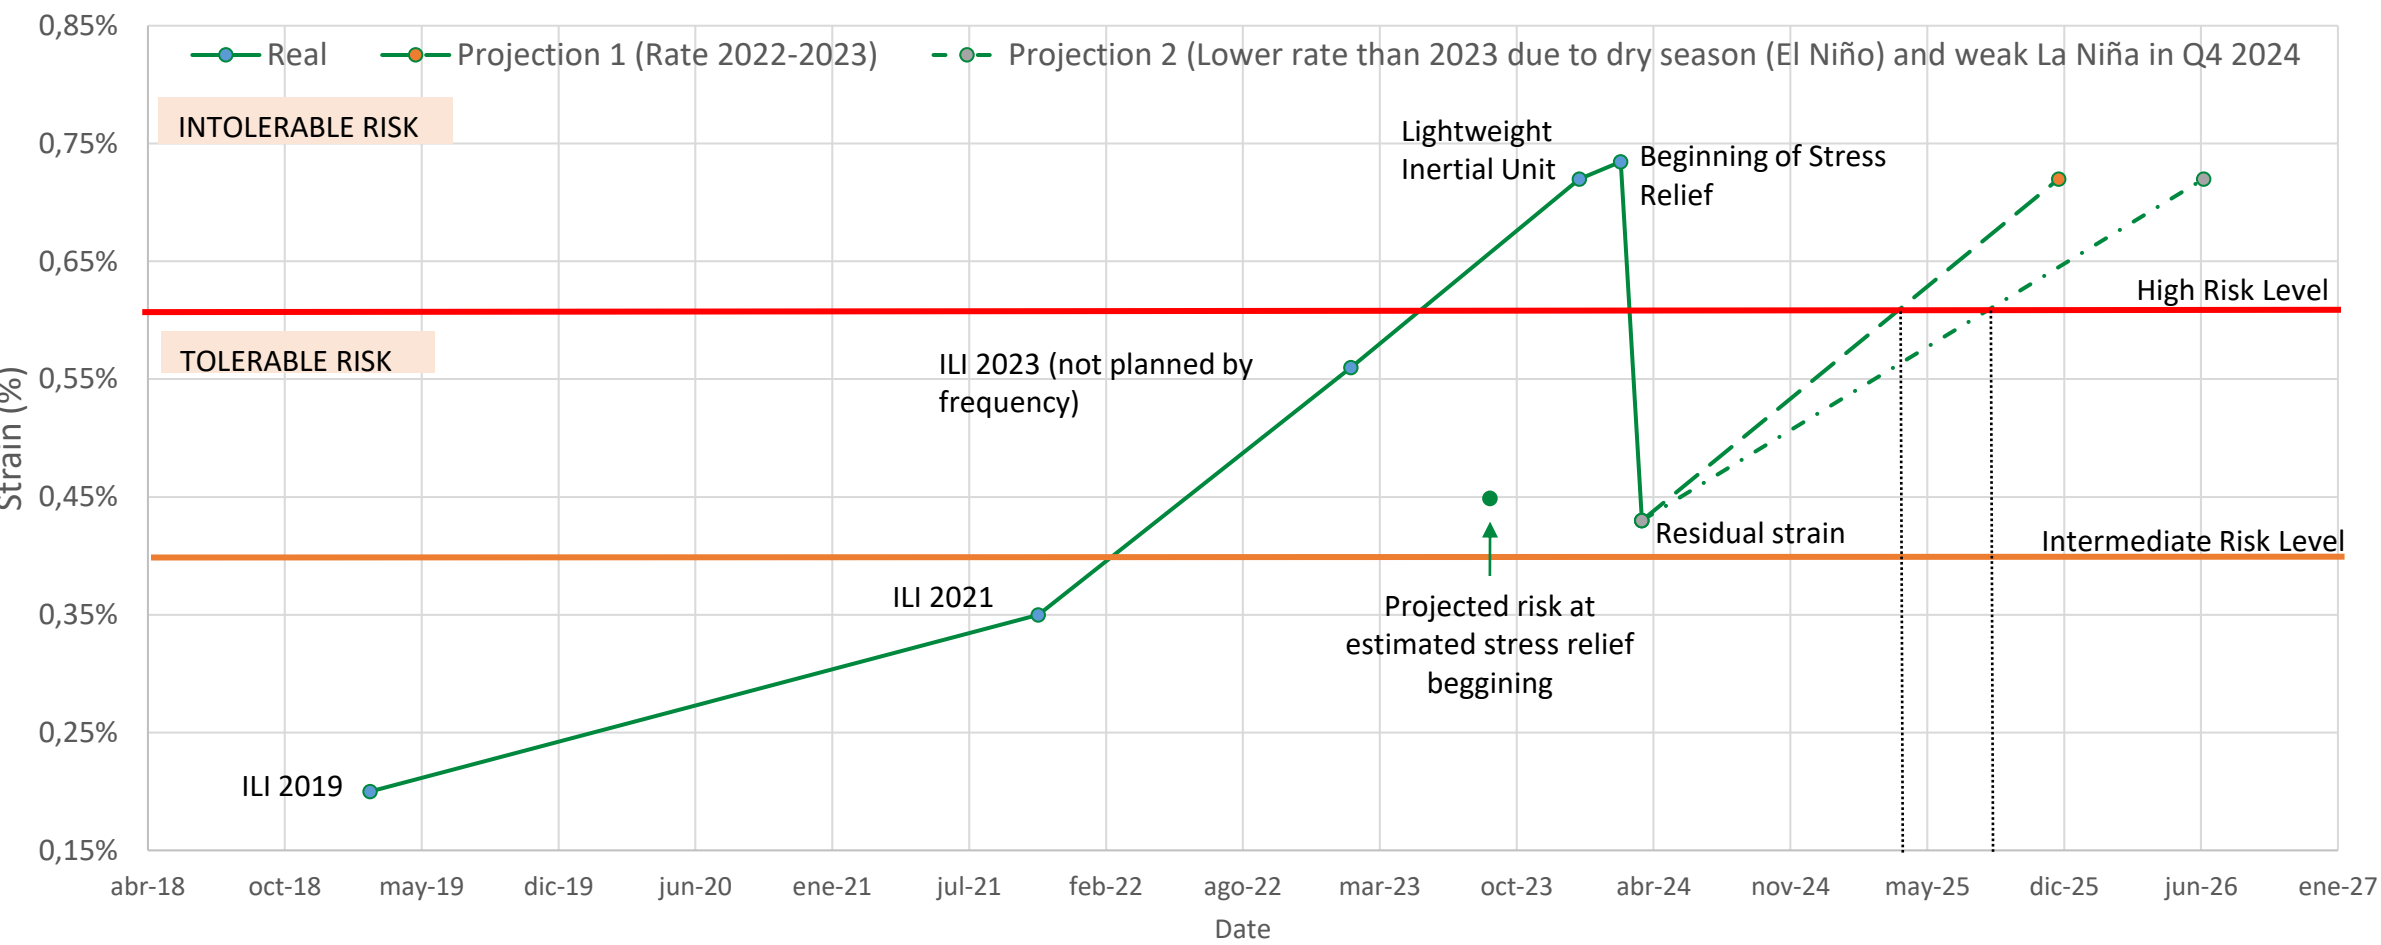
Risk behaviour between 2019 and 2024 and projections to 2025

The projected risk at a residual strain of 0.43% was expected to return to the High Risk zone between the first and third quarter of 2025

Ocensa opted to replace and reroute in response to mid-term risk forecasts and anticipated social challenges

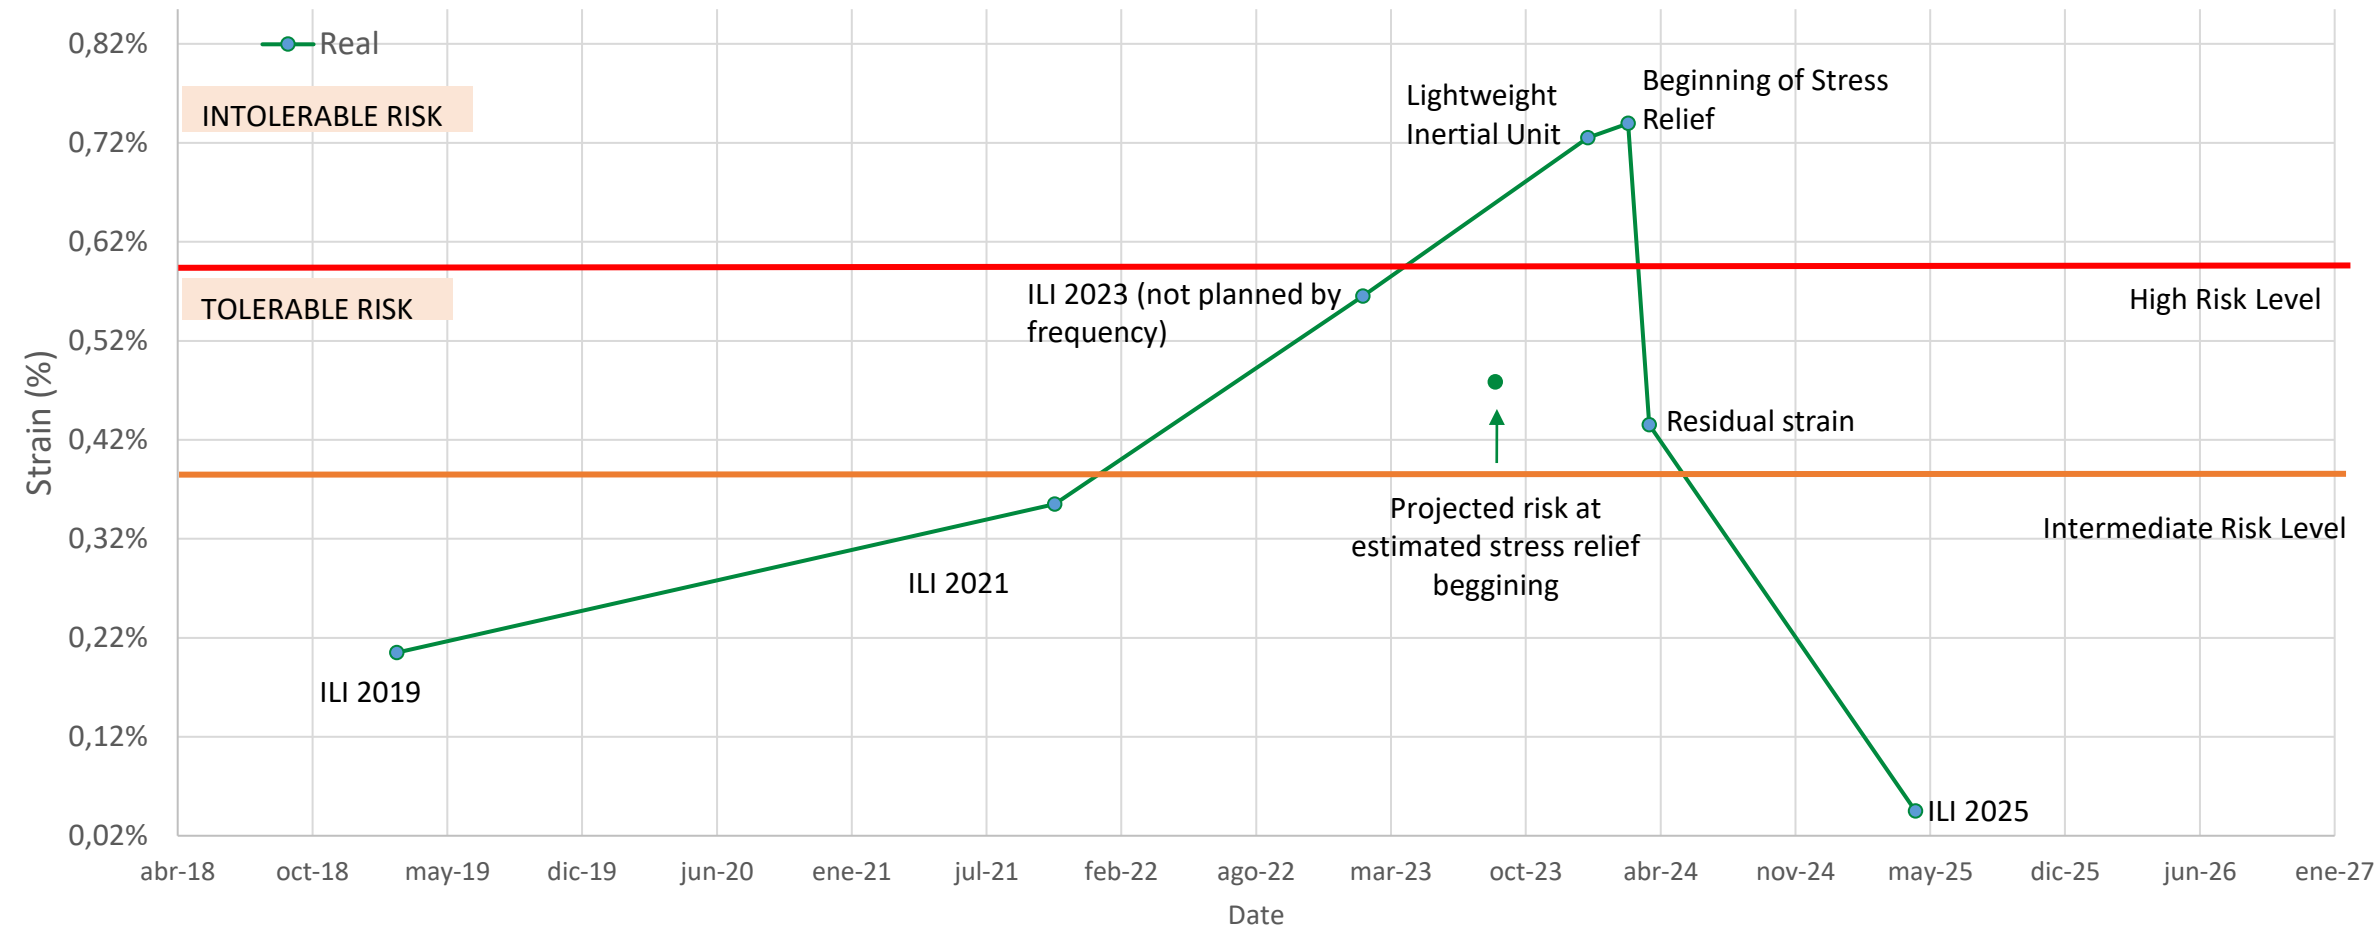
Risk behaviour between 2019 and 2024 and projections to 2025

The intervention reduced risk to pre-2019 levels, with no further measures expected for 10 years due to complementary geotechnical works

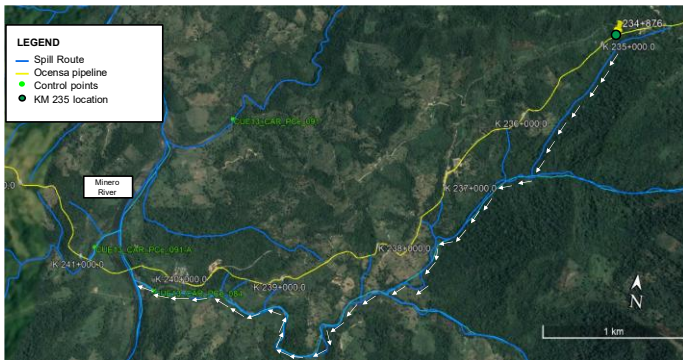
FIGURE 4. SPILL ROUTES ON THE KM 235 SECTION

Based on a hydrodynamic analysis of the various drainage systems and water bodies in proximity to the site, it was determined that in the event of a product loss of containment, it would take an average of 2 hours for the fluid to reach the nearest control point. This control point is located just before the confluence with the Minero River, which is traversed by the pipeline at KM 239, four kilometers downstream of the point of interest.

The consequence level associated with such a spill was evaluated as level 4 on the severity scale of the risk matrix. Given that this consequence could not be mitigated in the short term, the only variable that could affect the risk level was the probability of failure.

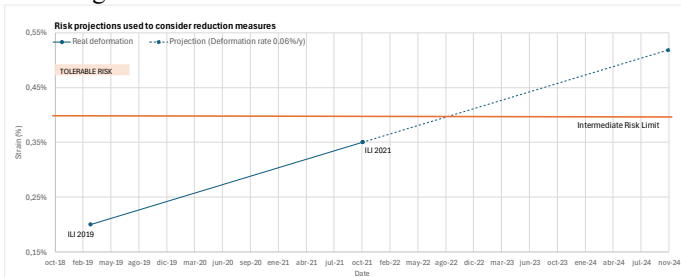
FIGURE 5. RISK PROJECTIONS USED TO CONSIDER REDUCTION MEASURES IN 2023

Considering this scenario, the deformation level projections indicated a gradual progression in risk by August 2022, although these levels were expected to remain within the company's tolerable range up to 2024, provided the deformation rate stayed the same. Analysis integrating findings from Risk Knowledge activities, such as topographic monitoring and rainfall pattern studies, led to a July 2022 decision to implement risk reduction strategies for 2023. This proactive approach was taken to ensure that risk would not reach an intolerable level and was further justified by the recognition—based on experience—that accessing the site could take more than six months.

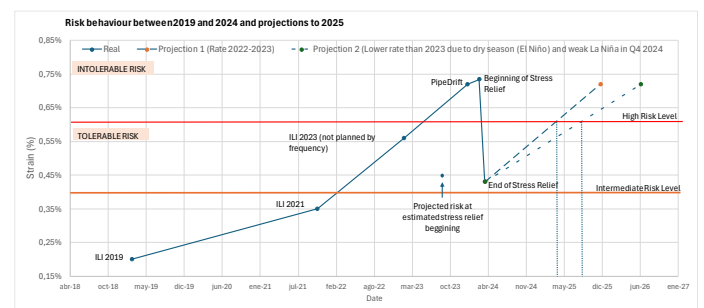
FIGURE 7. RISK PROGRESSION BETWEEN 2019 AND APRIL 2024 AND RISK PROJECTIONS TO 2025

Faced with these challenges and the weather conditions that ended in the parallel pipeline rupture, an Inline Inspection (ILI) run equipped with an Inertial Mapping Unit (IMU) was performed outside the routine monitoring schedule in February 2023. The findings indicated a total strain at point 3 of 0.535%, representing more than a twofold increase in the deformation rate, a result that was also confirmed by topographic monitoring. This escalation brought the site closer to an intolerable level of risk, prompting a preventive emergency declaration to facilitate the necessary stress relief activities. Projections based on the new deformation rates suggested that the risk level would soon exceed the pipeline's plastic deformation threshold, reaching up

to 0.72% bending strain. This trend was confirmed in January through a PipeDrift run, where the IMU tool was attached to a cleaning pig, providing essential data for ongoing strain monitoring and timely decision-making in this complex situation (see FIGURE 7.)

Following the pipeline stress relief activities, residual bending strain was assessed by performing topographic measurements as a Risk Knowledge activity seeking to confirm that tolerable or acceptable risk were achieved with this intervention. This analysis indicated a reduction in bending strain across the entire section, with varying residual strains observed at the three critical points detailed in Table 2. The point 3, located downstream of the section, exhibit only a partial recovery that was linked to plastic deformation, as confirmed by simulating the loading conditions by finite element analysis. The estimated residual strain at this location was approximately 0.43%, indicating that risk was effectively reduced but not reaching the 2019 or even 2021 levels (see FIGURE 7.)
