IPG 2025
INTERNATIONAL PIPELINE GEOTECHNICAL CONFERENCE

PROTECCIONES GEOTÉCNICAS EN CRUCE DE RIOS, Pk 20,500 OLEODUCTO PUESTO HERNÁNDEZ – LUJAN DE CUYO ARGENTINA

Ing. Civil LEANDRO IVORRA

"GEOTECHNICAL PROTECTIONS IN RIVER CROSSING, PK 20,500 PUESTO HERNÁNDEZ - LUJÁN DE CUYO - ARGENTINA OIL PIPELINE"

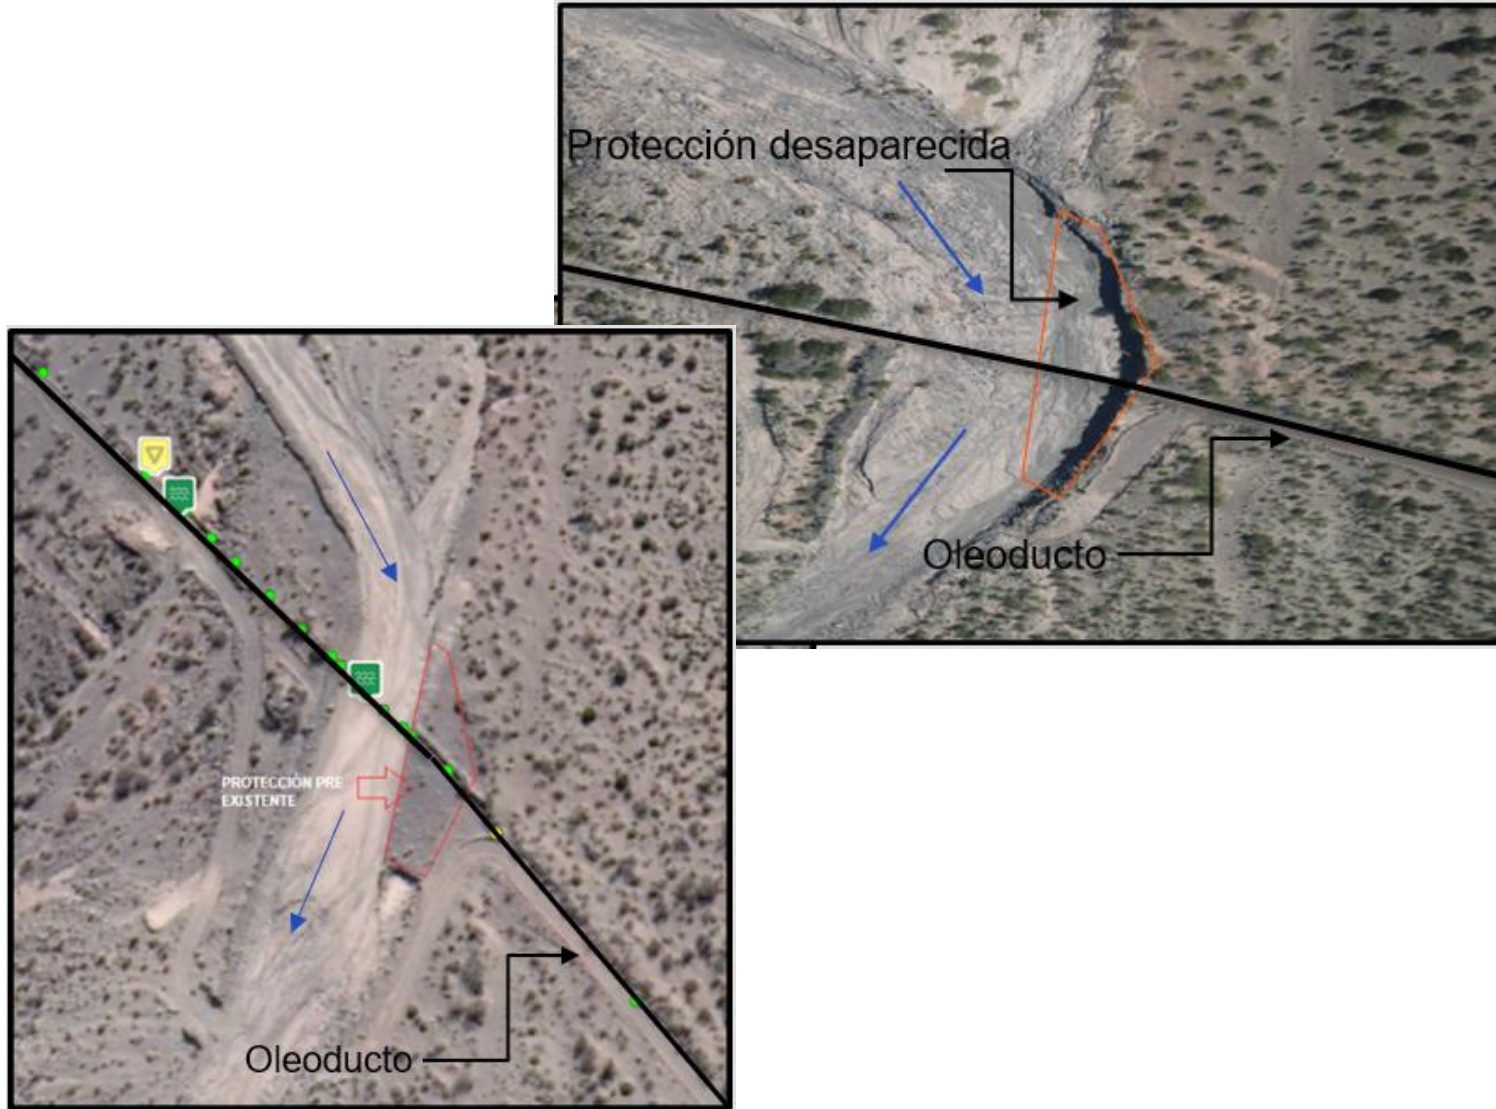
Situación del cauce pre existente vs situación post lluvias

La imagen de la izquierda muestra una obra de contención de antigua data y la de la derecha como quedó el cauce luego del evento.

Como se puede apreciar, la obra anterior, no acompañaba la natural curva del cauce (radio lo que generó su colapso no obstante haber estado varios años en servicio).

Ante esta conclusión, lo que se buscó fue que la nueva obra, acompañara el natural escurrimiento de las aguas intentando generar un re encauzamiento de las mismas hacia la zona media del cauce donde el ducto tiene una tapada superior a los 3 metros.

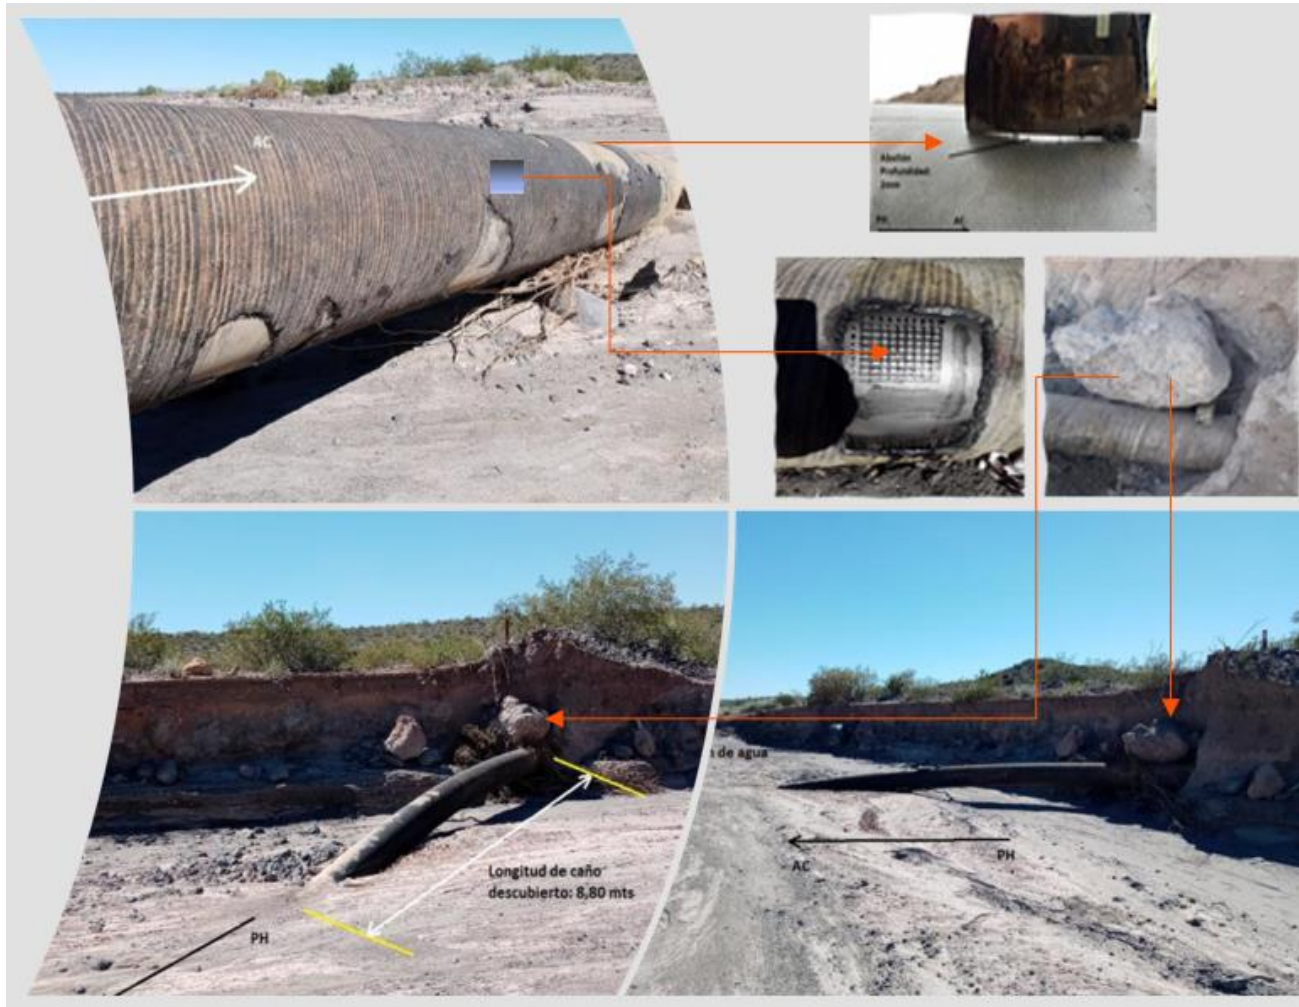
- Arribados al lugar, nos encontramos con el ducto descubierto y seriamente dañado en su revestimiento.
- El mismo presentaba el impacto de piedras menores (pérdida de revestimiento) y de elementos mayores que generaron abolladuras y pérdida de material por arrastre.
- Se detallan en la imágenes una de las piedras arrastradas por la corriente y que generó un impacto sobre el ducto. Por otro lado se enseñan algunos de las evaluaciones mecánicas sobre la línea.
- **Es muy importante destacar que el lugar era permanentemente monitoreado y que esta situación se debió a una Lluvia de mas de 50 años de recurrencia**

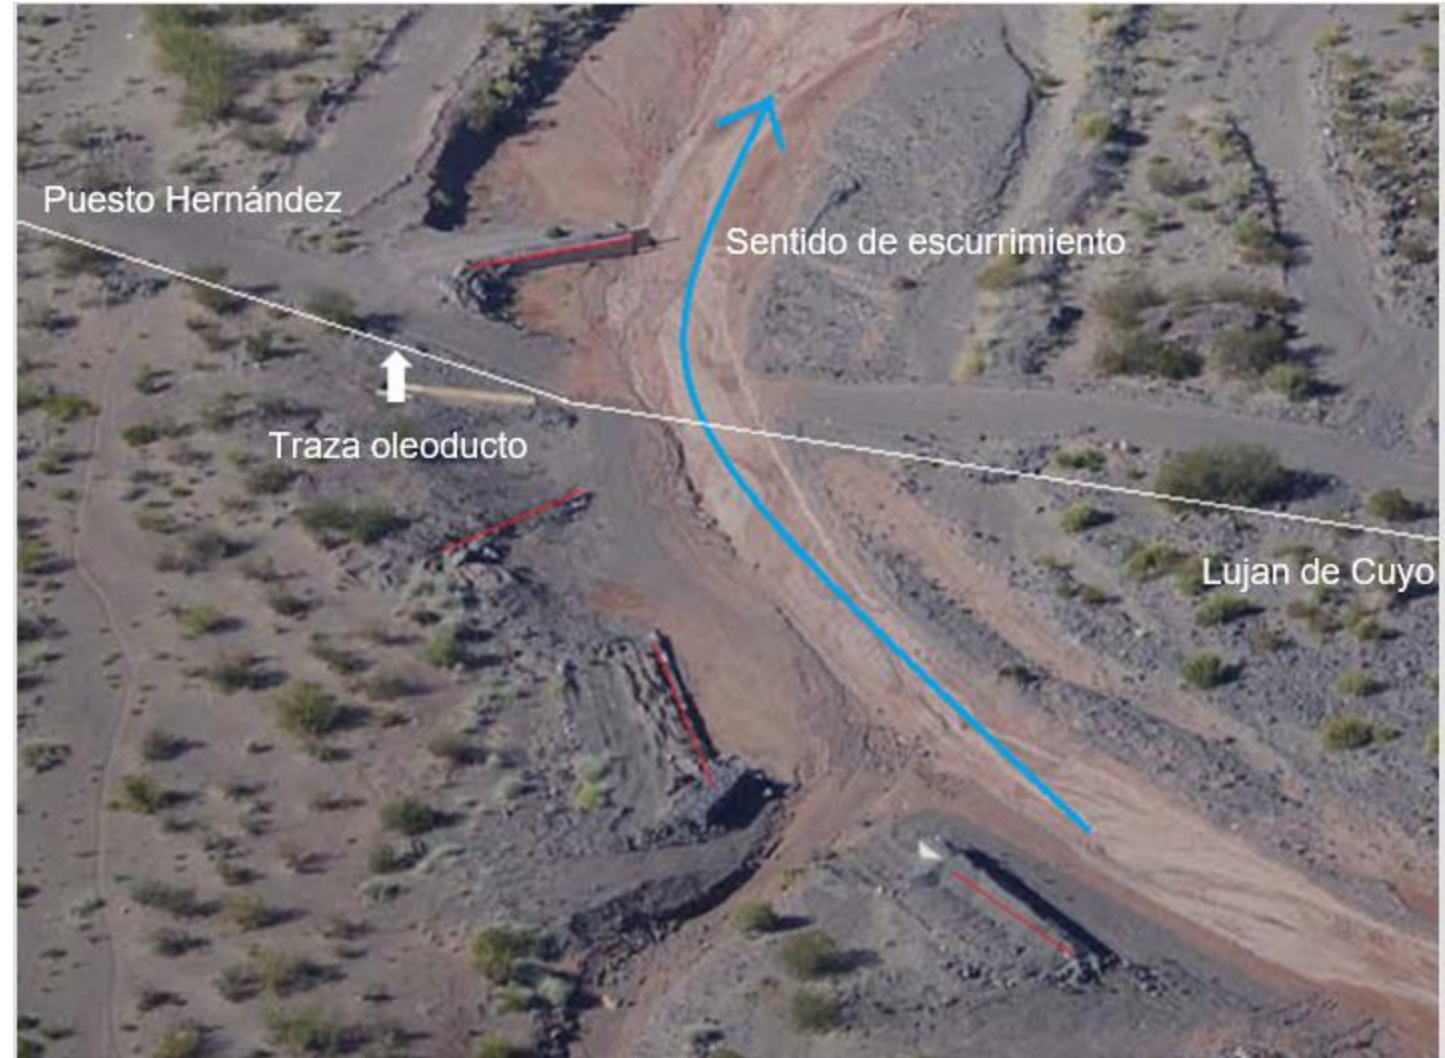
Situación actual.

Cauce completamente recostado hacia su margen de menor radio de curvatura debido al accionar redireccionador de las escolleras materializadas

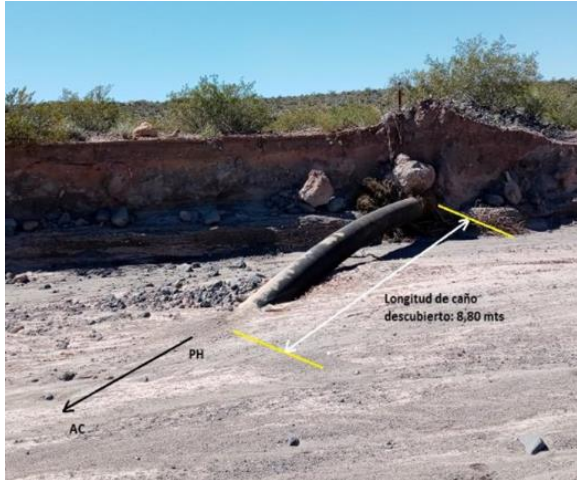
Image 4 – Exposed pipeline – Source: Author of the paper

On a tour carried out during the month of February 2021, field personnel detected, after a series of heavy rains in the area, the pipeline completely exposed at Pk 20,510. A length of 8.80 meters of exposed pipe is observed.

The first step was to perform a visual inspection of the pipeline for cracks or dents. Fortunately, the mechanical integrity of the line remained unchanged, but dents were found due to impacts.

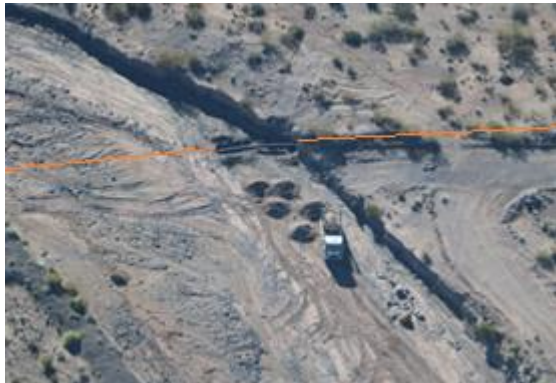
Image 5 – Aerial view of exposed pipeline – Source: Aereal patrol

In this position there was previously a protective work that had been completely destroyed by the meteorological event. (On many occasions, geotechnical protection works must be a "fuse" that acts as such in order to protect the pipeline so that the damage to it is as little as possible).

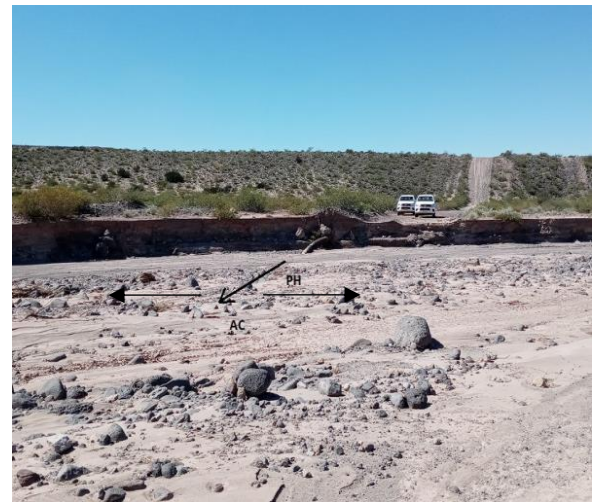
Image 7 – general view of the affected area – Source: Author of the paper
Restricted area 7,50 m each side

On the other hand, it can be seen that the semi-permanent channel has a significant drag of stones and other blunt elements that are potentially risky for the pipeline, in fact, it was corroborated a posteriori, that the deterioration of the lining and the dents found were due to the impact of the transported elements.

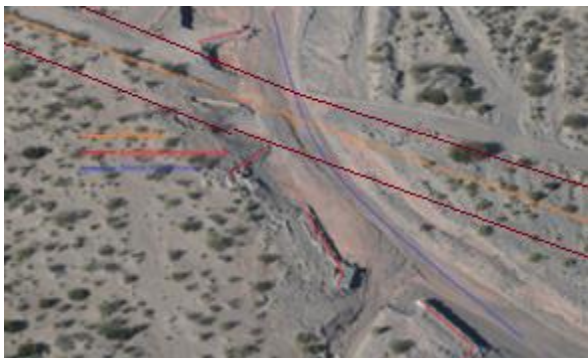
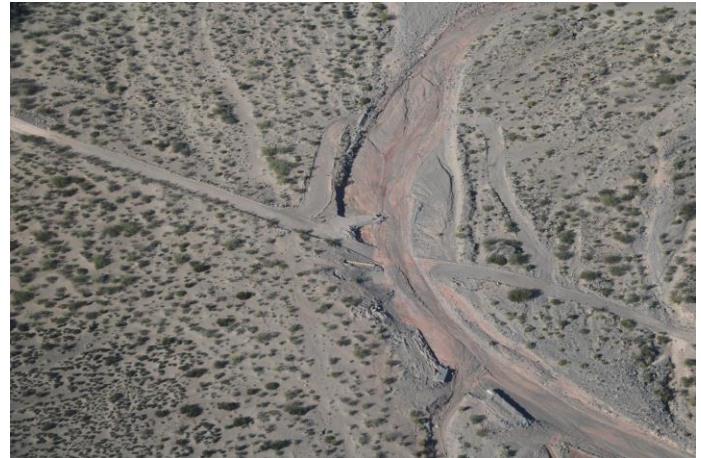
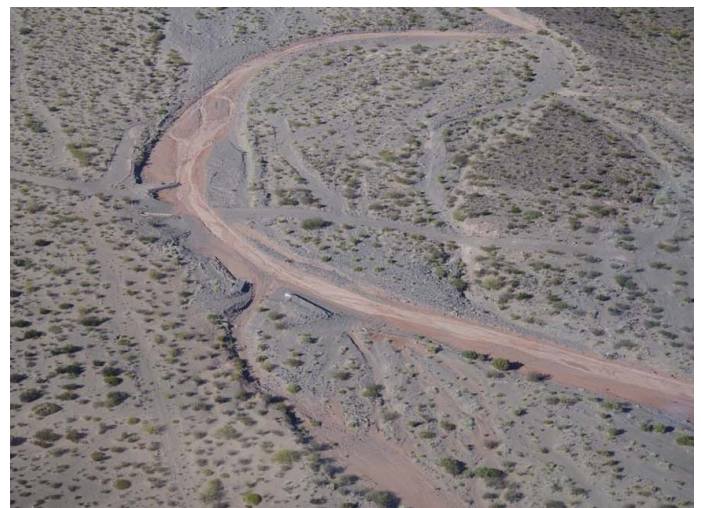
The riverbed has been backed on the north bank as planned and there have been no relevant developments at the moment.

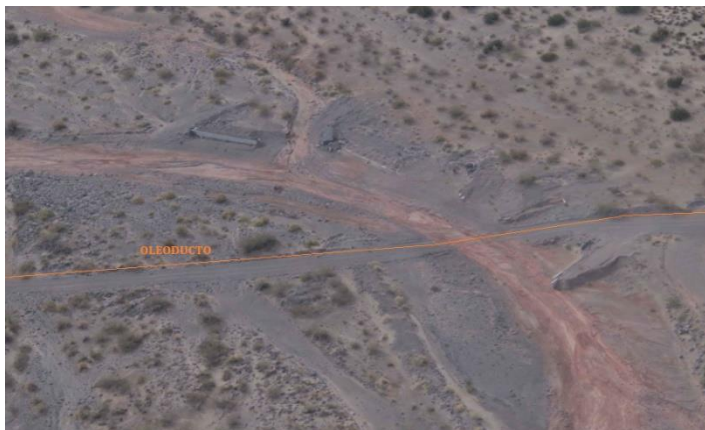
Image 29 - Aerial view of completed work with relative location of the pipeline - Source: Aereal patrol

The protective sleepers, arranged in double rows and with the floor arrangement between them, have generated an efficient barrier against erosion and the impact of large stones typical of the transport of this river, not having to intervene again in this area.

It is noteworthy that even though they are impacted, the sleepers that still remain with some exposed sector are intact.

The pipeline in the center of the riverbed, which had a 2.20 meter cap prior to the work, has managed to increase it to 3.00 m and the originally discovered area has been left with a plug of just under a meter, but it has remained stable thanks to the protections that prevent the waters from generating unwanted erosion.
