**RISK MANAGEMENT APPLIED TO THE CONSTRUCTION OF VARIANTS FOR
OLEODUCTO DE CRUDOS PESADOS (OCP): QUIJOS – COCA RIVER REGRESSIVE
EROSION CASE**

Angel Mauricio Pulupa Navarrete

OCP Ecuador S.A., Quito, Ecuador

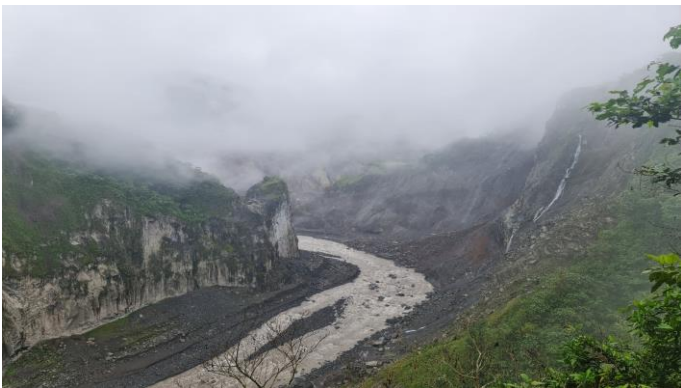
The collapse of the San Rafael waterfall has become one of the most significant case studies of retrogressive erosion in recent years. Formerly situated between the provinces of Napo and Sucumbíos, the 150-meter-high San Rafael waterfall was deemed one of the country's prime tourist attractions (2). However, in February 2020, the waterfall's collapse ensued, setting off an aggressive bed erosion process upstream in the Quijos - Coca River (Figure 2). This event, in April of the same year, reverberated throughout the hydrocarbon transportation industry in the country as it led to the rupture of two oil pipelines and a multiproduct pipeline located 1.5 km upstream from the waterfall site: Oleoducto de Crudos Pesados (OCP), Sistema de Oleoducto Trans Ecuatoriano (SOTE), Poliducto Shushufindi-Quito.

FIGURE 2: SAN RAFAEL WATERFALL, JUL 2023 [PHOTOGRAPH]. OCP ECUADOR S.A.

This condition compelled the operators to construct variants from their original routes, successfully restoring the crude oil transportation service 30 days after its rupture (3). However, the advancement of the headward erosion due to channel deepening of the Quijos – Coca River continued to impact the infrastructures situated upstream, resulting in the collapse of two bridges. One of these bridges was located at the crossing of the Montana River along the E45 road, while the other was built as an access point for window 2 of the Coca Codo Sinclair project.

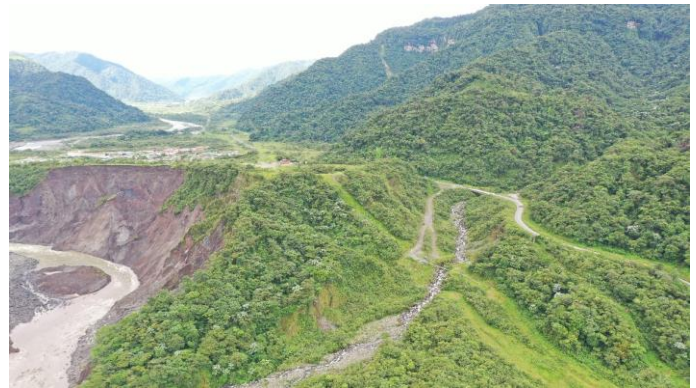
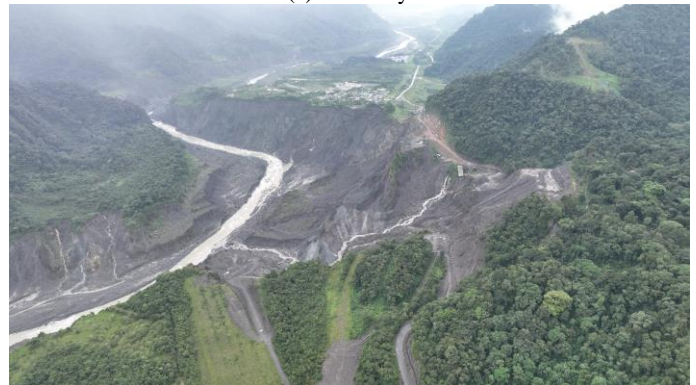
FIGURE 3: OCP KP 97. [PHOTOGRAPH]. OCP ECUADOR S.A.

From April 2020 to August 2023, it is estimated that the erosion of the Quijos – Coca River has caused the removal of 204 million cubic meters of material (Figure 3)(5). OCP Ecuador S.A., the operator of the OCP, has constructed 8 temporary bypasses and 2 permanent variants by 2023, with an estimated cost of 31 million USD. Additionally, Petroecuador EP has implemented 7 variants for the SOTE and 5 variants for the Poliducto Shushufindi – Quito, at a cost of 16.2 million USD (4).

Between March and May 2021, a gradual advancement of the lateral erosion front of the Quijos - Coca River was reported at KP 97 of the OCP (San Luis). During this period, the suggested actions from the study phase outlined in the Proximity-Based Risk Matrix were implemented. Ultimately, in April 2021, the lateral erosion front of the Quijos - Coca River was located 70m from the OCP, prompting the initiation of construction work on a bypass. This distance between the erosion and the OCP provided the necessary time to construct an 800m-long pipeline bypass before the erosion reached the original route, thus ensuring the operation of the OCP and preventing a spill of 12,000 bbl.

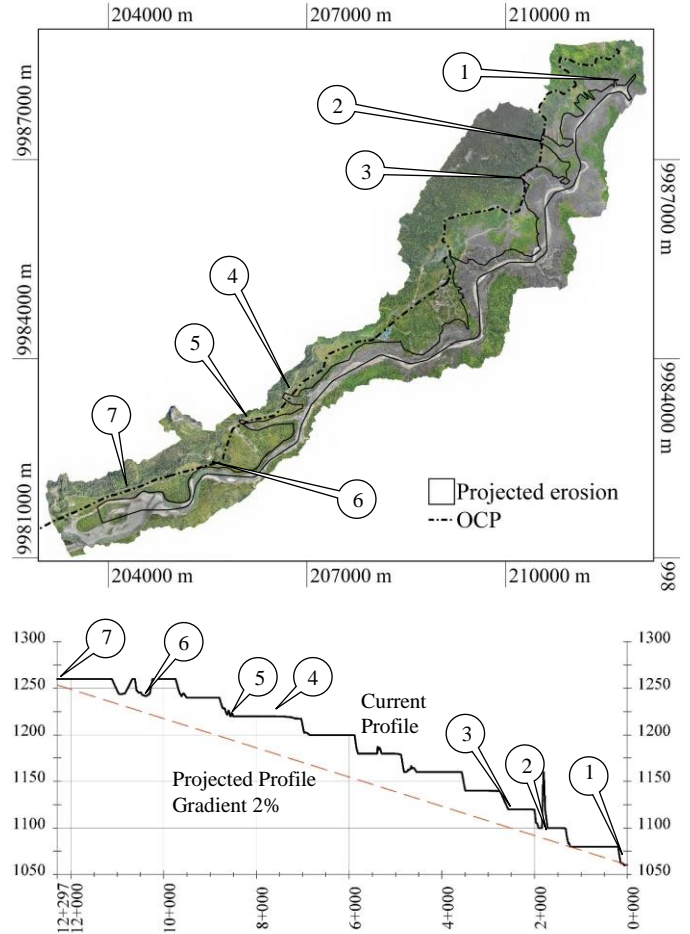
The random nature of the variables governing the behavior of regressive erosion in the Quijos – Coca River significantly complicates the temporal prediction of this phenomenon. However, using the collected data, it's possible to make an estimation of the most likely geometric configuration that the lateral erosion front would assume. Figure 8 displays the outcome of the scenario in which the Quijos Coca River channel reaches its equilibrium at a 2% slope, and its banks achieve stability at a 43° angle.

FIGURE 8: GEOMETRIC PROJECTION OF THE EROSION FRONT. BASED ON ORTHOPHOTO JUNE 2023, WGS84 Z18S.

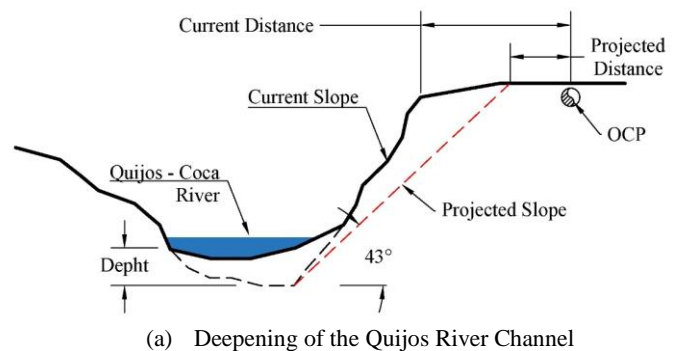
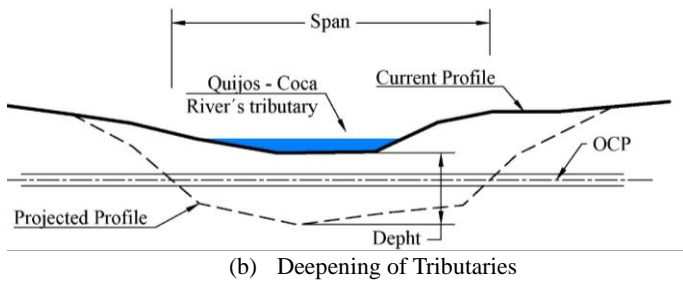
Table 1 presents a summary of the main projected impacts that the realization of this phenomenon would entail. It considers that the progression of the deepening axis of the erosion front of the Quijos - Coca River would create an elevation difference between its channel and its tributaries (Montana, Marker, Piedra Fina, Loco, and Malo rivers), triggering similar erosive processes (Figure 9)

FIGURE 9: OCP POTENTIAL IMPACTS. SCENARIOS

Point	KP	Depth (m)	Span (m)	Reference
1	93+057	-	-	2020 rupture
2	95+501	43	131	Montana river
3	96+082	69	263	Marker river
4	100+797	26	81	Loco river
5	106+615	2	67	Malo river
6	102+596	-	18	San Carlos
7	104+186	-	-	Headward location
