MANAGEMENT RISK IN BLANCO RIVER

¹Oleoducto de Crudos Pesados, Quito, Ecuador

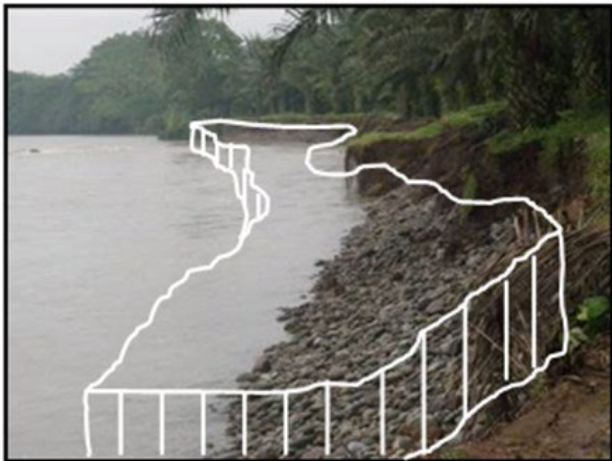
The 2011, 2017 and 2023 inspections noted changes in the river configuration, especially on banks where important sections were lost or there were coverage losses due to flooding.

Figure 1: Magnitude of erosion with a loss of the left bank in 20m.

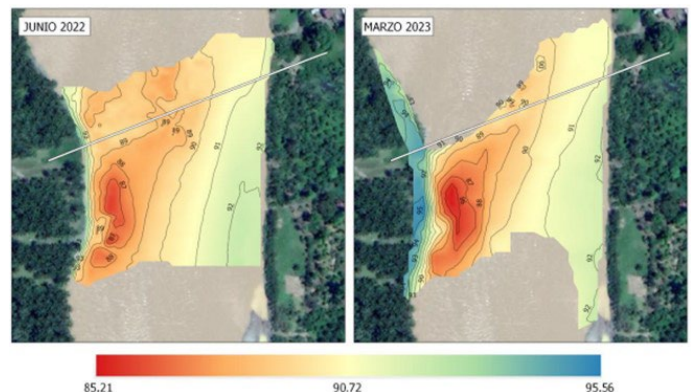
The Figure shows on the left side the bathymetric survey results in June 2022, while on the right side the bathymetric survey results get in March 2023 are shown. In March 2023, it was not possible to collect data on the pipeline axis near the left bank due to river conditions. A greater distance can be observed between the contour lines in the central zone, explicitly, a lesser slope which could initially indicate sediments accumulation or rather the erosion extension zone without any deepening, it can also be observed a lower upstream elevation and close to the river left bank, which could indicate erosion or sediment transfer.

Figure 3: Spatial bathymetry between the years 2022 and 2023.

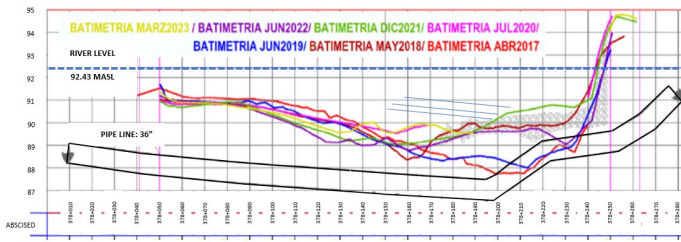
Figure 4: Illustration of the evolution of the erosion of riverbed over pipeline between the years 2017 and 2023.

Erosion changes were identified in the profiles on the pipeline from May 2017 to May 2018, where an erosion process of approximately 212 m³ was observed on the river west bank. It could be said that part of the material that was on the river west bank had moved towards the deep channel. Considering the pipe position delivered by OCP and the results obtained in the bathymetry in May 2018, the pipe was not discovered.

The erosion changes in the pipeline profiles were identified between May 2018 and June 2019, where an erosion process was observed on the river west bank of +22,201 m³ approximately. It was also determined in June 2019 bathymetry that the pipeline was partially uncovered between KP 378+206 and KP 378+238 for a length of 32 meters approximately.

In June 2022, abrupt changes in erosion and sedimentation were observed on the west bank between KP 378+190 and KP 378+240, while on the east bank, the pipeline remains protected by an approximate burial level of three (3.0) meters between KP 378+050 and KP 378+090.

Currently, sedimentation changes are identified in the pipeline profiles between June 2022 and March 2023, where a sedimentation process was observed on the east bank of the river, between KP 378+090 and KP 378+190. It is also determined that from KP 378+050 to KP 378+190 the pipe is buried an average of 2.26 meters.

The deposit of stone material, recommended in 2019, contributed to protecting the pipeline, therefore, in 2020 the pipeline was buried more than 2 [m] deep.

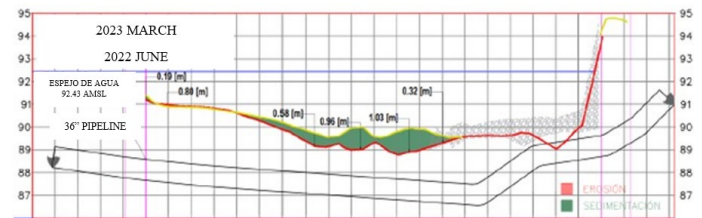
From the graph profiles, we can identify an increase in height between approximately 2 cm - 99 cm between the KP 378+090 and KP 378+190. The bathymetries directed in 2022 and 2023, it is observed that there is little erosion and a greater tendency of sedimentation in the channel tending towards the river right bank.

Figure 5: Illustration of the evolution of the erosion of riverbed over pipeline between the years 2022 and 2023.

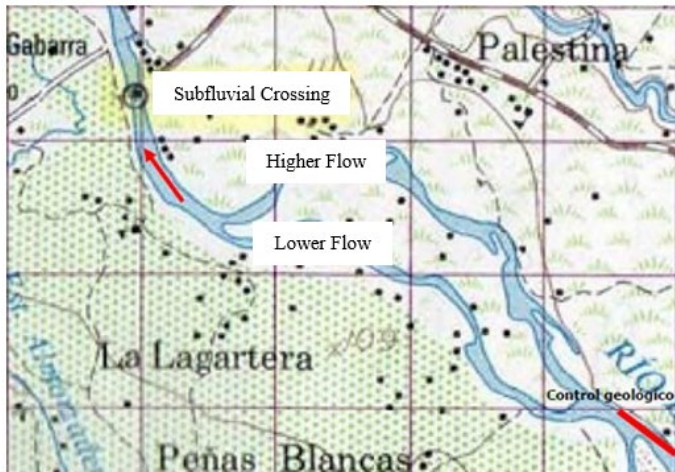
Figure 8: Configuration of the Blanco River with two branches before the sub fluvial crossing.

The Blanco River in the crossing sector is a winding and branching river. The crossing upstream is an island in the center of the river with two lateral channels. Upstream of the island on the right bank, there is a rock outcrop which acts as a geological control and directs flow towards the right side. The right channel currently handles a higher flow than the left channel. For this reason, the channel downstream of the confluence is mainly controlled by the right channel.

As a result of channel control through the right channel, a curve with extrados is formed towards the right bank towards the OCP crossing area.

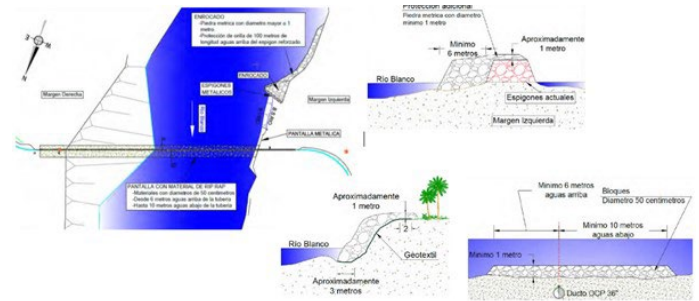
Figure 12: Recommended works to control erosion in the channel and left bank.

It is recommended to reinforce the existing breakwater by expanding its width and protecting its embedment against the shore. It is recommended to do this work using metric stone.

It is recommended to build a lateral protection upstream of the breakwater using metric stone.

It is recommended to place RIP-RAP from 6.0 meters upstream to 10 meters downstream on the ROW along the entire length of the crossing. This armoring generates bottom control, decreasing the depth of the channel and improving the stability of the pipeline at the crossing site.

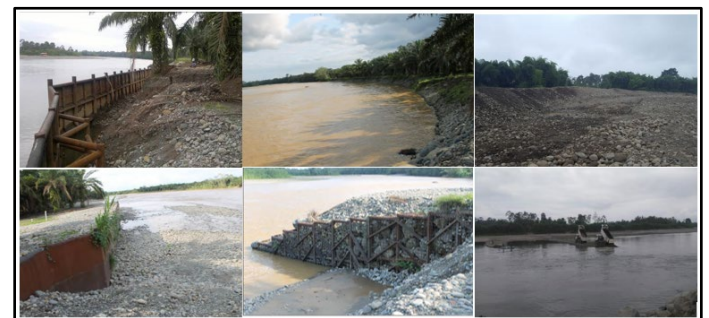
Figure 13: Sequence of implemented erosion control works.

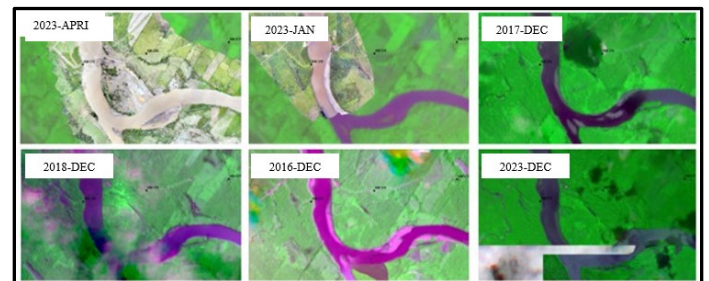
The multitemporal analysis focuses on 3 critical points (of the 2 polygons surveyed): KP 379, KP 381 - 382 and KP 389. To carry out this analysis, the orthophotos generated by Drone & Gis in September 2022, January 2023, and April 2023, as well as Planet satellite images from January 2022, November 2020, December 2019, December 2018, December 2017, December 2016, and December 2015. In the case of satellite images, a combination of bands 1, 4, 3 to give more prominence to the water. Below are the images of the points mentioned for the different dates analyzed:

Figure 14: Multitemporal analysis satellite images.

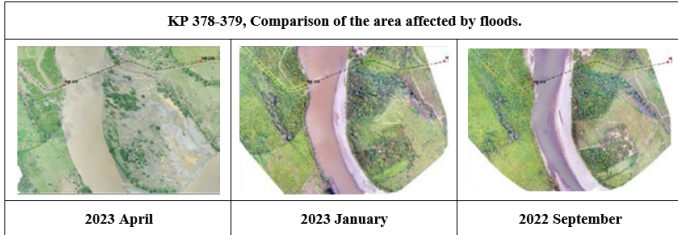
In the April 2023 survey, it has been identified that in the sector of the Blanco River crossing, (KP 378 -379) an area of about 23 hectares has been affected by floods and because of this there is evidence of a loss of vegetation on this surface. The following images show the comparison between the last 3 monitoring carried out in this sector:

Figure 15: Analysis of orthophotos between the years 2022 and 2023.

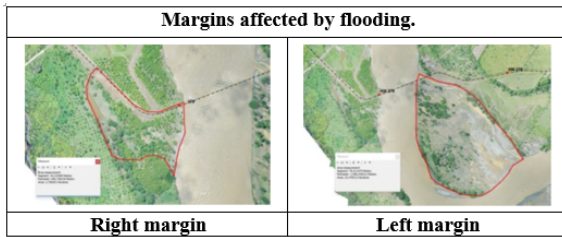
Figure 16: Evidence of the dragging of material on the banks of the Blanco River caused by flooding.

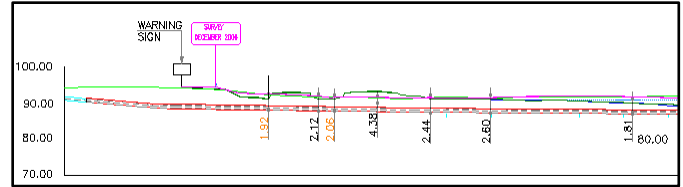
The following graph shows the two erosion areas on the right bank of the Blanco River, as a consequence of the extraordinary floods that occurred in the first four months of the year 2023, the erosion areas are produced by water currents that were washing the sandy silt material of which it is composed lithologically, the margin, although there is erosion, the integrity of the pipeline is not in danger. The possibility that a similar event occurring in 2024 is quite probable since the flooding was

caused by the overflow of a dam that the mining activity built several years ago, and which was insufficient.

Figure 18: Enlargement of the right section of the bathymetric profile, (August 2023).

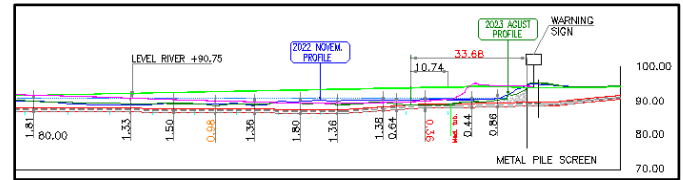
The graph below shows two important erosion areas, the first located in the middle zone of the river, where the cover is 0.98m, slightly like the cover in November 2022. The most important finding is located close to the left bank, where the loss of cover of the pipe is evident, which includes the uncovering of a third of the structure, in a length of 10.74m. There is no possibility of a no-support condition as an immediate event.

Figure 19: Enlargement of the left section of the bathymetric profile, (August 2023).
