Landslide phenomenon that affected the integrity of the OCP DDV at abscissa KP 318+419; analysis and solution.

Efrén Santin¹

Oleoducto de crudos Pesados OCP Ecuador S.A

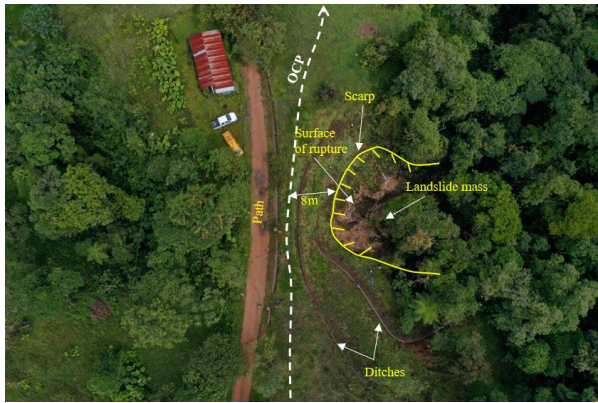
FIGURE 1. Slide location.

The heavy crude oil pipeline (OCP Ecuador S. A) at the abscissa KP 318+419 crosses a low to moderate hilly area and is surrounded by moderate slopes with grassland vegetation within the right of way and secondary forest in the right bank outside the easement strip. The site where the landslide occurred is a gully that was filled with soil from the cutting of slopes during the construction of the ROW, this phenomenon of mass removal generated corresponds to a crescent-shaped rotational landslide, the escarpment formed by the landslide had a height of 11m and a length of 48m, the distance to the axis of the OCP was 8.0m (see figure 1); the slope has a slope of 40 degrees. (OCP ECUADOR S.A, 2021).

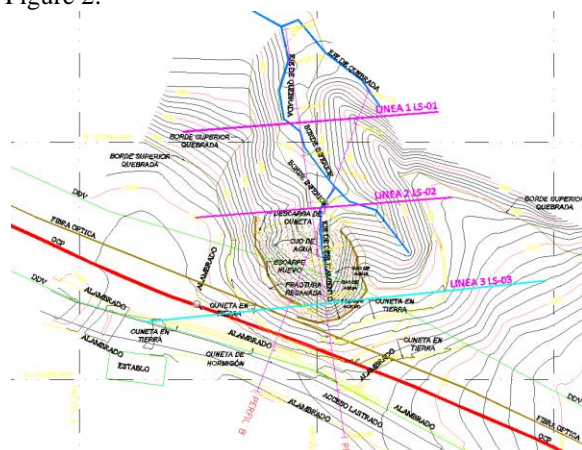
FIGURE 2. Location of the lines of geophysical research.

In the KP 318+400 sector, three seismic lines were executed, two of 55.00 meters and one of 80.00 meters in length, whose location by coordinates is show in Figure 2.

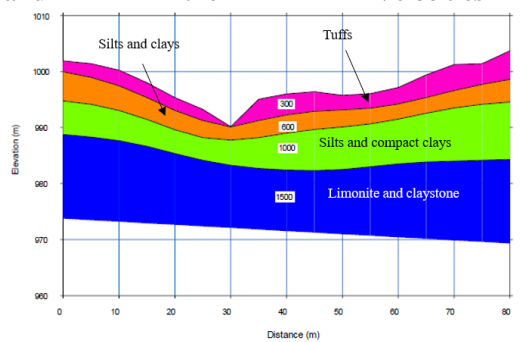
FIGURE 3. Interpretation of the geophysical line LS-03 As can be seen, the materials that make up the geological environment are very similar, the distribution in layers is

due to the different degree of compaction, moisture content, etc. (OCP Ecuador S.A, 2021)

The lithology of the site corresponds to a sequence of dark brown tuffs with an average height of 4.0m, its SUCS classification corresponds to clayey silt and sandy silt soils, slightly humid, under this stratum there is a layer of very compact light gray clays, and at the base of the landslide the presence of a layer of weathered yellowish-white siltstones of very compact consistency was observed. The subsurface water runoff is observed through these two layers of material, and they constitute the fault plane of the landslide (see figure 2 and figure 3). (OCP Ecuador S.A, 2021)

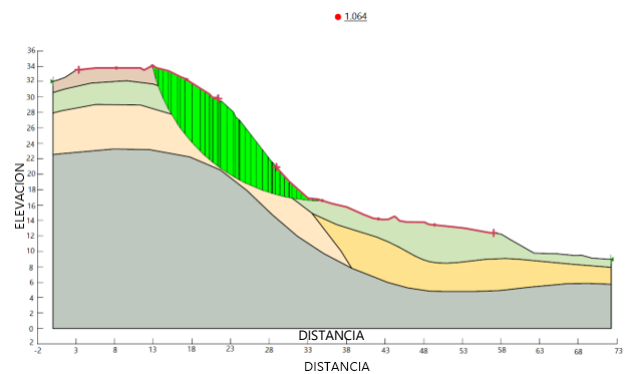
FIGURE 6. Stability analysis under static conditions.

In this stage, the stresses and deformations are generated under the current conditions, that is, according to the parameters obtained from the undisturbed samples, a stability analysis is carried out, assuming a rise in the water table. As a result, it is obtained that the slope in static conditions was stable.

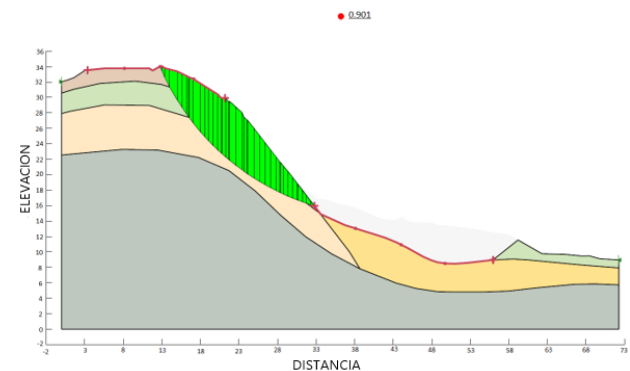
FIGURE 7. Stability analysis under pseudostatic conditions.

In this stage, a retroanalysis is carried out in the stability analysis model, where a loss of the values of the mechanical properties of the soil is considered due to the saturation of the soil structure. That is, make a model in which the problem of slope instability is presented with the objective of reproducing the approximate change pattern in pseudostatic conditions (with seismic acceleration data according to the history of earthquakes in the area of influence of the study site). As we can see in the figure, the slope is unstable with the presence of earthquakes of moderate intensity.
