## **WORKS PERFORMED AS MITIGATION MEASURES AFTER HEAVY RAINFALLS**

Petrobras Transporte S.A. - Transpetro  
São Sebastião, Brazil

### **ABSTRACT**

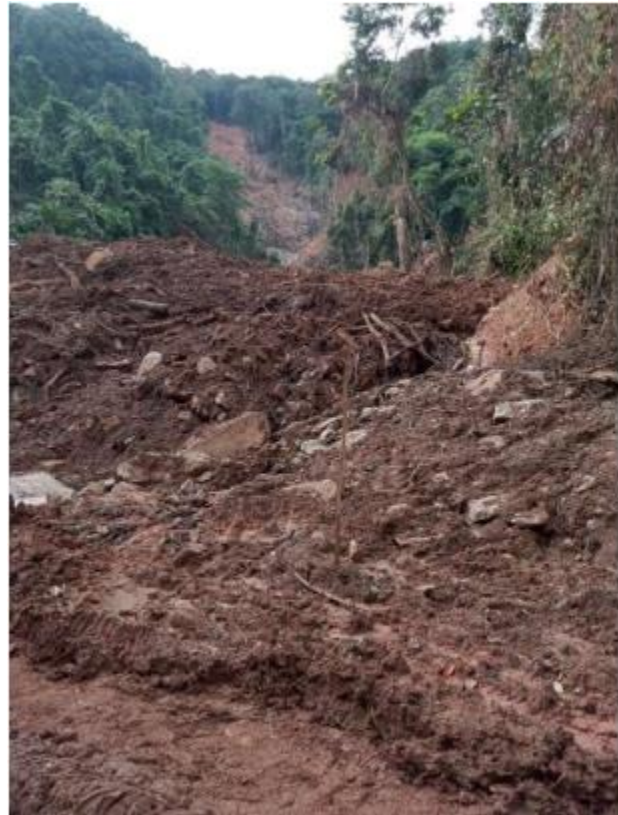
Km 36+150:

Occurrence of high-dimension landslide on steep, high and densely vegetated natural slope. Great quantities of soil, rock and mud formed a mudflow (3).

Figure 1: km 36+150 right after the rainfall (4)

Visual reconnaissance of the right-of-way, cleaning of the area by means of removal of soil and trees, pipe localization field survey, installation of steel plates, re-sloping of upstream debris, installation of provisional drainage system to divert water which would otherwise open new paths.

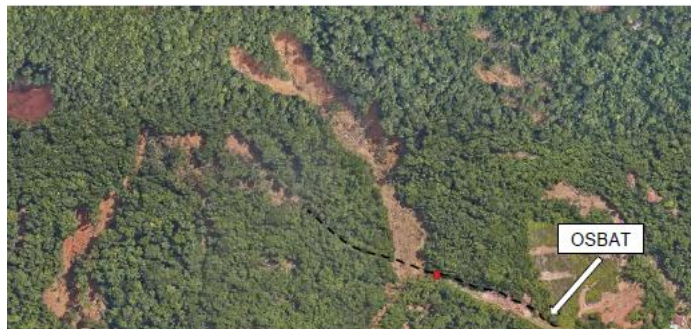
Figure 2: Aerial view showing large landslides. (3)

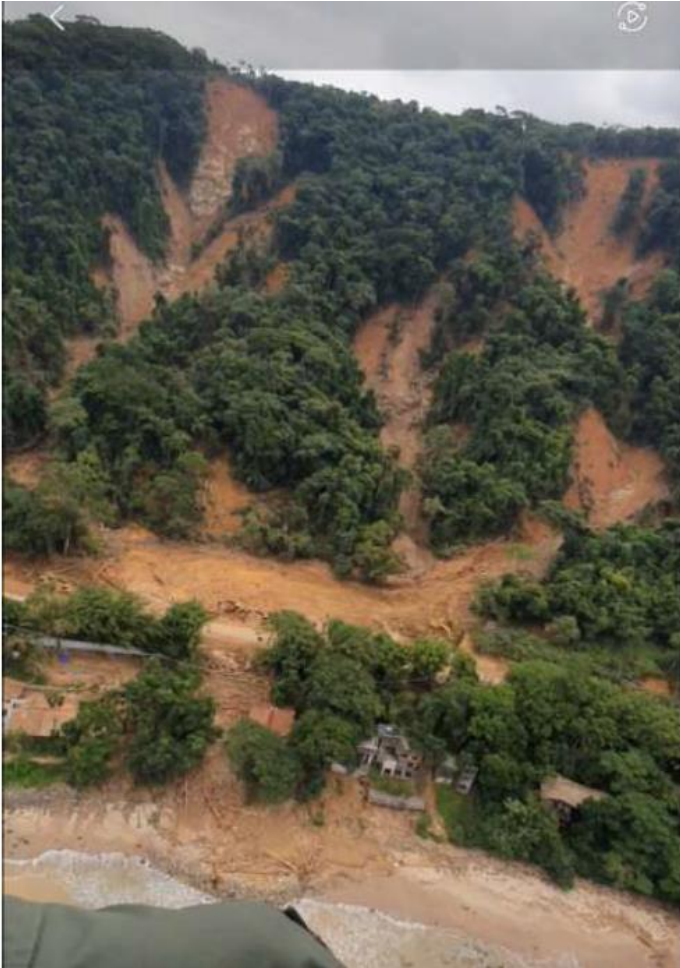
Km 37+000:

Massive spot affected by three large debris flows (4) on very steep natural slope, densely vegetated. Large amounts of soil and vegetation converged forming a downhill movement, reaching tens of meters down to the nearby highway. Many logs and rocks were in movement, others remain in the thalweg awaiting conditions to move again. Exposed rock can be seen at the top, showing the huge erosive power of the process. Channels were sculped along the flow path, leaving the exposed rock at the top. (3)

Figure 3: km 37+000 - Three debris flows crossing the right-of-way and the road reaching the shore. (4)

Visual reconnaissance of the right-of-way, cleaning of the area by means of removal of soil and trees, pipe localization field survey, installation of steel plates, installation of furrows at the main landslide event, installation of provisional drainage system to divert waters which would otherwise open new paths, and ground levelling with the nearby roadway.

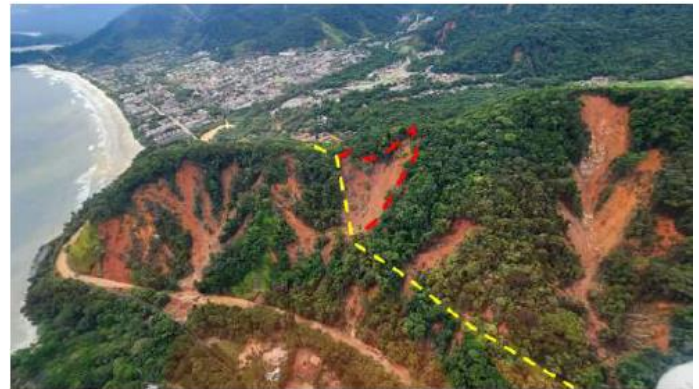
### Km 37+500:

Large landslide upstream from the right-of-way and transversal to it, debris deposition over the right-of-way. Inertial PIG run showed no evidence of lateral movement, evidencing the movement was not deep. (4)

The landslide scar has considerable width, showing how large a soil and vegetation amount was involved in this event.

Figure 4: km 37+500: Large upstream landslide, yellow dotted line shows OSBAT

Visual reconnaissance of the right-of-way, cleaning of the area by means of removal of soil and trees, pipe localization field survey, installation of provisional drainage system to divert water.

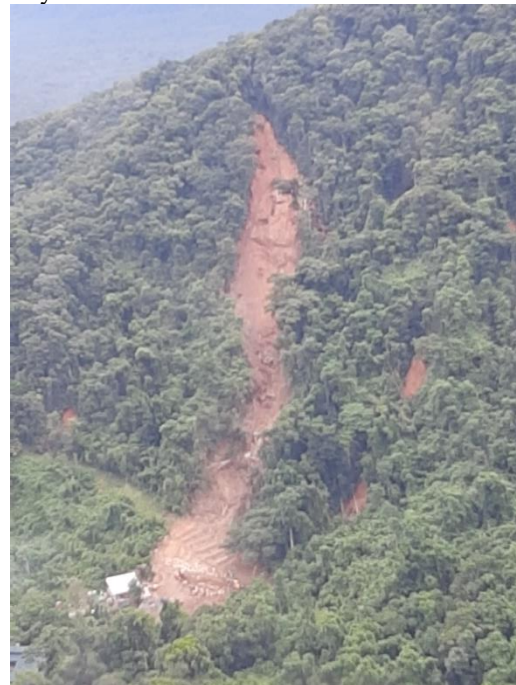
### Km 41+100:

Upstream lateral landslide, large volume of soil, rocks and trees moved downhill and deposited on the right-of-way. Huge mass amounts deposited on the right-of-way, potentially overloading the pipeline.

Soil, rock, and trees moved downhill, reaching the right-of-way and a house.

Figure 5: km 41+100 - Deposited mass on the right-of-way

Visual reconnaissance of the right-of-way, cleaning of the area by means of removal of soil and trees, pipe localization field survey, installation of steel plates, installation of furrows at the main landslide point to divert water.

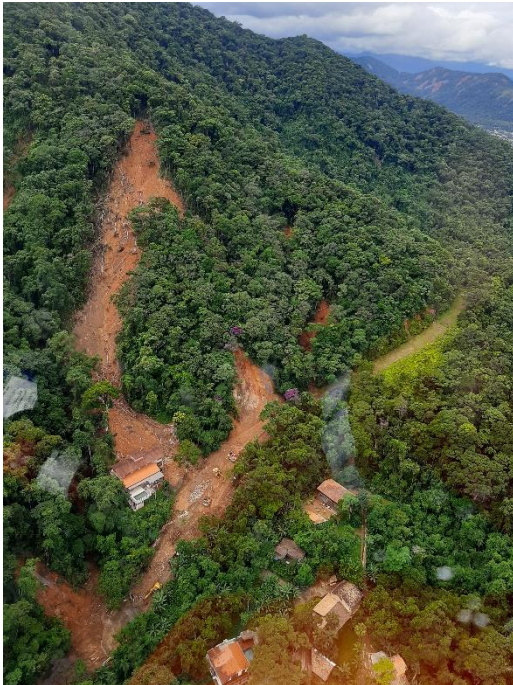
### Km 41+700:

This spot was affected by two process types: huge landslide followed by mudflow and cut slope slide involving both soil and

rock. Additionally, downstream from the right-of-way, another landslide occurred.

Figure 6: km 41+700: Multiple occurrences

Visual reconnaissance of the right-of-way, cleaning of the area by means of removal of soil and trees, pipe localization field survey, installation of steel plates, installation of furrows at the main landslide center, installation of provisional drainage system, removal of loose rocks, provisional covering of downstream slope with plastic sheets.
