ASSESSMENT OF PIPELINE RIVER CROSSINGS UNDER ENVIRONMENTAL CHALLENGES

Marcelo Moya
 TBG
 São Paulo, Brasil

Guilherme de Lima
 NHC
 São Paulo, Brasil

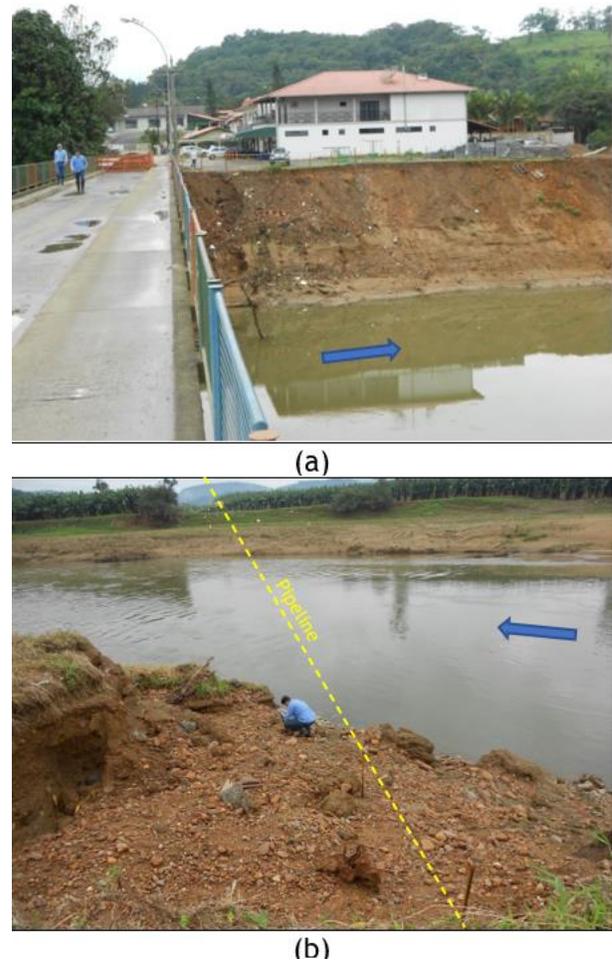
In June 2014, an extreme rain event caused significant flooding in the cities along the riverbanks, including Jaraguá do Sul and Guarimirim. This event led to bed degradation and bank erosion at various locations along the Itapocu River, resulting in damage to bridges and other infrastructure (Figure 1).

Figure 1. BANK EROSION NEAR A DOWNSTREAM BRIDGE (a) BANK EROSION AT THE CROSSING (b). PREPARED BY THE AUTHORS (2025).

The study concluded that detailed investigation and implementation of mitigation measures are necessary to protect the pipeline on the left bank. Recommended options include the use of riprap structures on the left bank and more frequent monitoring of the pipeline cover in the main channel, as bed degradation can pose a long-term issue.

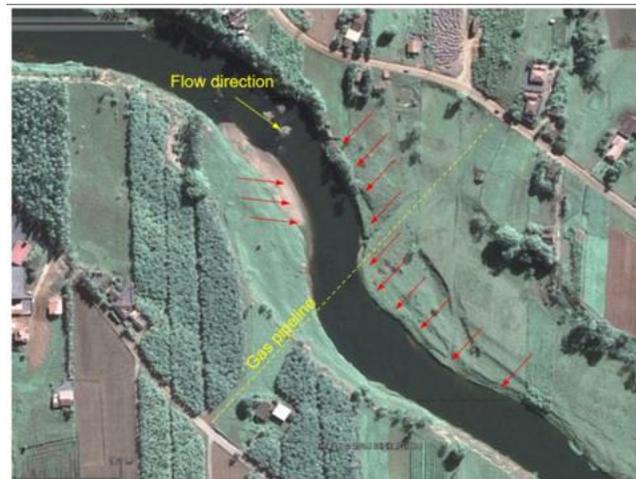
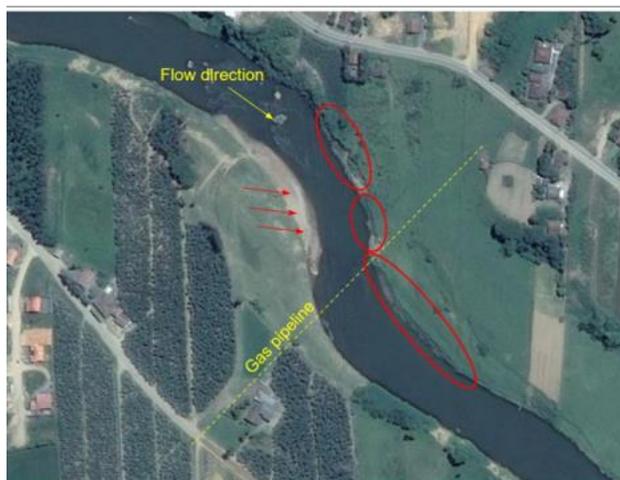
In addition to the hydrologic study, a morphological assessment was conducted using satellite images taken before and after the flood event. Figure 2 illustrates the study area in 2009 and 2014. The high flow velocities during the flood event caused severe bed degradation and bank erosion on the left bank at the crossing. Although the pipeline remained covered in the main channel, the top of the pipeline became exposed for a few meters on the left bank.

The geomorphic analysis identified the presence of a small dam for water supply upstream of the crossing and sand mining activities in the river. These factors have reduced the amount of sediment available, thereby increasing the potential for erosion processes in the river

Figure 2. STUDY AREA IMAGERY IN (a) JUNE/2009 AND (b) JUNE/2014. PREPARED BY THE AUTHORS (2025).

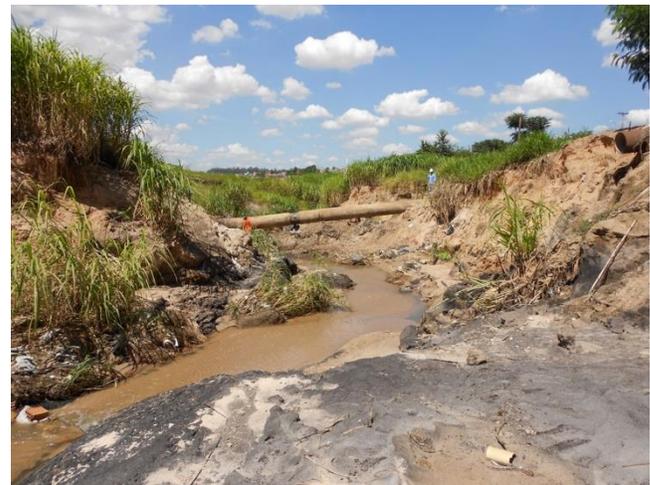
An accelerated erosion process occurred at the Jardim Novo Maracanã creek crossing, resulting in the exposure of the pipeline following intense rainfall in late February and early March 2015 (Figure 3).

Figure 3. PIPELINE EXPOSED AFTER AN EXTREME FLOOD EVENT AND CHANNEL DEGRADATION PROCESS. PHOTO FROM 02 DE MARCH 2015. PREPARED BY THE AUTHORS (2025).

Several alternatives were evaluated to protect the pipeline and stabilize the ongoing erosion process. These included the implementation of an aerial crossing, the use of concrete culverts to support the pipeline, the river channel restoration, and the lowering and replacement of the crossing.

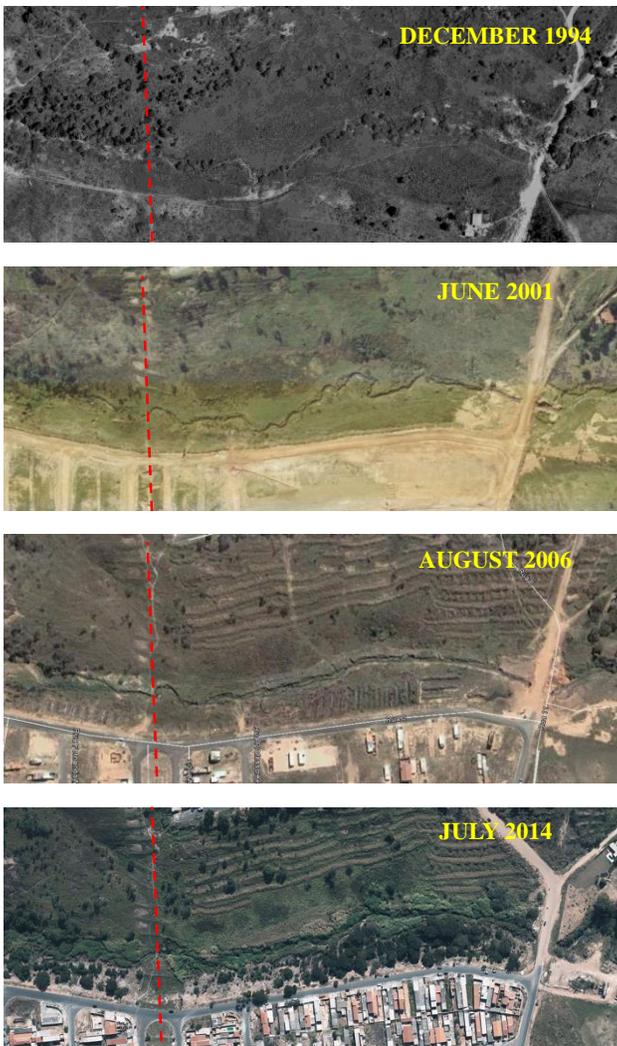
Hydrotechnical analysis revealed significant morphological changes in the stream, including channel erosion and channel straightening. Figure 4 presents satellite images showing the changes that occurred in the river channel. These changes, driven by urbanization and the stream's natural characteristics, progressively reduced the soil cover over the pipeline, ultimately leading to its exposure triggered by a flood event.

Figure 4. SATELLITE IMAGERY ANALYSIS. PREPARED BY THE AUTHORS (2025).

Satellite and aerial imagery indicate that bed lowering began prior to 2001. In response to erosion identified in 2004, a gabion mattress structure was constructed to protect the pipeline and mitigate further degradation. While this intervention temporarily stabilized the upstream section, downstream retrogressive erosion persisted and likely intensified between 2005 and 2006, exacerbated by urban development (construction of a culvert at the downstream street). Contributing factors include increased impervious surfaces, stormwater drainage systems, and higher peak flood discharges.

The 2014 image (Figure 4) confirmed ongoing erosion downstream, showing the gabion structure, an energy dissipation basin, and signs of bank failure on the left margin. Continued bed lowering downstream eventually undermined the gabion base, creating a vertical drop that accelerated flow velocity during

floods (supercritical regime). This led to localized scour and structural failure of the protection system.

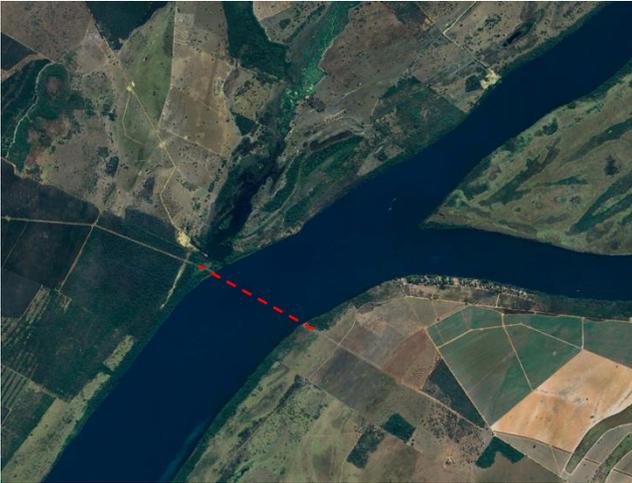
The Paraná River crossing is located between two hydroelectric power plants. It is located approximately 25 km downstream from the Jupuí HPP dam and about 200 km upstream from the Porto Primavera HPP dam. At the crossing, the Paraná River channel is approximately 1 km wide. Around 2 km upstream from the crossing, there is a river island known as Ilha Comprida (**Figure 5**).

Local changes in the fluvial geomorphology (riverbanks and riverbed) have been occurring since 1998 in the area near the crossing, causing continuous variations in the coverage and exposure of the pipeline's upper part, as well as erosion along the banks which is a risk to the integrity of the gas pipeline.

Figure 5. SATELLITE IMAGERY OF CROSSING LOCATION. PREPARED BY THE AUTHORS (2025) BASED ON A GOOGLE EARTH IMAGE.

The erosive processes observed at the crossing are active and are expected to continue progressing. However, due to the local geomorphological and hydraulic characteristics, erosion at this site tends to occur gradually. Since the pipeline's upper part is already exposed in some sections and is likely to become exposed in others, pipeline protection works should be implemented. Possible alternatives for protecting the pipeline include lowering the pipeline using Horizontal Directional Drilling (HDD); excavating a deeper trench parallel to the current crossing; or covering the right of way with a layer of small riprap, gabion mats, or articulated concrete mats.

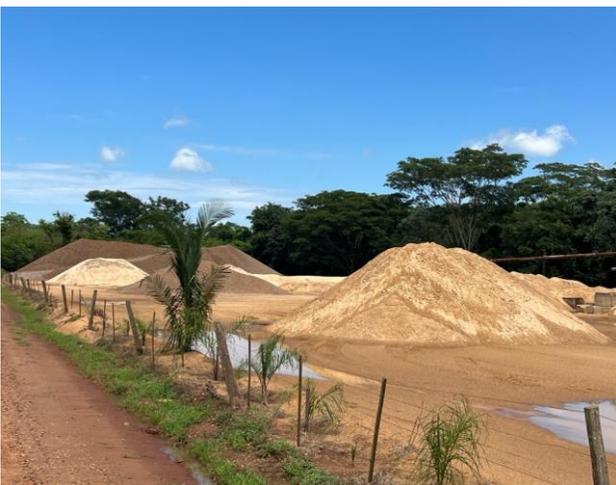
Additionally, large volumes of sand and gravel are extracted through dredging near the crossing, which alters the riverbed geomorphology, reducing coverage and/or exposing the pipeline (Figure 6). Moreover, there is constant vessel traffic that generates waves and turbulence along the banks (Figure 7).

Figure 6. PHOTO FROM SAND DREDGING ACTIVITIES. PREPARED BY THE AUTHORS (2025).

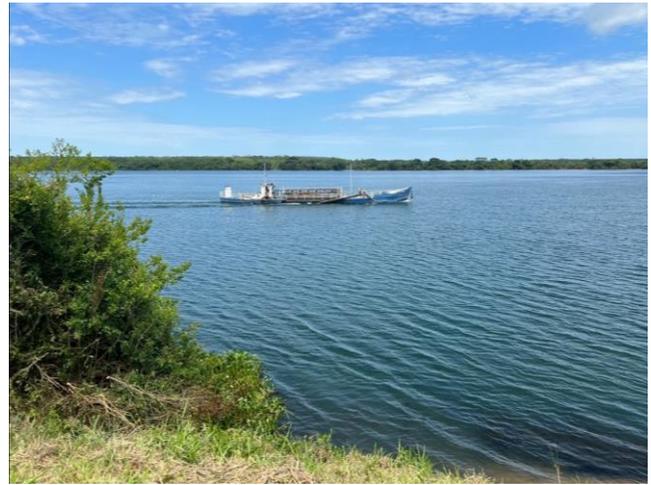
Figure 7. PHOTO FROM VESSEL NEAR THE PIPELINE CROSSING. PREPARED BY THE AUTHORS (2025).
