IPG2025-003

GEOLOGICAL GEOTECHNICAL INSPECTION ON 2.600 KM ON THE RIGHT OF WAY IN BRAZILIAN GAS PIPELINE

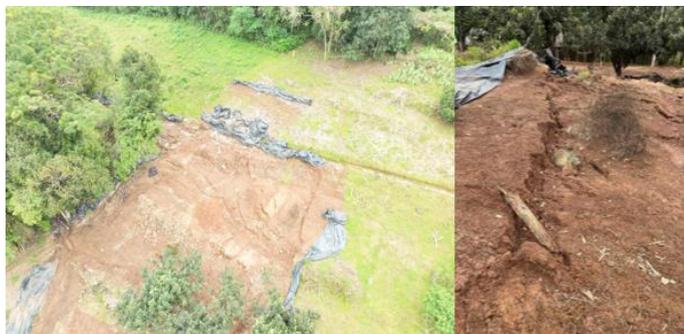
- I. The occurrence at km 1117+187S (Figure 3) consists of a landslide accompanied by fissures along the pipeline right-of-way, primarily on the left side and extending laterally toward a nearby road (approximately 20 meters from the right-of-way). The fissures are predominantly aligned longitudinally with the pipeline, although some transverse fissures are also observed. The fissure system exhibited progressive displacement, forming subsidence steps ranging from centimeters to decimeters in height. Initially, the area showed signs of incipient creep; however, following the extreme weather event, the movement rate reached levels consistent with landslide conditions, according to the classification proposed by Varnes (1978).

FIGURE 3 – Km 1117+187S – The base of the image corresponds to the left side of the right-of-way. On the right, detail of the subsidence step and erosional rills.

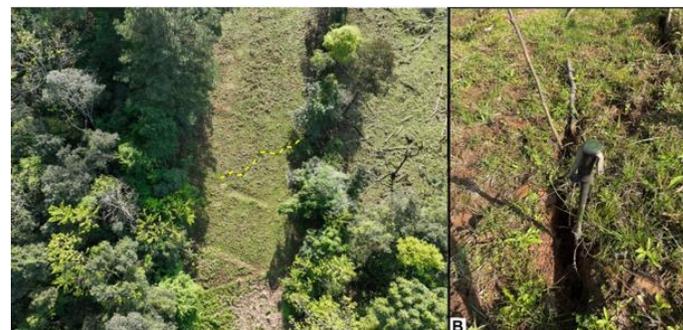
- IV. The newly identified occurrence at km 1120+670S (Figure 6) refers to a midslope landslide that resulted in a surface crack approximately 15 meters in length, transversely crossing the pipeline right-of-way, with a vertical displacement (scarp) of up to 0.2 meters.

FIGURE 6 – A) Aerial image of the study area. The crack is represented by the yellow dashed line. Downstream is at the top and upstream at the bottom of the image. B) Detail of the crack.

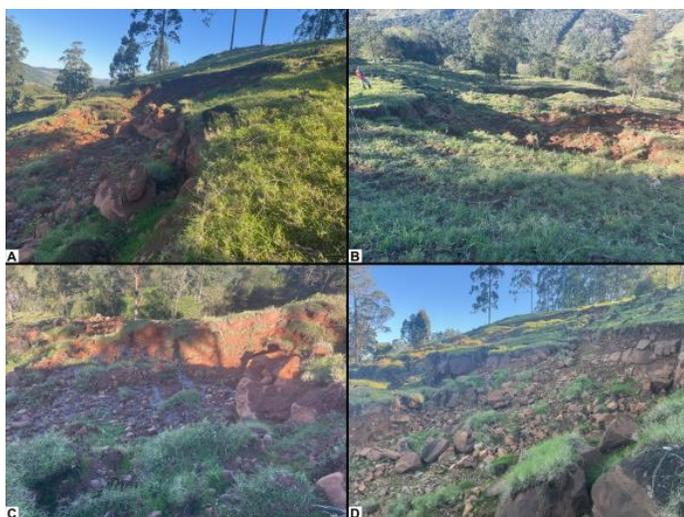
- II. The geotechnical occurrence at km 1119+813S (Figure 4) consists of a landslide located outside the pipeline right-of-way, on its eastern side, approximately 10 to 15

meters from the right-of-way boundary. Due to the local geology, characterized by volcanic flow deposits, only a thin soil layer (ranging from centimeters to decimeters) overlies the bedrock, forming a sharp contact that favours the development of this type of sliding feature. Interflow sedimentary layers between the volcanic flows typically facilitate strong horizontal groundwater movement, resulting in a water emergence at the slip surface that further contributes to the landslide process. As observed previously, this configuration indicates the evolution of pre-existing creep processes, whose velocities increased significantly due to the abnormal infiltration of rainfall into the rock mass.

FIGURE 4 – Geotechnical occurrence at km 1119+813S, classified as having an aggravated risk level. A) Downstream view. B) Upstream view. C) Detail of the slip surface with water emergence. D) Downstream view.

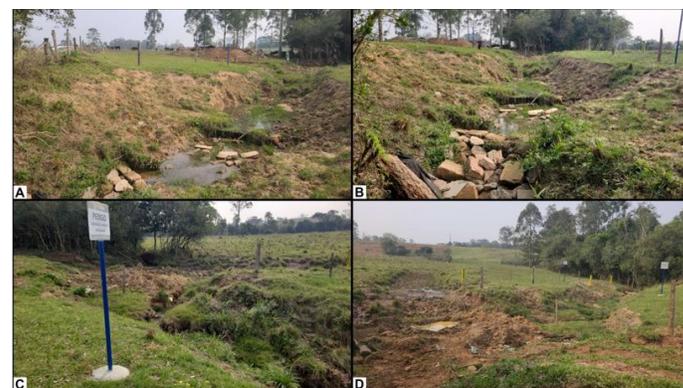
- V. The occurrence at km 1156+066S (Figure 7) refers to erosion affecting both banks of a watercourse, including its channel and the western edge of the pipeline right-of-way. It is recommended to monitor the progression of this feature and, in case of worsening erosional processes, assess the conditions and develop a containment project for the crossing, focusing on stabilizing both banks, restoring the right-of-way slopes—especially the right bank—and rehabilitating the channel. The erosion was intensified due to the abnormal water flow in the area.

FIGURE 7 – Geotechnical occurrence at km 1156+066S with aggravated risk classification. A) Downstream view from the upstream bank and left side of the pipeline. B) View of the right side from the crossing point. C) Downstream bank view towards the right side. D) Upstream view from the downstream bank and right margin.

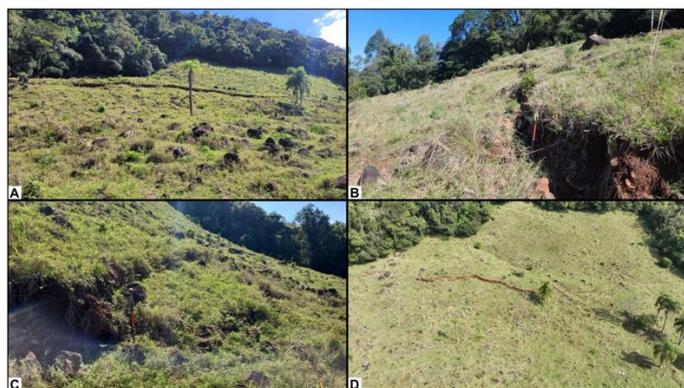
- III. The geotechnical occurrence at km 1120+210S (Figure 5) refers to a landslide/creep process located outside the pipeline right-of-way, on the western slope, approximately 80 meters away. The landslide scar is approximately 100 meters long, subparallel to the pipeline corridor, and exhibits a scarp with a vertical displacement of up to 1 meter in the most downstream sections. The exposed layer reveals a predominantly colluvial soil composition. Such heterogeneous and poorly consolidated soils are highly susceptible to mass movements. Once again, the percolation of rainfall into the rock mass contributed to increased velocities in the creeping process, ultimately leading to a landslide.

FIGURE 5 – Geotechnical occurrence at km 1120+210S, classified with an aggravated geotechnical risk level. A)
