IPG2025-006

URGENT INSPECTIONS AND ACTIVITIES ON THE RIGHT-OF-WAY AFTER HEAVY RAINFALL IN RIO GRANDE DO SUL - BR

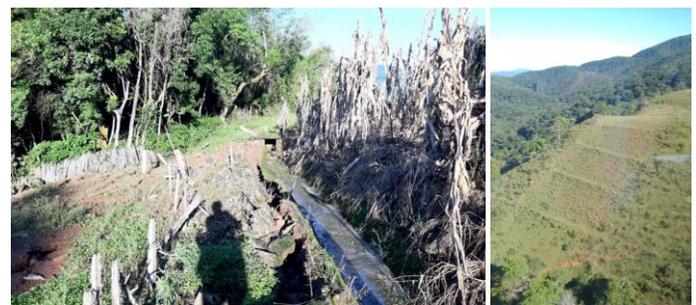
When access was possible, field inspections were carried out at “Sensitive Sites” where faults in the terrain were noted, followed by an Aerial Geotechnical Inspection using a helicopter to assess the damage dimensions (Figure 2).

FIGURE 2. Field and Aerial May 2023 images of Geotechnical hazards on RoW Rio Grande do Sul TBG Pipeline segment. Prepared by the authors (2025).

In these inspections, approximately 80 geotechnical anomalies were identified, of which 17 required reassessments and two were considered more critical (risk level “medium”).

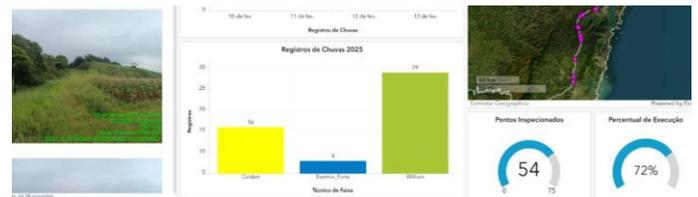
Figure 9. The result of the inspections with the assessed geotechnical occurrences and the productivity of the field team.

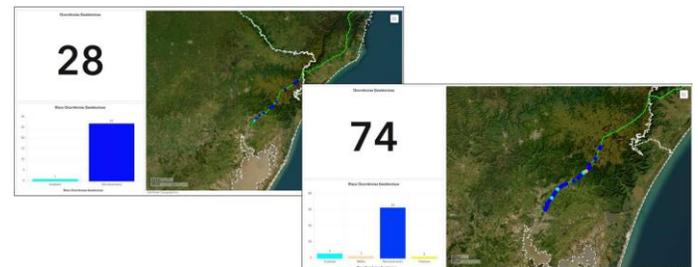
Finally, since there was the data from the last geological-geotechnical inspection, recently carried out months before the event, it was possible to compare how much the section was damaged by the rain, as shown in figures 10 and 11, where the number of known occurrences increased from 28 to 74.

Figure 10 and 11. The result of the inspections before the events and after the events.
