RIVER CROSSINGS: RIVER DIVERSION THROUGH THE RIGHT OF WAY

Martín Carnicero
Transportadora de Gas del Norte
Buenos Aires, Argentina

ABSTRACT

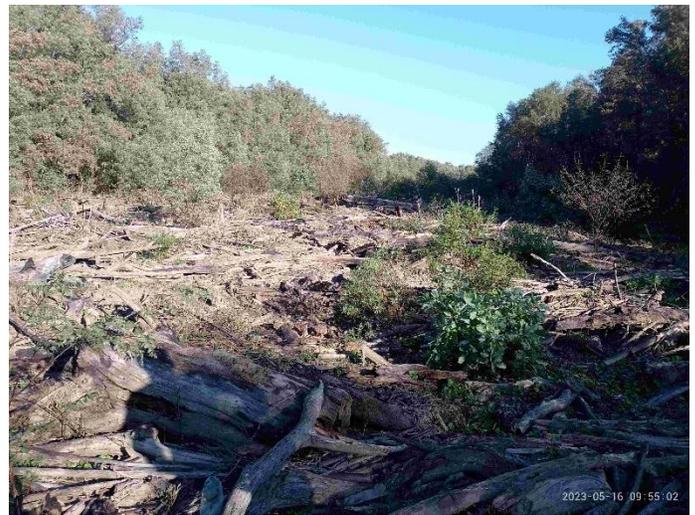
Putting together the high discharge, small dimensions of the river and mild slope, flooding of a huge area becomes apparent. The river responds to this combination of factors by dividing its course into many branches which after a while are blocked with debris and sediments, before opening a new branch. Also, every rural road within the flood valley becomes a water course, changing the flow pattern and, thus, the amount of water and the location where water enters the ROW.

FIGURE 5: BLOCKED RIVER BRANCH WITH DEBRIS AND FINE SEDIMENTS

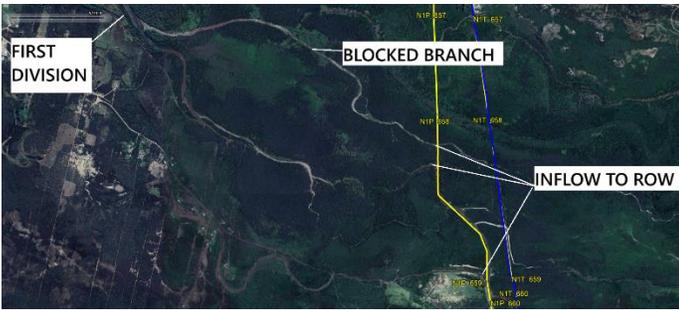
FIGURE 6: POINTS OF ENTRANCE INTO THE ROW

In successive years after construction water entered the ROW first at the main river course, then after it was blocked, using old meanders and low zones to other three points of entrance.

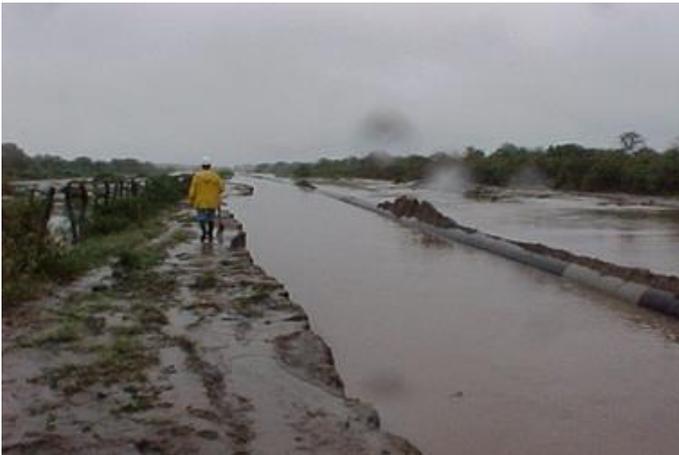
This process took place on both lines ending in the exposition of pipelines after extreme flood events; one in 2000 and the other in the summer of 2016. As seen in Figures 7 and 8, two long segments (of approximately 80 meters) of pipeline without counterweights were exposed, that coincide at locations where the ditch raised slightly its elevation.

FIGURE 7: BUOYANCY OF 24” LINE AFTER YEAR 2000 FLOODING

Final remediation was reached for de 24" line by horizontal directional drilling a new crossing that is approximately 1,100 meter long and 20 m deep. The same alternative was chosen for the 30" line nowadays.

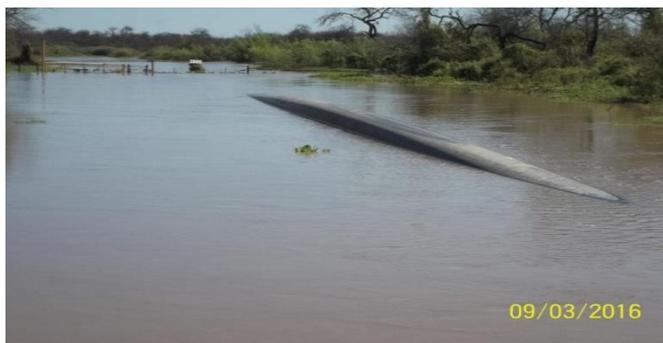
FIGURE 8: BUOYANCY OF 30” LINE AFTER YEAR 2016

For the 30” line, preliminary remediation was implemented whenever access was possible after water recede. Given the massive flood that occurred throughout the entire flood valley, access became a problem. The nearest paved road is 10 km west, while dirt roads, which are privately owned, are between 10 and 17 km long. Upgrade and maintenance of access roads involve a considerable amount of time and money. Given the fact that rain could end in May and floods can begin in October, the time window of dry weather and access that allows to implement a major scale remediation work limited to four months (June through September).

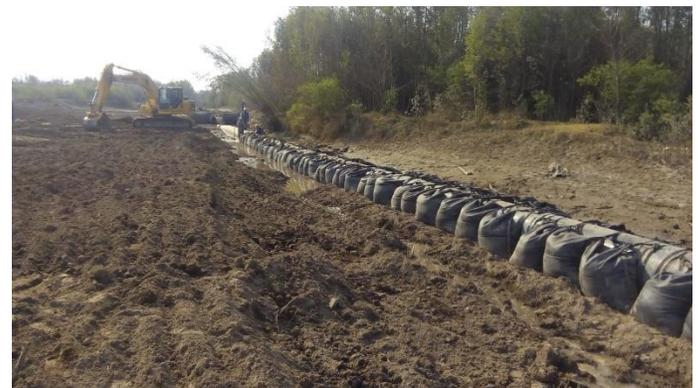
Temporary remediation works were undertaken consisting of sandbags placed over the pipeline. Originally, they overcame buoyancy forces. However, since water kept flowing along the ROW, its foundation was eroded. Thus, an instable situation developed in which the pipeline was ok with the counterweights while flooded but then tensioned downwards when not. This was solved by avoiding free spans by supporting the bottom of the pipeline.

FIGURE 10: SANDBAGS PLACED FOR PRELIMINARY REMEDIATION

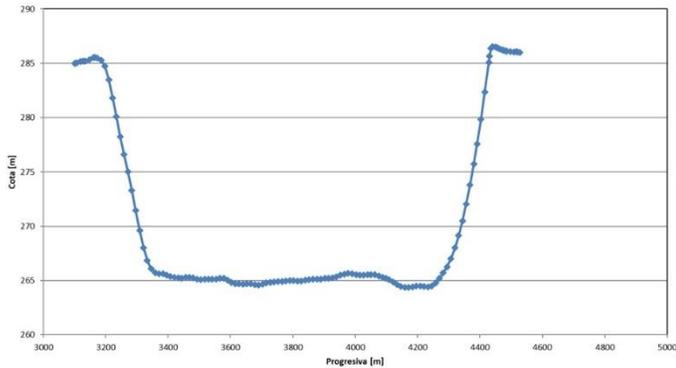
FIGURE 11: NEW HDD CROSSING FOR THE 24" LINE

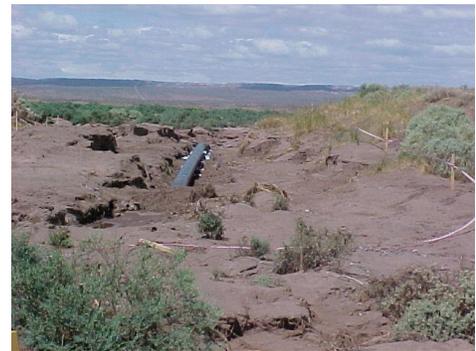
FIGURE 14: PIPELINE EXPOSED AT THE EDGE OF FLOODPLAIN AFTER 2004 FLOOD

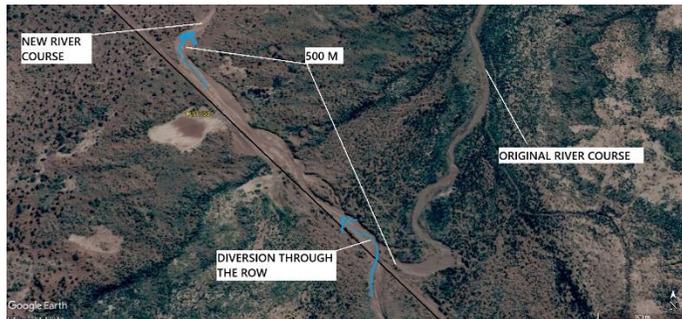
This situation didn't experience any substantial change until approximately 2014. During that year, the river changed its course and started to flow through the ROW for approximately 500 meters. Among the possible reasons for this change are the lack of significant floods from 2004 to 2014, which may cause the deposition of sediments on the original river, plus the fact that the ROW offered a preferential path during high flows.

FIGURE 17: DIVERSION THROUGH THE ROW

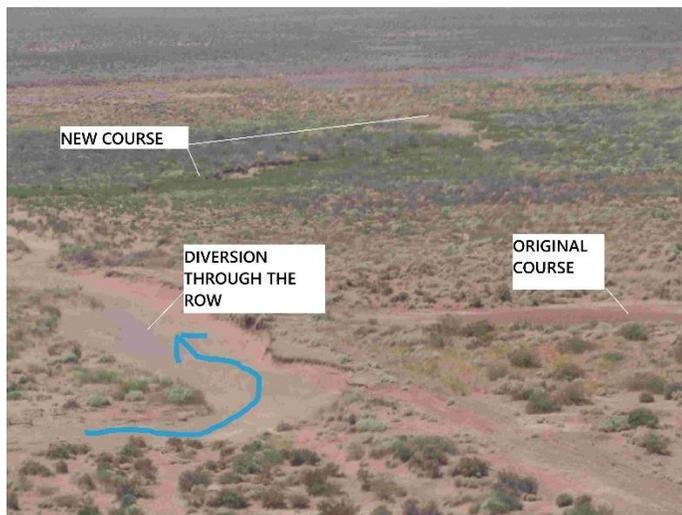
FIGURE 18: AERIAL PICTURE OF 2014 SITUATION

The new situation presented a completely different hydrotechnical threat to pipeline integrity since instead of localized exposures, a 500-meters stretch of pipeline was affected on its left new bank. As stated earlier, the original pipeline design contemplated a concrete coating of only 24 m long, located at the original crossing. Thus, the pipeline was not prepared to account for buoyancy or stresses induced by water flows in case of exposure. This was the case after the 2014 flood where new segments along the river had minimum lateral soil cover, which was now the focus of further monitoring surveys. At the beginning, temporary remediation works were implemented to restore flow through the original river course and the lateral soil cover by soil movement works. Given the fact that floods are not common due to the annual precipitation regime,

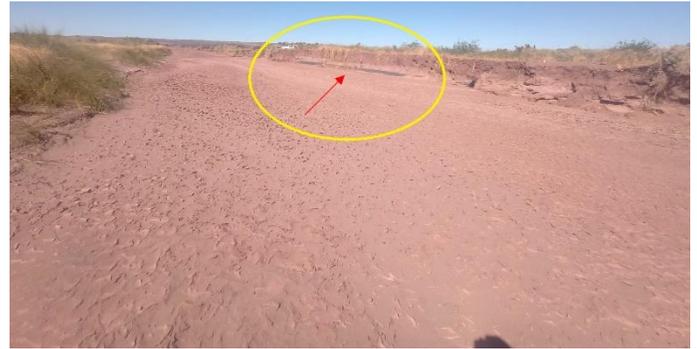
this scheme proved suitable for a while. In January 2022, a new storm took place, exposing approximately 35 m of pipeline.

FIGURE 19: EXPOSED PIPELINE ALONG LEFT BANK

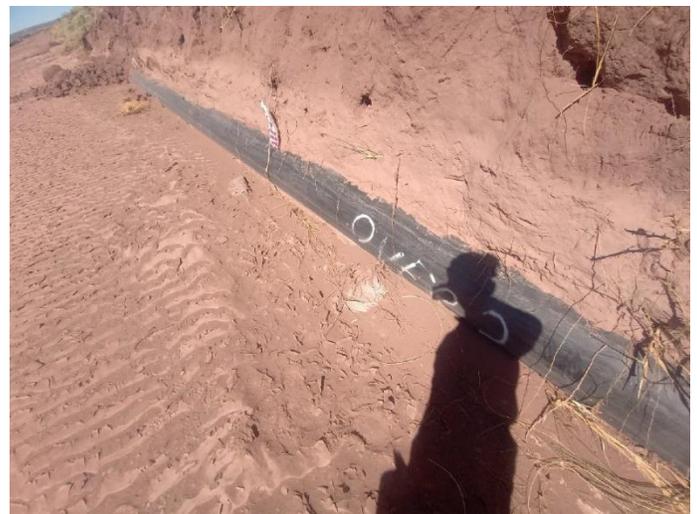
FIGURE 20: DETAILED PICTURE FROM THE SAME AREA

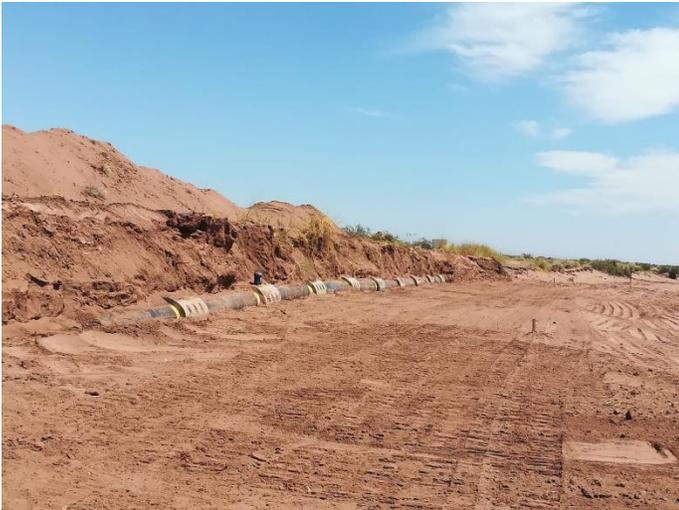
FIGURE 21: COUNTERWEIGHTS OVER THE EXPOSED SEGMENTS

Temporary remedial measures were implemented immediately in the field. A typical solution was constructed to avoid further damage consisting in placing counterweights and a building left bank protection with geotubes that performed well in other locations with similar erosive processes. Geotubes are common in isolated places in the desert since stones for gabions and rip-rap protections are harder to get within a reasonable distance. They are filled with local soil and covered in their exposed surface with a thin layer of cement mortar to protect them from scratches from debris, especially bushes and thorns. An additional flexible protection at their foot was placed to avoid scour and sliding of the geotubes pile, made out of flexible concrete mats. Soon after construction, a flood took place verifying a suitable performance of temporary works.

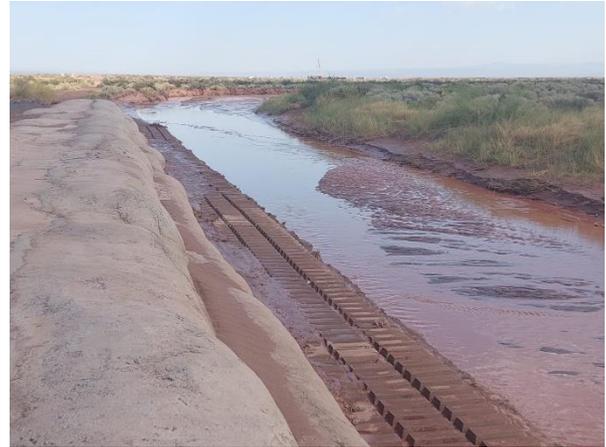
FIGURE 24: PERFORMANCE AFTER A FLOOD IN 2022

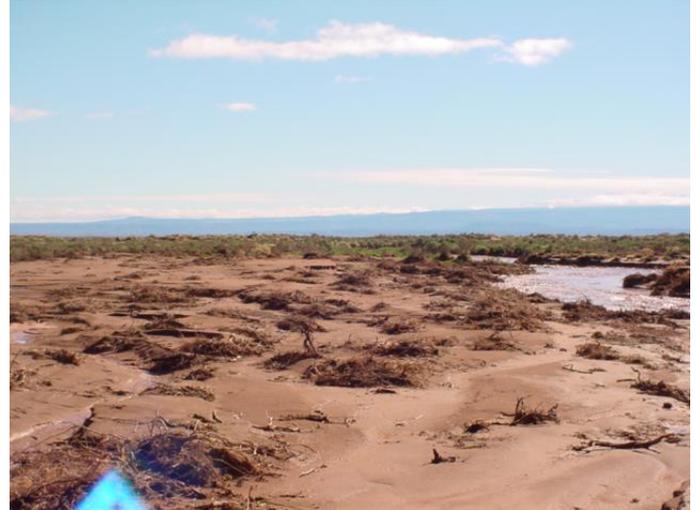
- The extent of the flooded area is massive. As shown in Figure xx, the dimensions of the cross section of the original river course (22 m wide and banks of 1.5 m) could only cope with minor flows. Flood conditions will develop as soon as a strong storm takes place, a fact that was corroborated by a filed visit after a flood in April 2004.

FIGURE 28: FIELD SURVEY AFTER A FLOOD

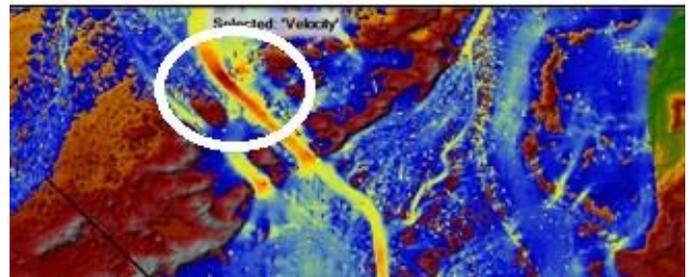
- After diversion through the ROW, exposed segments of pipelines are congruent with zones of highest velocities, as values reached in that area were in the order of 3 to 4 m/sec.

FIGURE 29: DETAILED VELOCITY MAP AT THE ROW
