ASSESSING ARC-SHAPED DEFORMATION IN A BURIED GAS PIPELINE WITHIN SOFT COASTAL SOILS: A CASE STUDY IN SÃO PAULO, BRAZIL

TRANSPETRO, PETROBRAS Transporte S.A., Guararema, São Paulo, Brazil

6TH INTERNATIONAL PIPELINE GEOTECHNICAL CONFERENCE IPG 2023

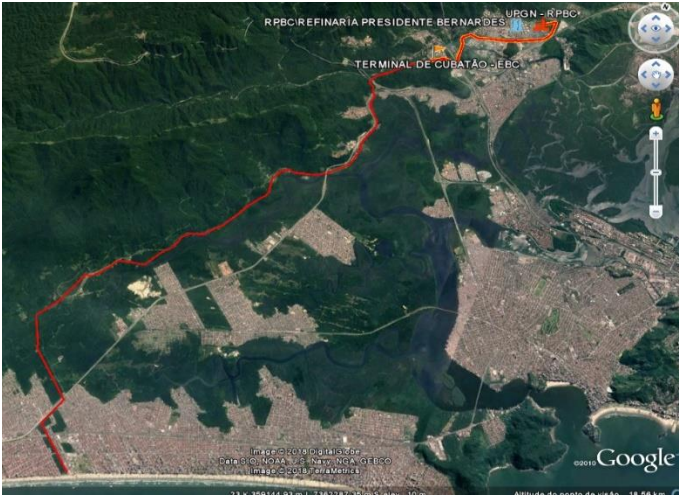
FIGURE 1: PATH OF THE 16" GAS PIPELINE, EXTENDING FROM THE SEAFLOOR (SUBMERGED ALONG THE COASTLINE) TO THE REFINERY, NAVIGATING THROUGH DIVERSE TERRAINS, INCLUDING MULTIPLE MARINE SOIL DEPOSITS.

As depicted in Figure 1, this pipeline extends across a land segment of approximately 29 kilometers. It features a nominal diameter of 16 inches and a nominal wall thickness of 0.375 inches (9.5mm). The pipeline is constructed from API 5L X65 steel, characterized by a minimum yield strength of 448 MPa (65,000 psi). It is engineered to operate under a maximum allowable operating pressure of 101 kgf/cm². This pipeline serves as the critical link connecting the offshore extraction platform in the sea to a major refinery located in the state of São Paulo.

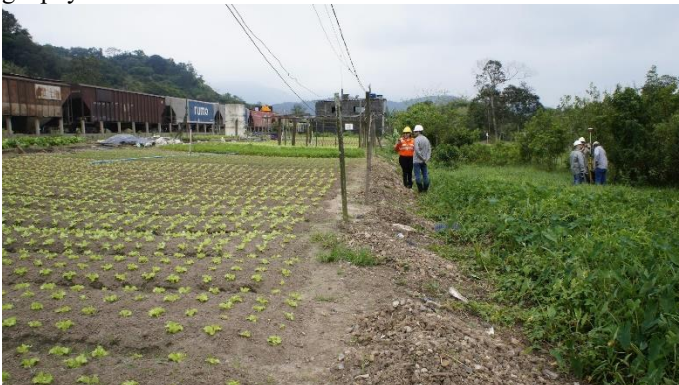
FIGURE 2: AT-GRADE PHOTOGRAPH DEPICTING THE SITE WHERE THE ARC-SHAPED DEFORMATION IMPACTED THE GAS PIPELINE.

In Figure 2, a ground-level photograph of the area is observed, and the pipeline is buried on the right side of the image, where individuals are locating the pipeline using geophysical methods.

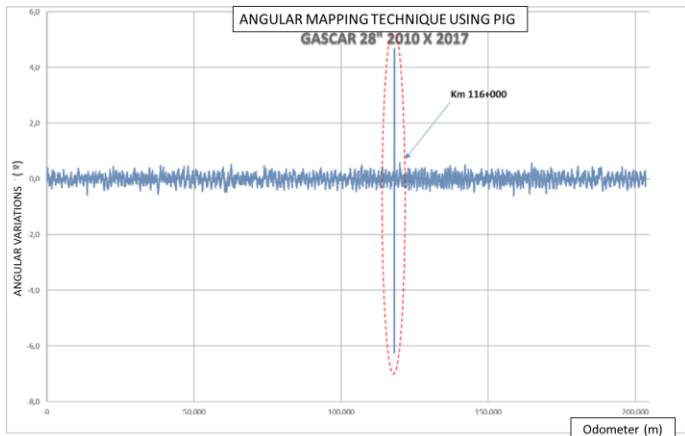
FIGURE 3: VISUALIZING ANGULAR VARIATIONS USING RUSSO'S METHOD (2015) [1].

This method entails comparing the angles between pipeline magnets and welds, capturing their respective coordinates, establishing vectors connecting them, and scrutinizing the angular variations within these vectors.

The results, systematically logged within a spreadsheet, are subsequently translated into a graphical representation, greatly facilitating the expeditious identification of any angular anomalies. This process yields the coordinates of areas where

ground and pipeline movements are suspected, warranting further on-site examination through more granular and intricate methodologies, as depicted in Figures 3 and 4.

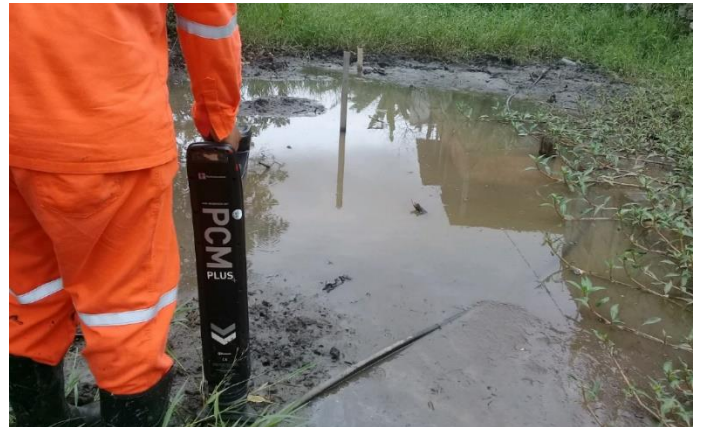
FIGURE 5: PIPELINE POSITION MAPPING USING PCM EQUIPMENT AND METHODOLOGY

Subsequently, the pipeline's precise position underwent meticulous validation using a direct physical method: a metal rod was carefully inserted into the ground until it contacted the upper generatrix of the buried pipeline.

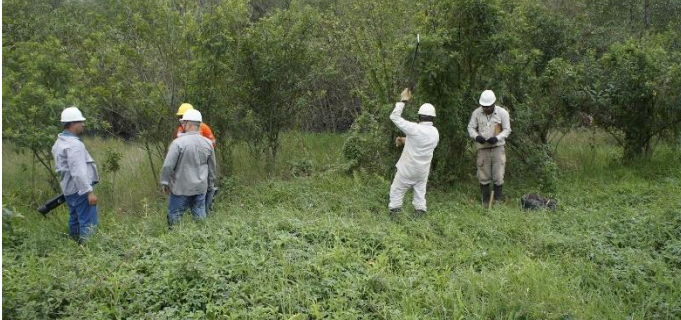
FIGURE 6: GEOREFERENCED PLANIMETRIC, ALTIMETRIC, AND TOPOGRAPHIC SURVEY OF THE PIPELINE AND SURROUNDING TERRAIN, INCLUDING SIMULTANEOUS SPECIALIZED TECHNICAL INSPECTION.

To enhance comprehension and analysis, a specialist team, consisting of experienced field technicians, geotechnical engineers, and engineering geologists, conducted a comprehensive field inspection (Figure 6).

Additionally, georeferenced planialtimetric surveys were conducted to better understand the phenomenon by mapping the pipeline's position and the surrounding area.

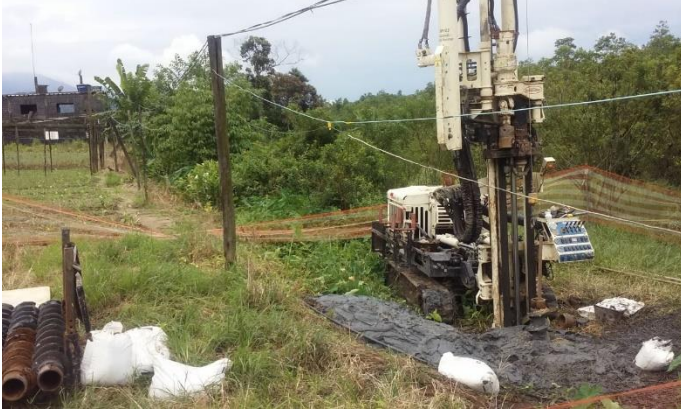
FIGURE 9: INTEGRATED GEOTECHNICAL INVESTIGATION EMPLOYING SPT (STANDARD PENETRATION TEST) AND ROTARY DRILLING TECHNIQUES.

Furthermore, a supplemental combined drilling operation was executed in the vicinity of the central area of the Arc-Shaped deformation (refer to Figure 9) to obtain soil and foundation rock samples for analysis. The drilling procedures adhered to the protocols outlined in the Drilling Manual [14].

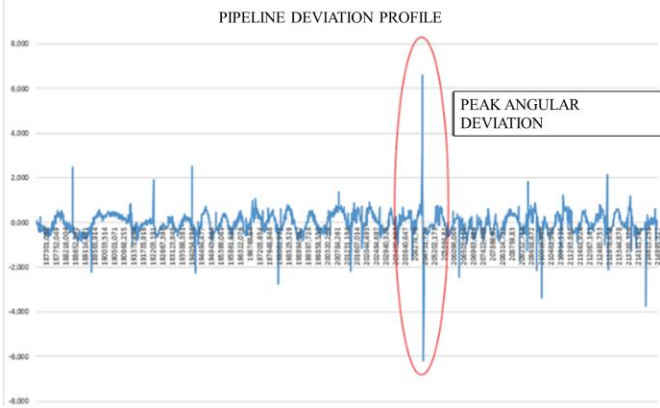
FIGURE 10: PEAK ANGULAR DEVIATION OBSERVED IN THE PIPELINE DEVIATION PROFILE, HIGHLIGHTING A DISTINCTIVE NON-NATURAL ARC-SHAPED DEFORMATION AT KILOMETER 17+900.

During an inertial PIG run in 2018, a noticeable angular deviation in curvature was observed when compared to the previous run in 2012. This discrepancy is graphically represented in Figure 10 and is further detailed in Figure 11.

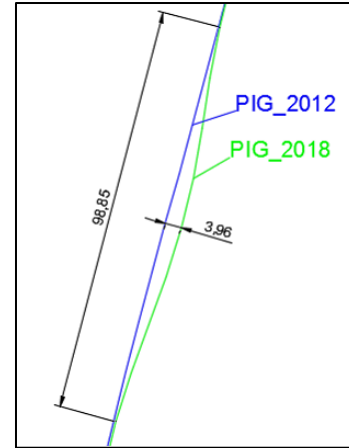
FIGURE 12: SITE PLAN OF THE PIPELINE'S ALIGNMENT OBSERVED DURING BOTH INERTIAL PIG RUNS IN 2012 AND 2018.

Figure 12 offers a site plan of the pipeline's alignment, specifically focusing on the area of peak angular deviation, observed during both inertial PIG runs in 2012 and 2018 (a 6-year time span). It vividly portrays an arc-shaped deformation characterized by a maximum deflection of 3.96 meters over a distance of 98.95 meters. This deformation is precisely located at kilometer position 17+900 within the Municipality of São Vicente, São Paulo, situated along the southern coast of São Paulo state, Brazil.

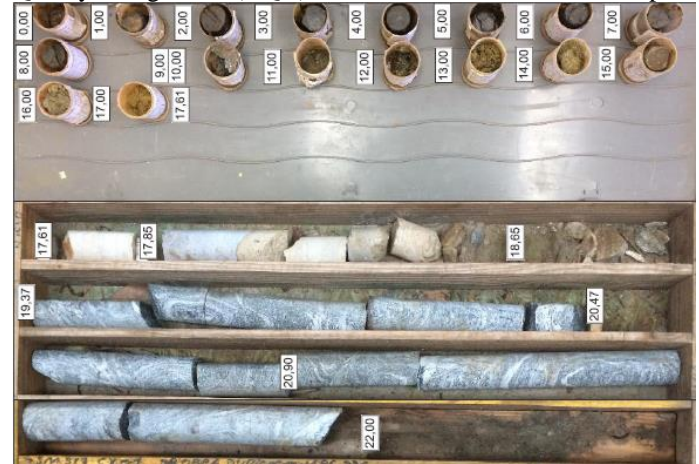
FIGURE 17: ROCK SAMPLES IN THE RQD TEST.

Metamorphic Rock Layer (Gneiss): Situated immediately below the aforementioned layers, featuring an excellent Rock Quality Designation (RQD) within the initial 5 meters of depth.

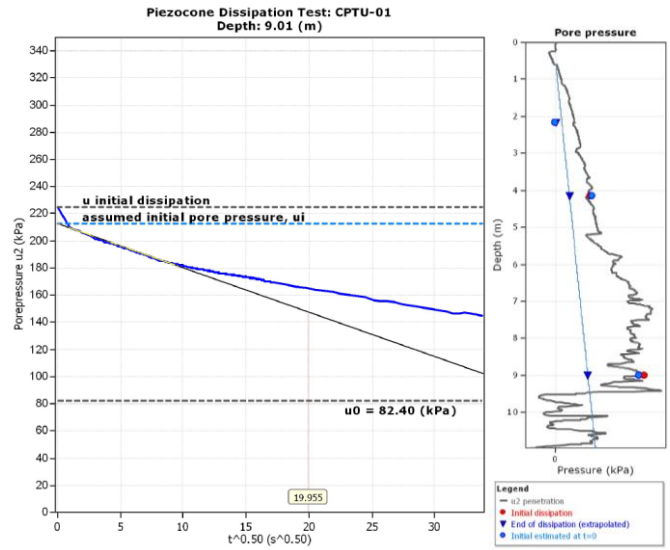
FIGURE 20: PORE PRESSURE DISSIPATION TEST AT 9M DEPTH, PROXIMATE TO THE SOFT ORGANIC CLAY TO COMPACT SANDY SOIL TRANSITION.

The pore pressure dissipation tests conducted, as depicted in Figure 20, have unveiled artesian conditions, prominently noted at a depth of 9 meters within borehole 1. These observations were particularly pronounced near the interfaces between the soft clay and the compact sand layers. This finding provides compelling evidence of confined groundwater presence, thus underscoring the heightened vulnerability to soil deformations and associated geotechnical challenges in the studied area.

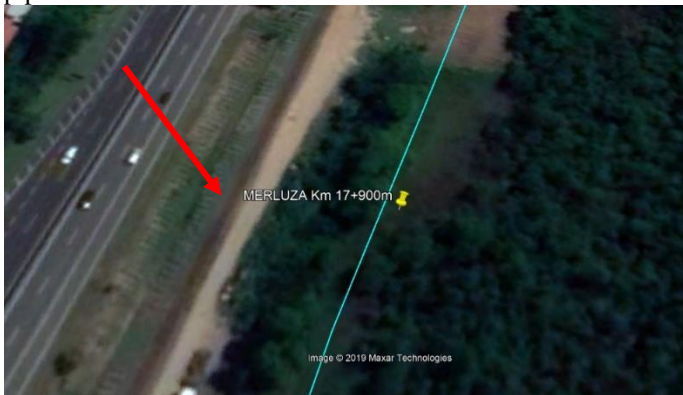
FIGURE 22: GOOGLE EARTH IMAGE FROM JANUARY 2014, DEPICTING A SINGLE RAILWAY LINE UPSTREAM OF THE PIPELINE.

Upon scrutinizing the images captured between January 2014 and June 2018, as depicted in Figures 22, 23, and 24, it was observed a railway line duplication project running parallel to the pipeline alignment. It's worth noting that this project maintained a lateral separation of more than 30 meters from the pipeline itself.

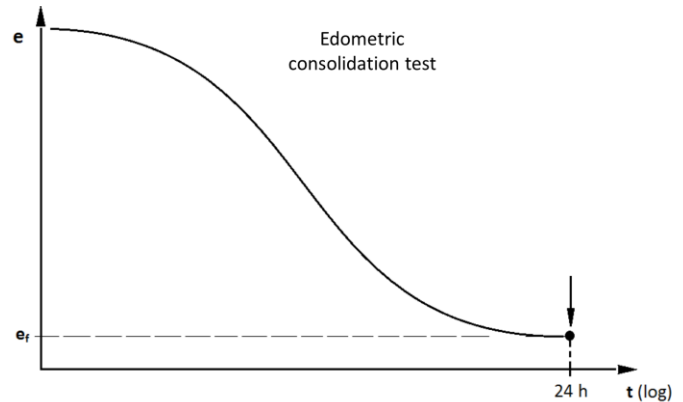
FIGURE 26: FIGURE MODIFIED FROM [12] OF A UNIDIMENSIONAL COMPRESSION CURVE.

Hence, the geotechnical hypothesis posits a scenario akin to the behavior seen in standard consolidation curves derived from oedometer tests following a singular load application over time. In this context, the soil undergoes compression and dissipates the initially incorporated energy. Notably, substantial soil displacements manifest primarily during the early stages of loading, and these displacements exhibit an exponential decline over time. This phenomenon is elucidated further by [12], as illustrated in Figure 26.

Considering the principles of consolidation theory and recognizing that the observed movement in 2018, initiated around mid-2015, did not align with natural creep behavior, we postulated the hypothesis that this movement had already reached a state of stability. In other words, it had entered the phase characterized by residual and inconsequential displacements, as depicted on the displacement curve.

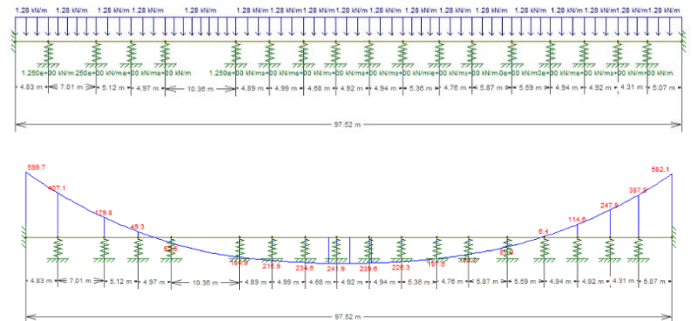
FIGURE 29: PIPELINE MODEL AS A SPRING-SUPPORTED CONTINUOUS BEAM WITH FIXED ENDS AND ITS BENDING MOMENT DIAGRAM.

Figure 29 illustrates the pipeline modeled as a structural beam, along with the applied loads under scrutiny. We adopted a distributed load model, representing the constant soil load, wherein the pipeline functions as a spring-supported continuous beam with fixed ends. These supports accurately mimic the soil's reaction on the opposing side of the soil load, emulating the concept of passive thrust. Furthermore, Figure 29 provides a visual representation of the bending moment diagram resulting from the comprehensive two-dimensional analysis.

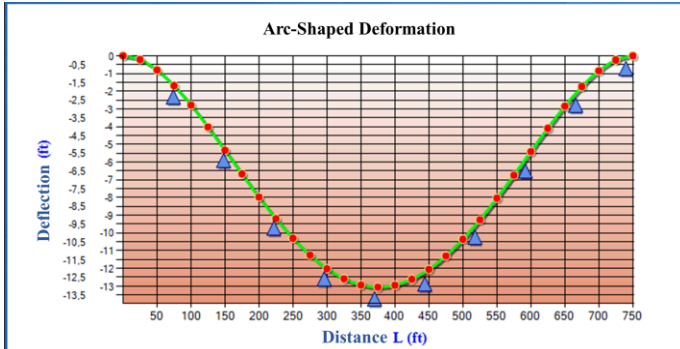
FIGURE 30: TRANSPETRO'S SPECIALIZED SOFTWARE FOR IN-SERVICE PIPELINE MOVEMENT ANALYSIS, IN ACCORDANCE WITH [2].

In Figure 30, we present the user interface of specialized software designed for a comprehensive integrity analysis of the pipeline, adhering to the principles outlined in [2]. This software accommodates input parameters such as the deformed geometry of the pipeline under load, operational data of the pipeline, technical specifications of the steel pipe, and the maximum loads derived from the theoretical stress model obtained through the simulation within the F-TOOL application. The software yields essential insights, including the theoretical elongation of the pipeline under the tensile stresses it experiences in that particular state.

The initial stress analysis results revealed tensile stresses induced by bending moments on the magnitude of 520 MPa, accompanied by pipe elongation totaling around 0.21 meters over the span of the identified arc-shaped deformation, which extends for 98 meters. While the elongation values fall within acceptable parameters, the estimated tensile stress levels, as per this methodology, suggest the onset of plastic deformation in proximity to the maximum deflection. This concern arises due to the fact that the pipeline (API X65) possesses a tensile strength of approximately 535 MPa when safety factors are not taken into account.

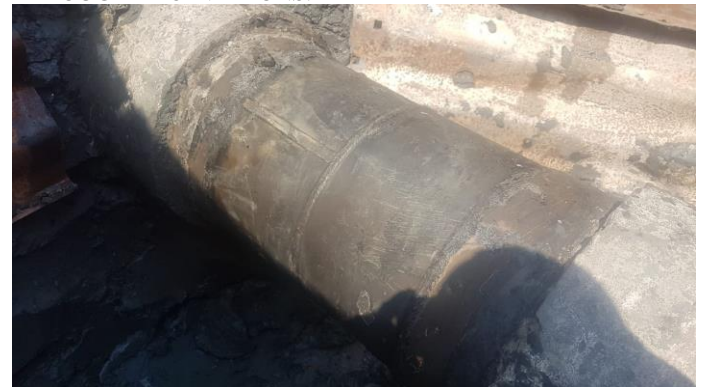
FIGURE 32: PHOTOGRAPH OF THE EXCAVATED PIPELINE JOINT FOR SUPPLEMENTARY STRESS ANALYSIS INSPECTIONS.

Figure 31 illustrates the precise locations of the three inspection points situated around the maximum extent of the arc-shaped deformation. Figure 32 provides a visual representation of the trench excavated at one of these points, offering insight into the integrity assessment of the pipelines. It's noteworthy that the pipeline is equipped with a concrete weight coating; however, it was observed that the welded joints of the pipeline lacked a concrete coating.

An array of tests and direct measurements was conducted on the pipeline steel at these selected points, encompassing visual inspections, assessments for geometric non-conformities, cross-sectional geometric measurements to verify ovalization, and crack detection tests using [10].

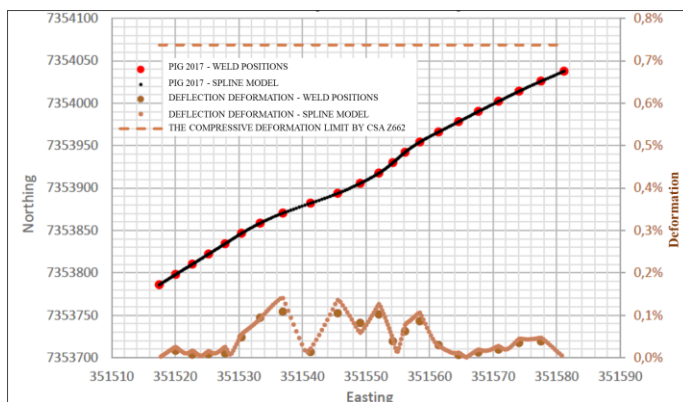
FIGURE 33: SPATIAL REPRESENTATION OF WELD POSITIONS, EMPHASIZING COMPRESSIVE DEFORMATIONS AND THEIR MAXIMUM STANDARD LIMITS.

Figure 33 shows the positions (easting, northing) of the welds and the elastic line represented by the spline for the arc-shaped region. It also presents the calculated bending deformations for these elements and the compressive deformation limit.

Based on the analysis of Figure 33, it is evident that the compressive deformations induced by bending moments within the arc-shaped region exhibit values below 0.15%. This measurement is notably lower than the prescribed standard limit of 0.74%.

This deformation analysis, characterized by greater coherence compared to the initial stress analysis, has led to the conclusion that the existing Arc-Shaped deformation of the pipeline falls within acceptable parameters. No discernible factors have been detected that pose a threat to the structural integrity of the pipeline as a result of this Arc-Shaped deformation. Consequently, it can be inferred that there are no imminent risks to the pipeline's structural stability in this context. The recommended course of action is to install soil
