GEOTECHNICAL PIPELINE RISK MANAGEMENT IN THE CHALLENGING ANDEAN AREA

A CASE STUDY OF THE KM 235 IN OCENSA PIPELINE, COLOMBIA

06 de Noviembre de 2025

GEOTECHNICAL PIPELINE RISK MANAGEMENT IN THE CHALLENGING ANDEAN AREA: A CASE STUDY OF THE KM 235 IN OCENSA PIPELINE, COLOMBIA

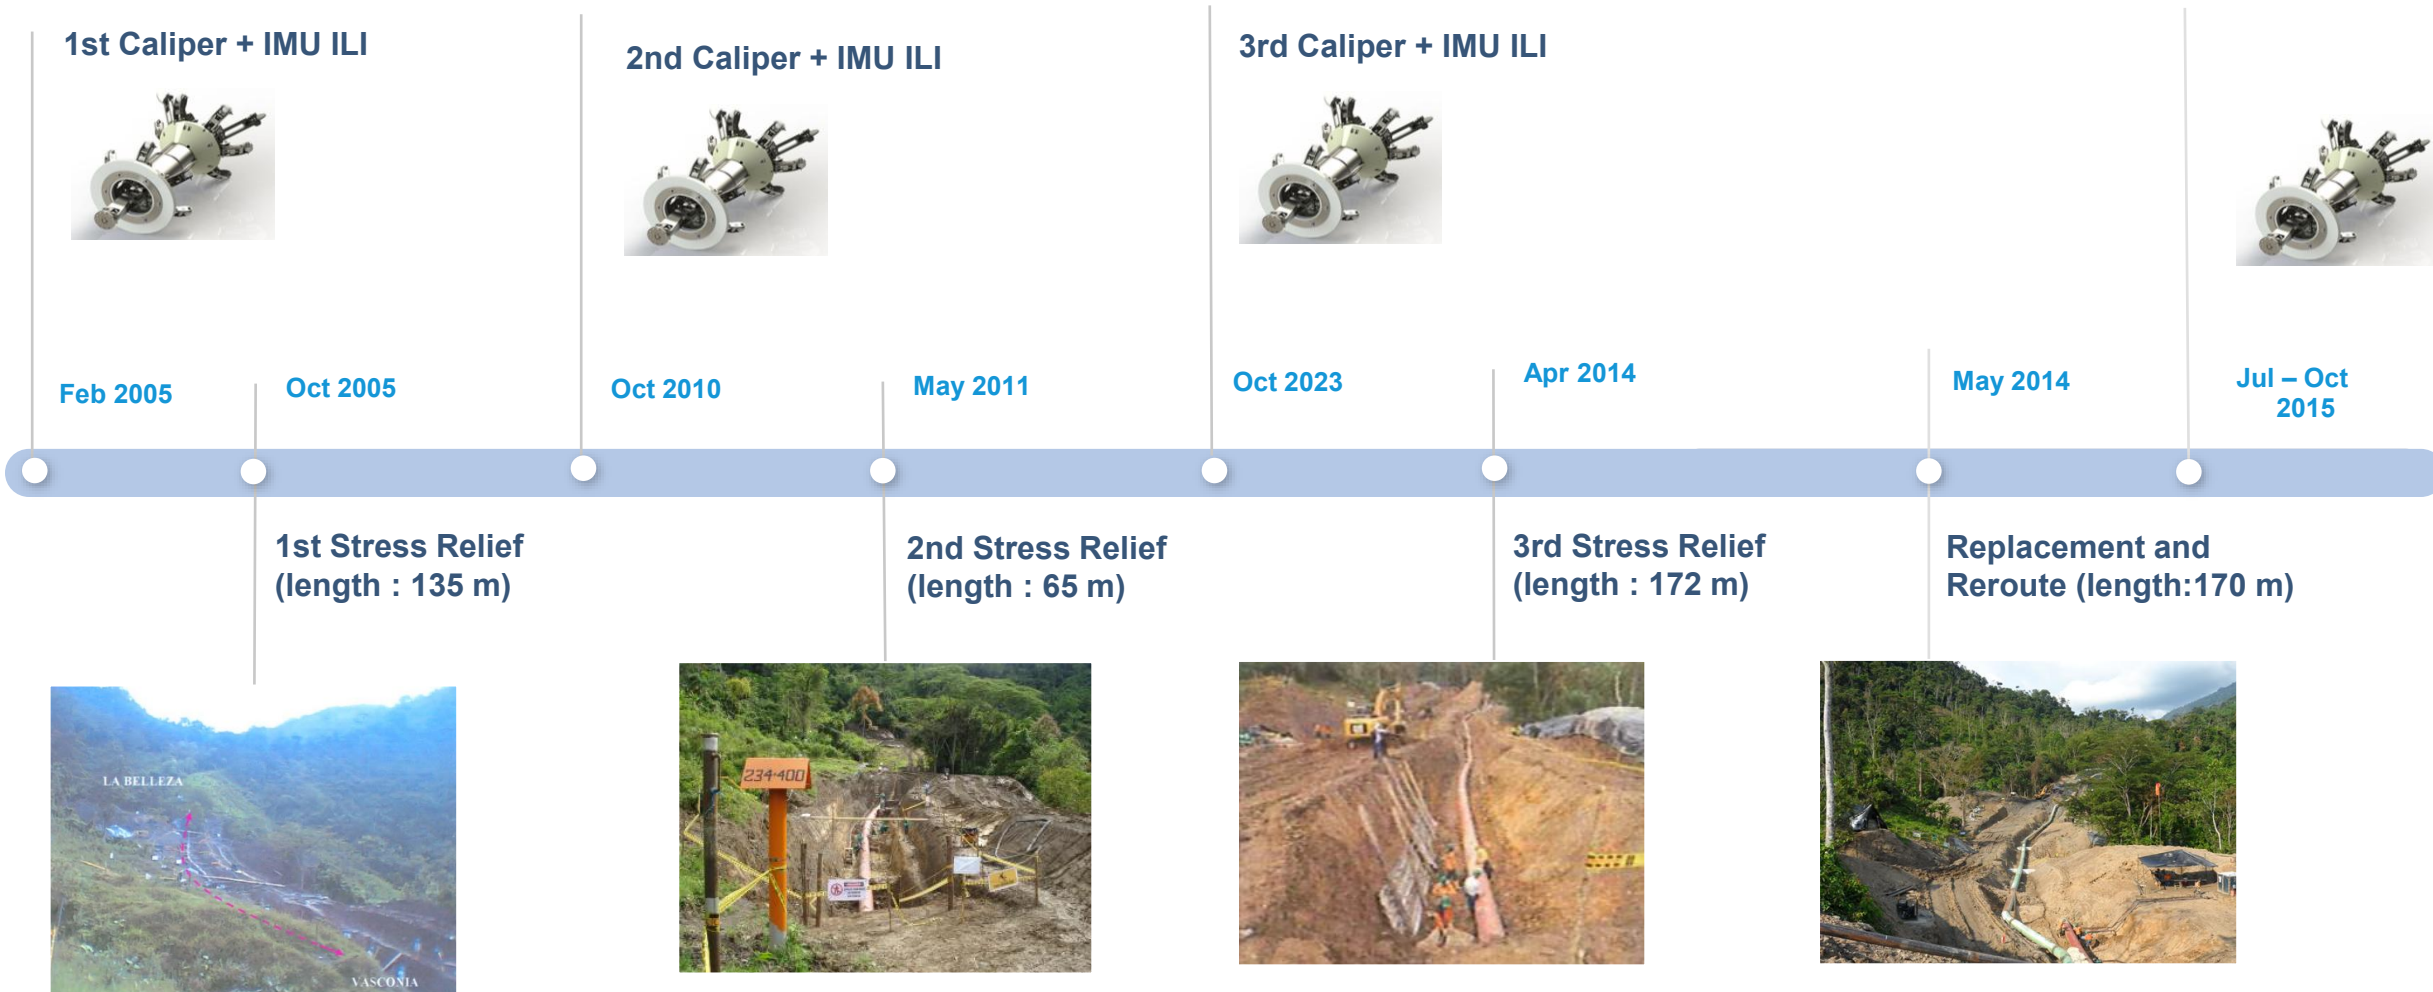
The pipeline needed **3 stress relief** activities and **1 replacement** in the **last 18 years** due to the external load exerted by the soil

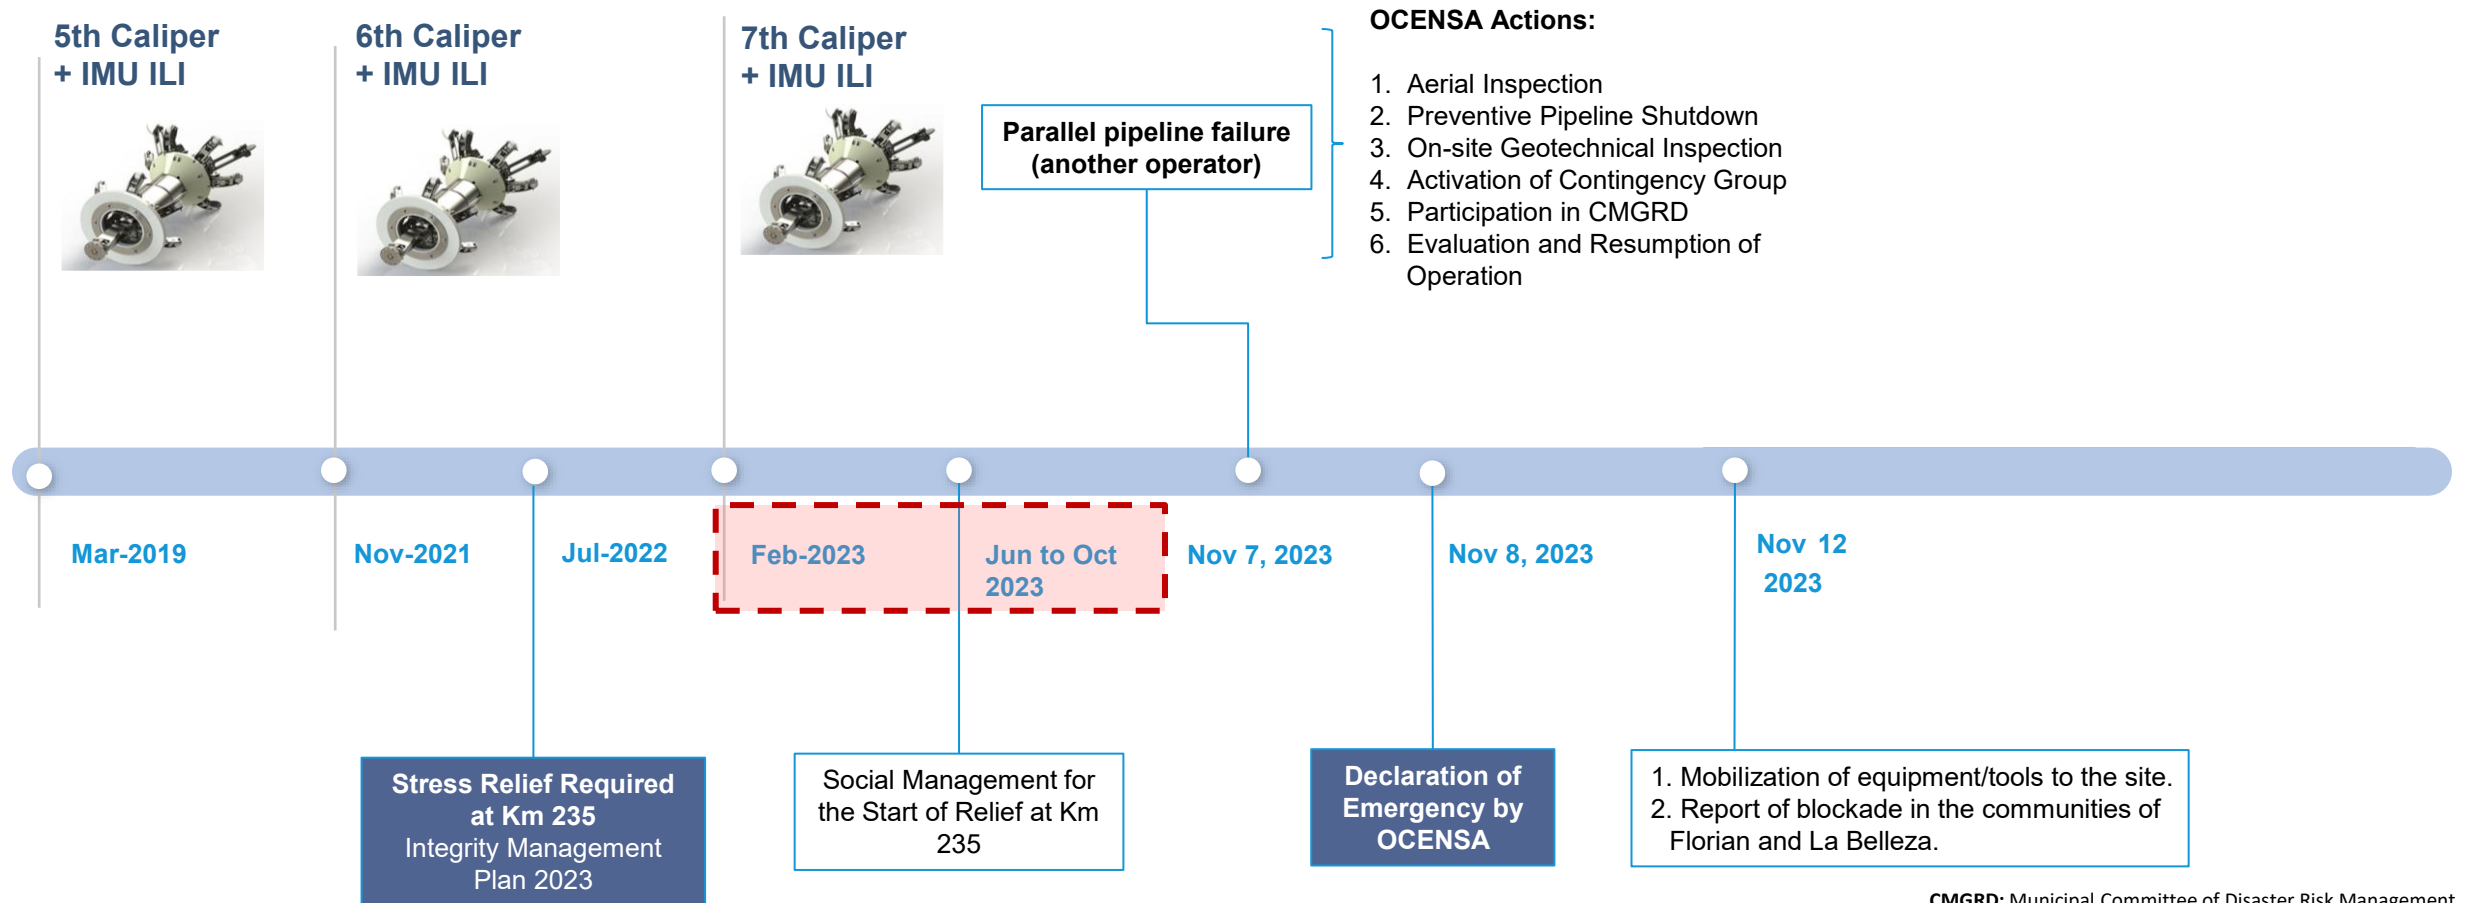
Increased rainfall linked to the ENSO weather phenomenon triggered risk monitoring efforts

By the end of the **third quarter of 2023**, strain exceeded projections by 36%, making stress relief a key priority.

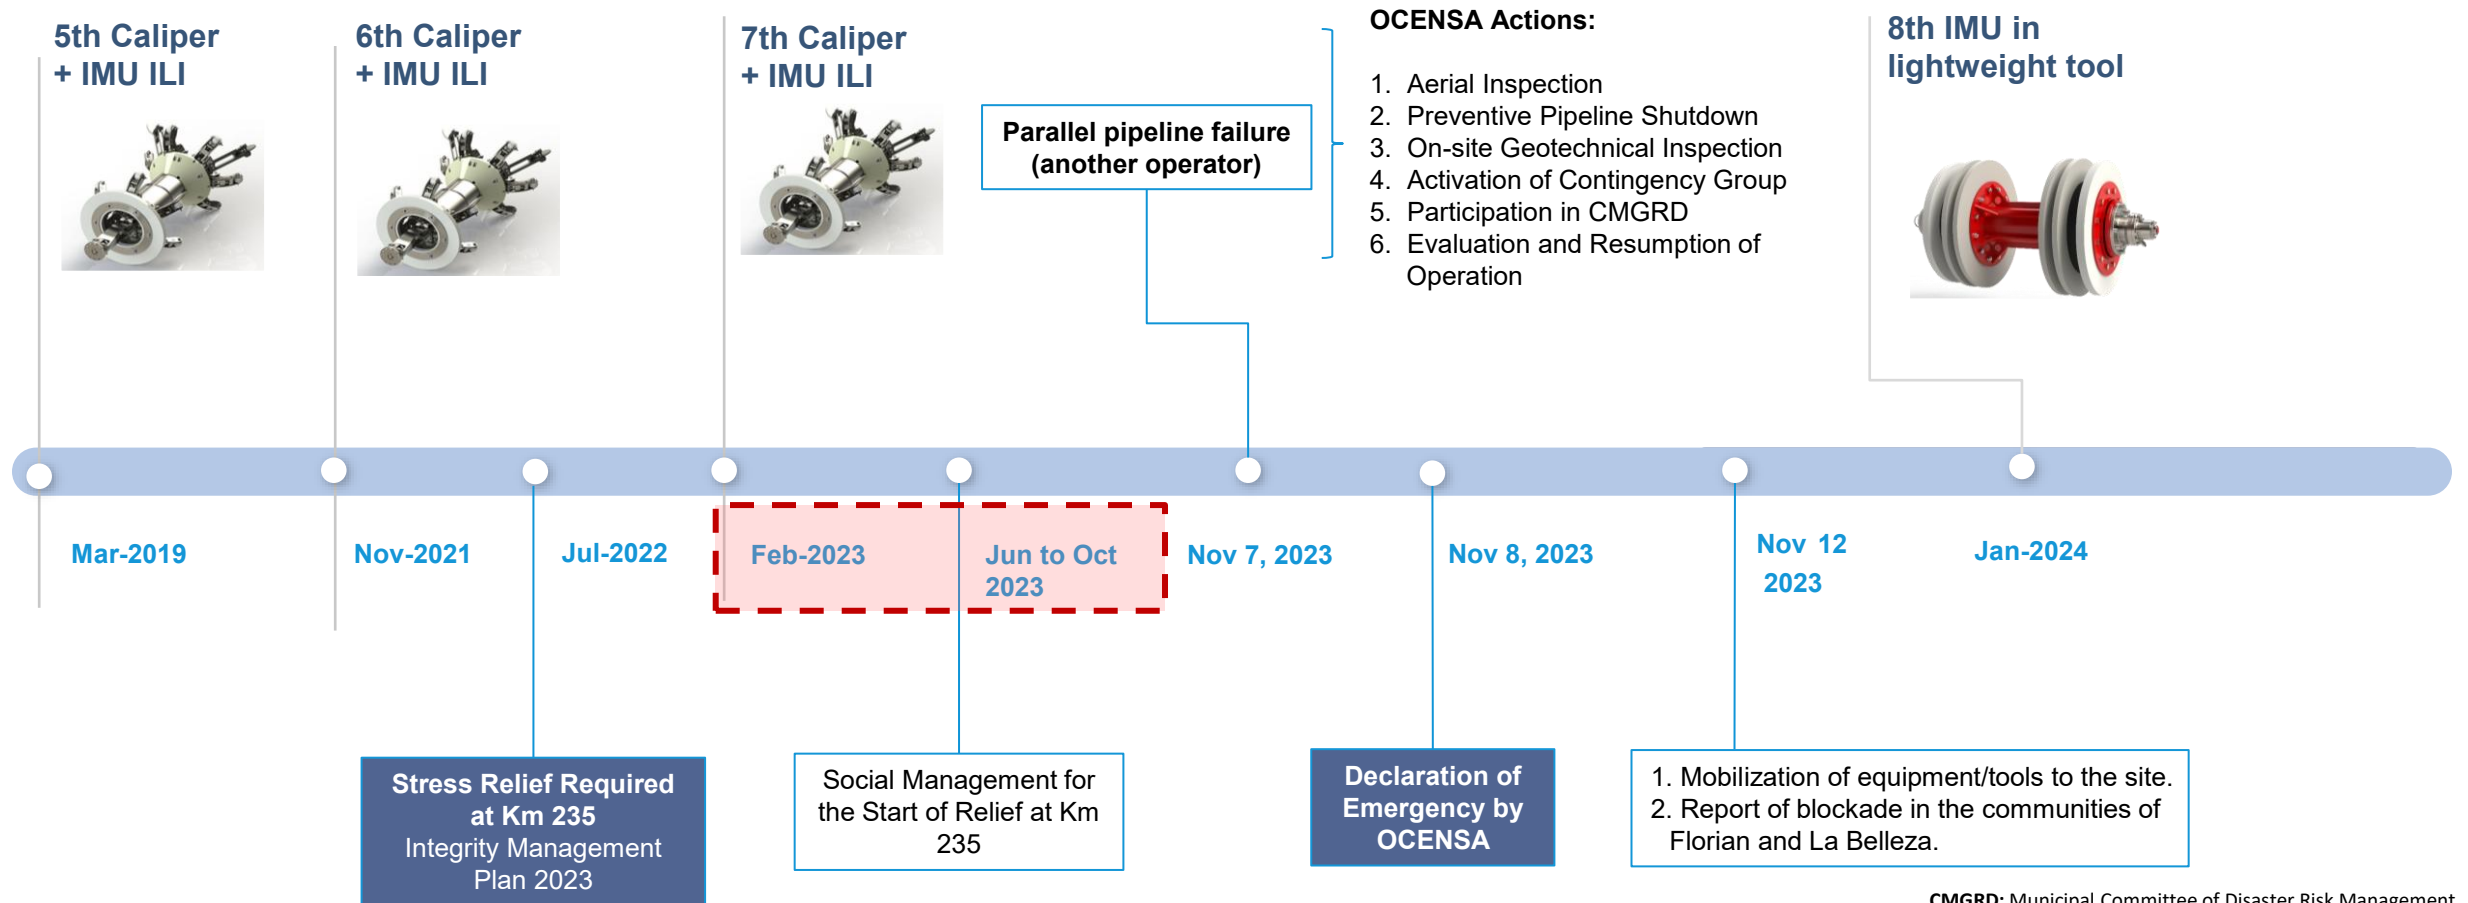
Given **social limitations** at the location, it became essential to **increase the frequency of monitoring pipeline bending strain**.

Lightweight Inertial Unit confirmed strain continued to increase at the same rate and was close to the Very High risk zone by the beginning of 2024

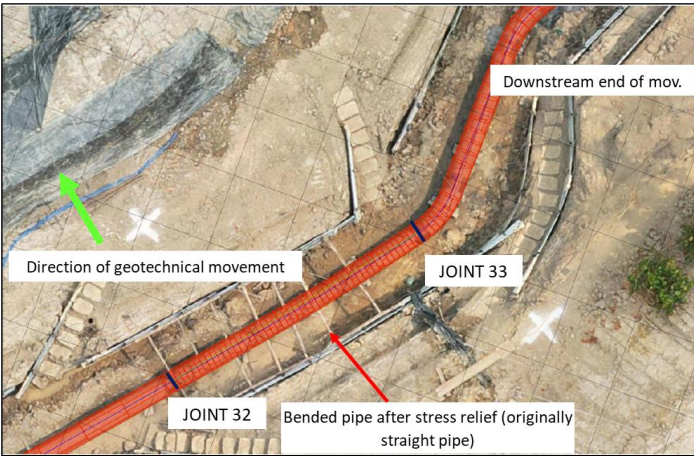
Topographic Mapping along the Pipeline

Bending strain decreased throughout the entire section, with section 3 showing a partial recovery attributed to plastic deformation.

Previous of Relief (ILI 2024)	After Relief (Topographic Survey 2024)
0.26 %	0.08 %
0.48 %	0.20 %
0.72 %	0.43 %

Bending strain decreased throughout the entire section, with **section 3** showing a **partial recovery** attributed to plastic deformation.
