IPG 2025
INTERNATIONAL PIPELINE GEOTECHNICAL CONFERENCE

PROTECCIONES GEOTÉCNICAS EN CRUCE DE RIOS, Pk 20,500 OLEODUCTO PUESTO HERNÁNDEZ – LUJAN DE CUYO ARGENTINA

Ing. Civil LEANDRO IVORRA

"GEOTECHNICAL PROTECTIONS IN RIVER CROSSING, PK 20,500 PUESTO HERNÁNDEZ - LUJÁN DE CUYO - ARGENTINA OIL PIPELINE"

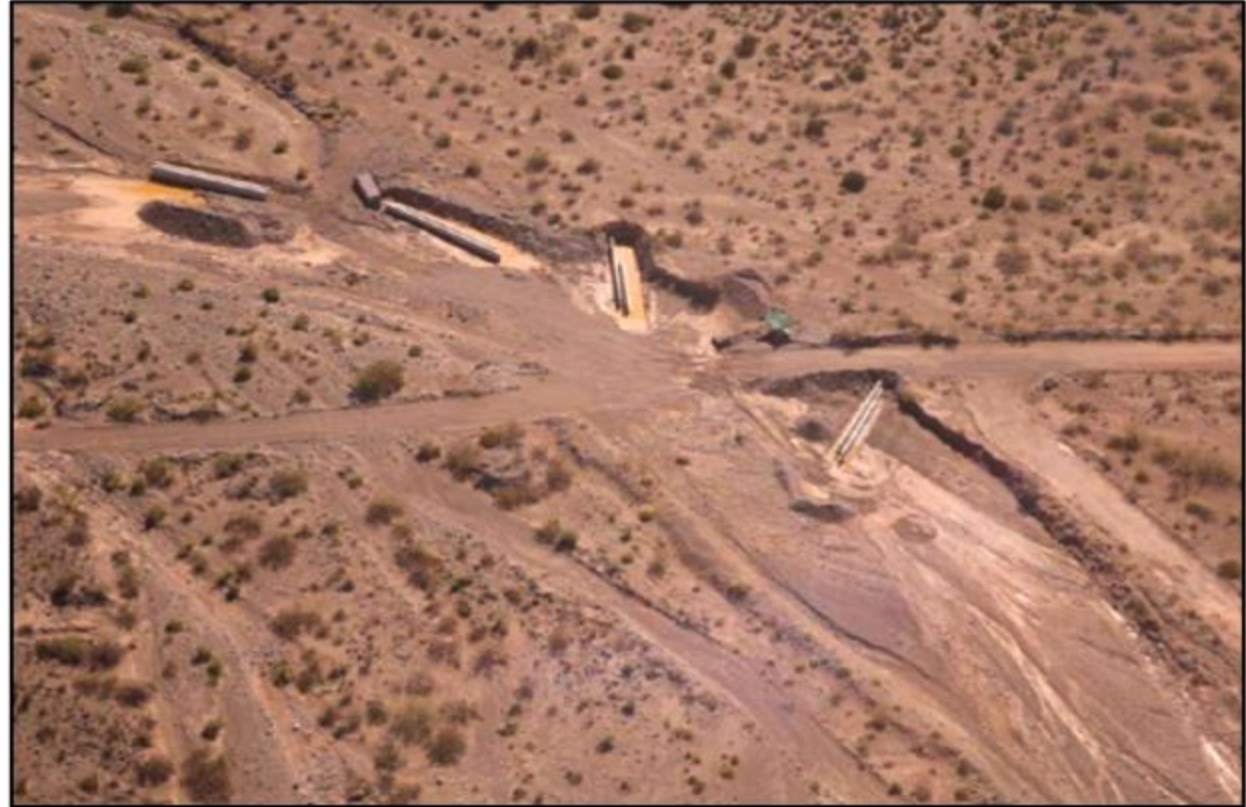
Obra a punto de ser finalizada.
Las fotos aéreas tomadas por el
patrullaje mensual, nos muestran
la materialización de la obra a poco
de ser finaliza en 2022
