**RISK MANAGEMENT APPLIED TO THE CONSTRUCTION OF VARIANTS FOR
OLEODUCTO DE CRUDOS PESADOS (OCP): QUIJOS – COCA RIVER REGRESSIVE
EROSION CASE**

Angel Mauricio Pulupa Navarrete

OCP Ecuador S.A., Quito, Ecuador

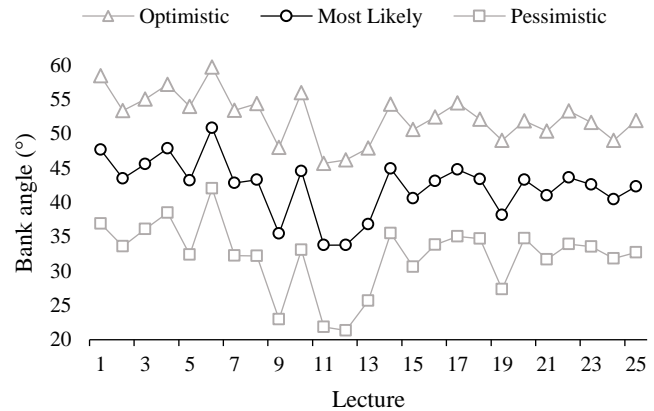
FIGURE 5: OPTIMISTIC, PESSIMISTIC, AND MOST LIKELY REPOSE ANGLE'S VARIATION

Figure 5 shows the behavior of the optimistic, pessimistic, and most likely angles for the banks of the Quijos – Coca River from KP 93 (Hostería El Reventador) to KP 97 (San Luis). It is noticeable that the values exhibit erratic patterns until around month 18; however, a slight stabilization of these values is observed at 52°, 43°, and 32° for the optimistic, most likely, and pessimistic angles, respectively.

These values align with the observations in the field, as the banks have not shown significant variations in the past year. This can also be contrasted with Figure 6, where it's evident that the regressive erosion of the Quijos – Coca River exhibited aggressive behavior until mid-2021, accounting for 80% of the total eroded volume by June 2023. Following this period, a deceleration of the erosive process is observed with a slight peak in August 2022. The maximum erosion volume was recorded in January 2023, reaching 204 million cubic meters, a value that has remained constant until June 2023.

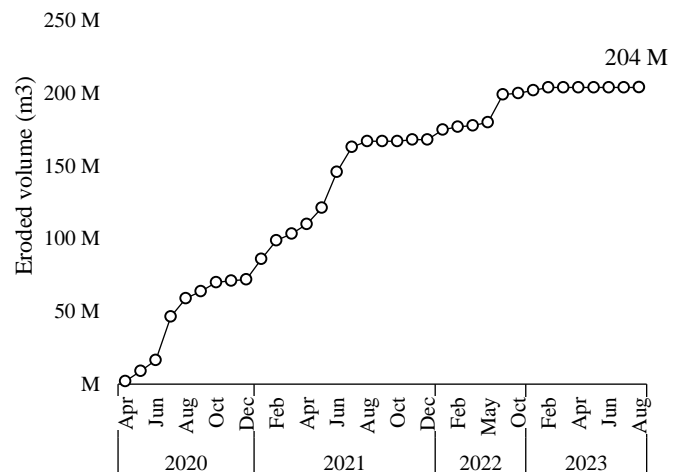
FIGURE 6: ESTIMATION OF EROSION VOLUME OVER TIME

The analysis of the eroded volume over time reveals that the erosive process has slowed down in the last year, despite having similar accumulated precipitation as in previous years. This could be interpreted as a reduction in the threat posed by the erosion front. However, experience has shown that these conditions can change within a matter of days.

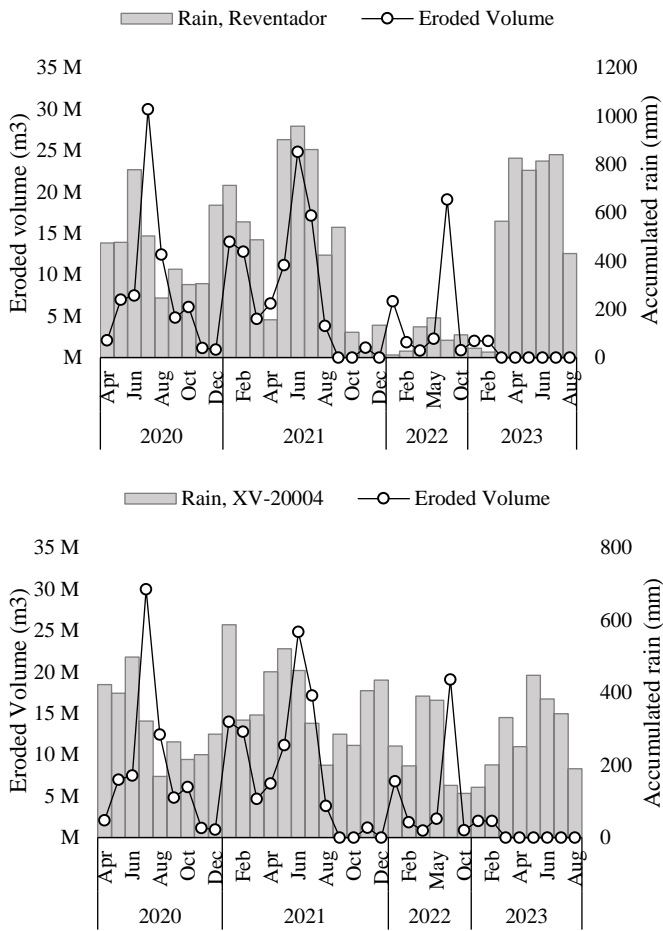
FIGURE 7: ERODED VOLUME VS PRECIPITATION

Furthermore, when comparing the eroded volume values against the recorded precipitation at the Reventador and XV-20004 rain gauge stations (Figure 7), it's noticeable that the peaks of precipitation coincide with the periods when regressive erosion is most active. While this relationship might seem intuitive, it provides the foundation for supporting geometric predictions of the behavior of the banks of the Quijos – Coca River, enabling the planning of action plans for reactivation events of the erosion front.
