IPG2025-006

URGENT INSPECTIONS AND ACTIVITIES ON THE RIGHT-OF-WAY AFTER HEAVY RAINFALL IN RIO GRANDE DO SUL - BR

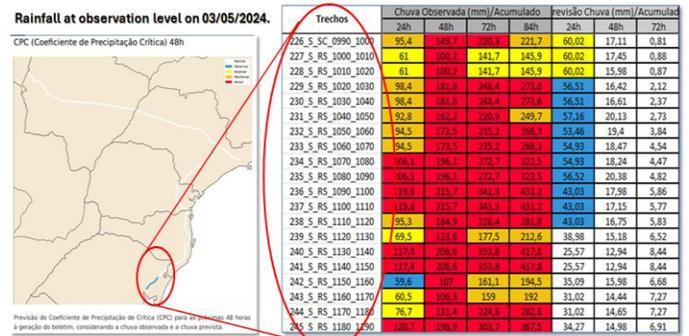
The month of May 2024 began with heavy rain throughout the Rio Grande do Sul ROW pipeline, reached rain alert levels (400 mm / 84h) in the first month fortnight, determining the beginning of segment inspection services between km 1,000+000S and km 1,190+000S (Figure 1).

Figure 1. Accumulated and Forecast Precipitation Records on RoW TBG Pipeline Segment between km 1,000+000S and km 1,190+000S, referring to May 3, 2025. Prepared by the authors (2025).

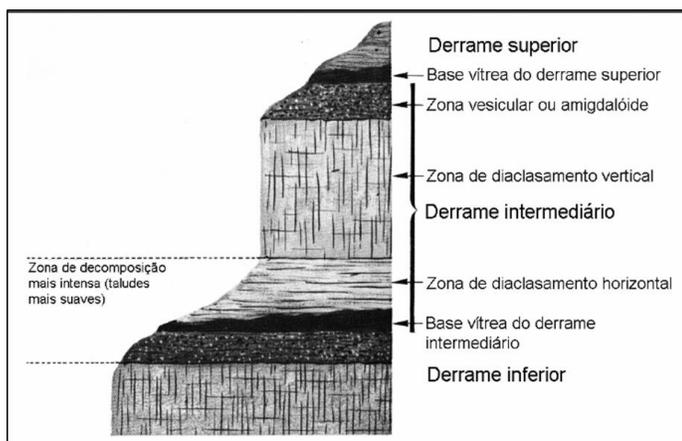
The land in this region is predominantly based on rocks from the "Serra Geral Formation" (FSG), which is made up of a succession of lava flows, with a lower layer of basic composition, such as basalts, and the upper layers formed by acidic rocks, according to Rigo (2007) (Figure 3).

Figure 3. Schematic representation of the structure of basaltic flows of the "Serra Geral Formation" (FSG). Edited by Rigo (2007), adapted from Leins and Amaral (1978).

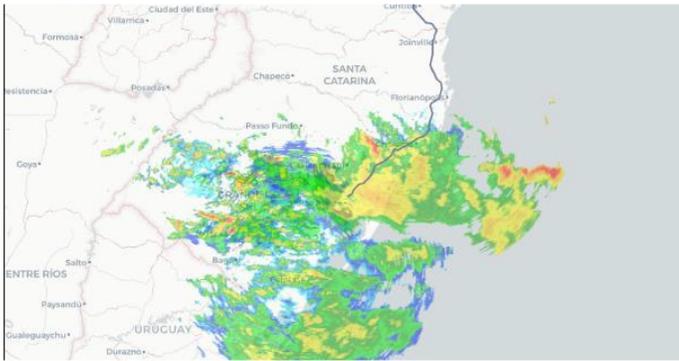
In this specific case, the team initially had an exact mapping of where the rains had reached levels above what can be considered normal for the pipeline range in that sector. As can be seen in figures 4 and 5, where the intensity of the rains was checked daily by sector, with accumulated rainfall for 24 hours, 48 hours, 72 hours, and 84 hours. Trends for the next 24, 48, and 72 hours were also monitored, providing a clear idea of the prioritization for field inspection.

Figure 5. The rainfall maps helped to show the places with the most rain along the pipeline.

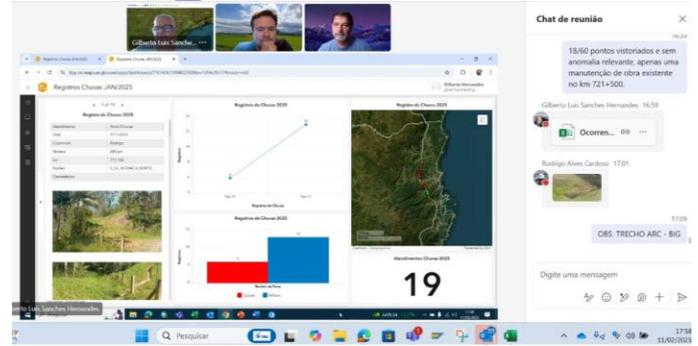
This was important so that with the information from the field teams, aerial surveys, areas of heavier rainfall, and the list of existing occurrences, with that the group could, in meetings with the field team, geotechnical engineer, and specialists, make prioritization decisions in an objective manner, as shown in figures 7, 8, and 9. At this stage, it was possible to monitor the inspections, records, and risk classification using the ARCGIS system.

Figure 7. The team analyzes the points that should be prioritized for inspection.

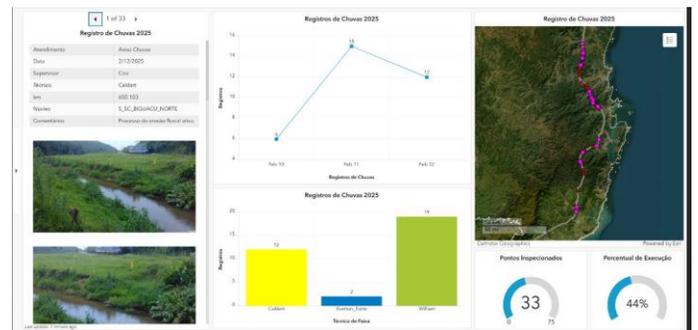
Figure 8. The team checks the productivity of field inspections, with field images coming just in time by ARCGIS.
