RIVER CROSSINGS: RIVER DIVERSION THROUGH THE RIGHT OF WAY

Martín Carnicero
Transportadora de Gas del Norte
Buenos Aires, Argentina

ABSTRACT

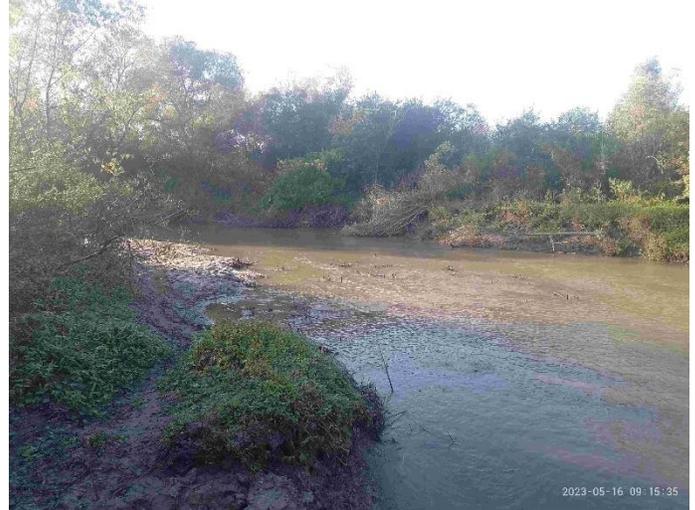
FIGURE 4: CROSS SECTION OF A RIVER BRANCH NEAR THE CROSSINGS

Putting together the high discharge, small dimensions of the river and mild slope, flooding of a huge area becomes apparent. The river responds to this combination of factors by dividing its course into many branches which after a while are blocked with debris and sediments, before opening a new branch. Also, every rural road within the flood valley becomes a water course, changing the flow pattern and, thus, the amount of water and the location where water enters the ROW.

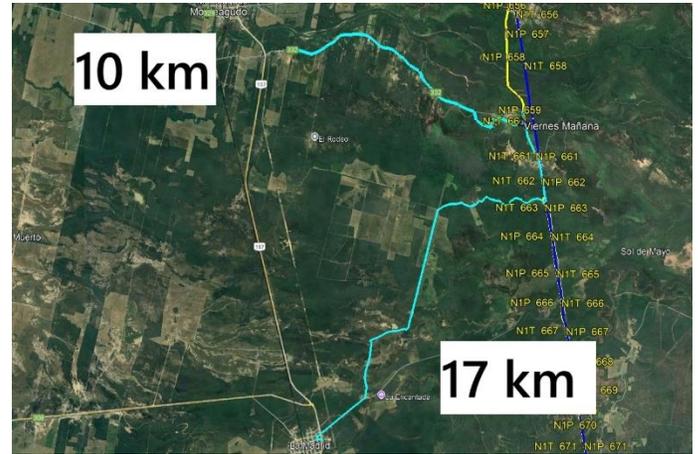
FIGURE 9: ACCESS ROADS

For the 30” line, preliminary remediation was implemented whenever access was possible after water recede. Given the massive flood that occurred throughout the entire flood valley, access became a problem. The nearest paved road is 10 km west, while dirt roads, which are privately owned, are between 10 and 17 km long. Upgrade and maintenance of access roads involve a considerable amount of time and money. Given the fact that rain could end in May and floods can begin in October, the time window of dry weather and access that allows to implement a major scale remediation work limited to four months (June through September).

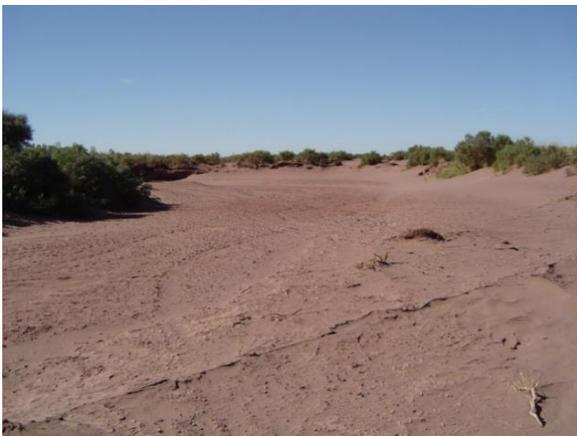
FIGURE 12: RIVER COURSE IN 2004

This crossing is located at the desert of northern Patagonia, where mean annual precipitation is around 300 mm, with the rainy season happening during autumn (March-June). While walking around the area back in 2004, it appeared as a minor creek in terms of width (22 m) and low banks (1.5 m). After a flood, this water course experienced a lateral migration that showed minimum soil cover at its left bank and an exposed segment of pipeline at the end of the flood plain, as water moved back to the main creek through the ROW after the discharge peaked. However, water kept flowing through the main course as a general pattern. Remediation works were oriented to two localized areas: protecting the river's original left bank and covering the exposed segment while blocking and diverting water at the edge of the flood plain out of the ROW.

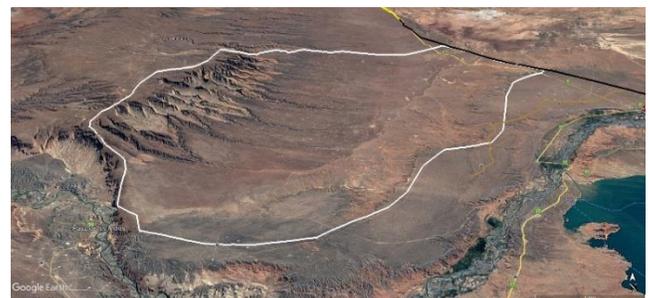
FIGURE 16: LIMITS OF THE 1,500 KM² WATERSHED

Although at that time it did not appear to be an extraordinary problem, a comprehensive study was carried out, including hydrologic and hydraulic modeling. The size of the watershed yielded a value of 1,500 km², which was in contrast with a 20 m wide creek but explained why the floodplain comprised a greater width of 2,000 m.

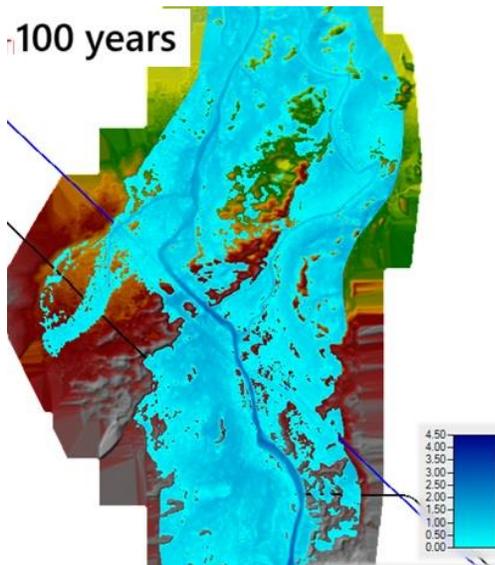
FIGURE 26: EXTENT OF THE FLOODED AREA AND WATER DEPTH

- The extent of the flooded area is massive. As shown in Figure xx, the dimensions of the cross section of the original river course (22 m wide and banks of 1.5 m) could only cope with minor flows. Flood conditions will develop as soon as a strong storm takes place, a fact that was corroborated by a filed visit after a flood in April 2004.

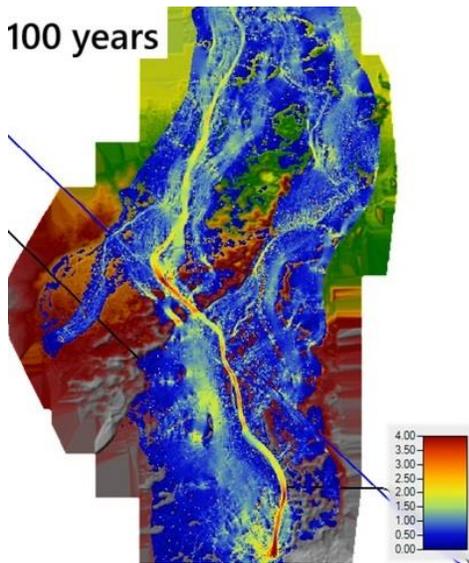
FIGURE 27: VELOCITY RANGE THROUGHOUT THE FLOOD PLAIN

- After diversion through the ROW, exposed segments of pipelines are congruent with zones of highest velocities, as values reached in that area were in the order of 3 to 4 m/sec.
