OCENSA'S RIGHT-OF-WAY STRATEGY. AN OVERVIEW OF THE PIPELINE INTEGRITY AND ITS ENVIRONMENT.

^{1, 2, 3, 4, 5} Oleoducto Central S.A. - OCENSA, Bogotá, Co.

ABSTRACT

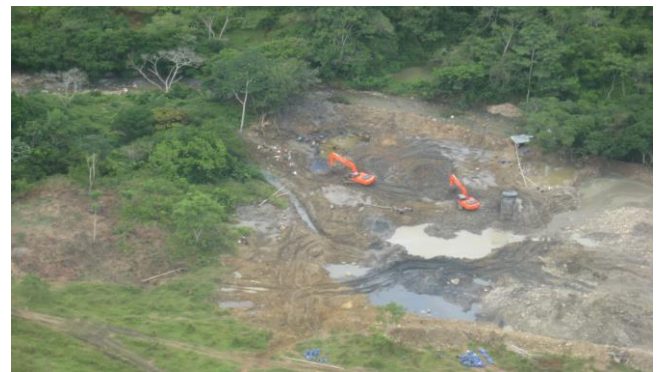
FIGURE 4: OPEN PIT MINING NEAR THE OCENSA PIPELINE. Source: Ocesa.

The so-called northeastern Antioquia (northwestern Colombian area), is rich in lode and alluvial gold mining. This has made legal and illegal open-pit mining very common. Routine patrols and inspections should be weekly and notification visits should be immediate (Figure 4).

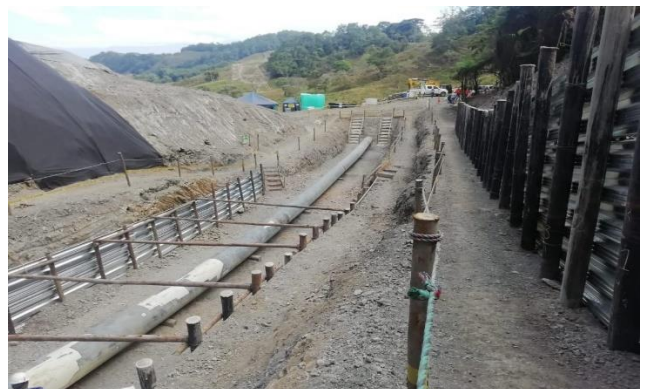
FIGURE 5: EXCAVATION FOR STRESS RELIEF.

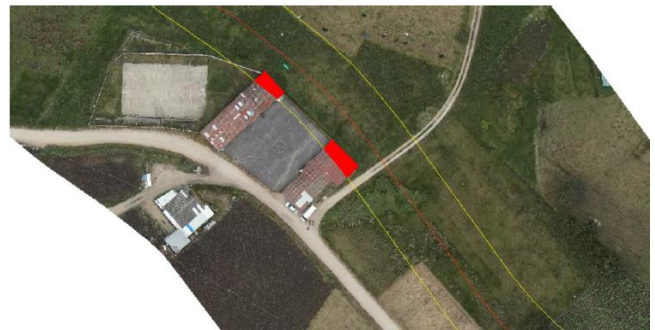
FIGURE 6: IDENTIFICATION OF ROW ENCROACHMENT DETECTED WITH UAV. Source: OcenSA.

It should identify threats that are close to DDV in a larger area of influence (Figure 6).

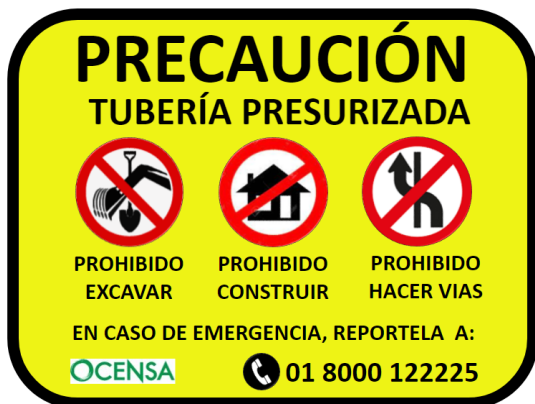
FIGURE 10: IMAGE OF PREVENTIVE SIGNAGE AT RELEVANT SITES. Source: Ocenasa.

Campaigns are carried out to place signage at sites identified as potential disaster scenarios, and where there are crossings with relevant third parties, roads, towns, etc. This signage indicates that there are buried structures, that they should not be excavated and informs of the toll-free line 018000 to which they should call if they require more information or to locate the buried line.

In the past, this signage had not been systematically installed due to physical security problems in the areas through which the pipeline passes (Figure 10).

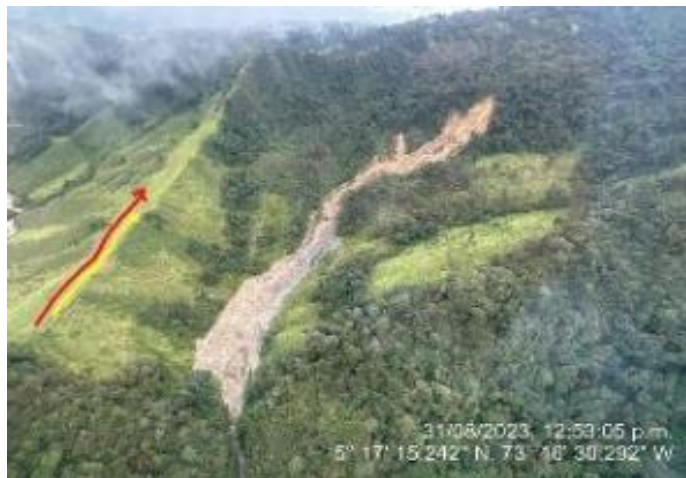
FIGURE 7: Flow of soils over a ravine. The mass was dammed for a large rock under a bridge. Source: OCENSA, aerial patrol.

That is the case of the KP 105, in the mountainous zone. There, a flow of soils over a ravine accumulated the material against a bridge due a large rock obstructing the passage of the soil mass. This situation threatening to create an avalanche affecting the ROW 200 m downstream. The rock was demolished, and the gradual decreasing of the dammed mass soil was monitoring via UAV technique. The height of the dammed mass was reduced from 0,9 m under the plate of the bridge to 2,7 m a month later (Figures 7, 8, 9 and 10).

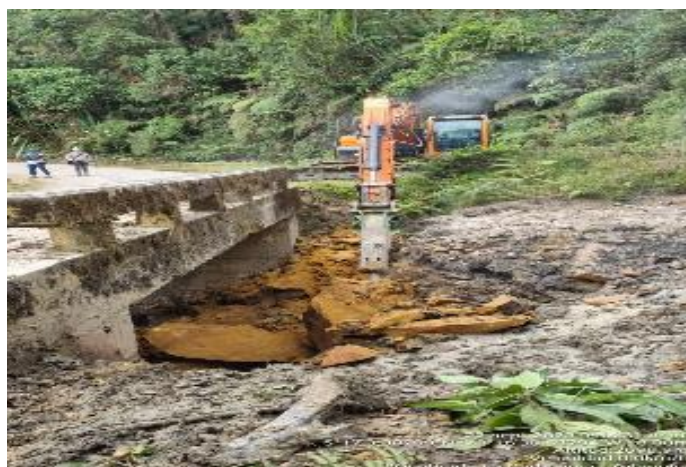
FIGURE 8: Demolishing of the rock under the bridge. Source: OCENSA

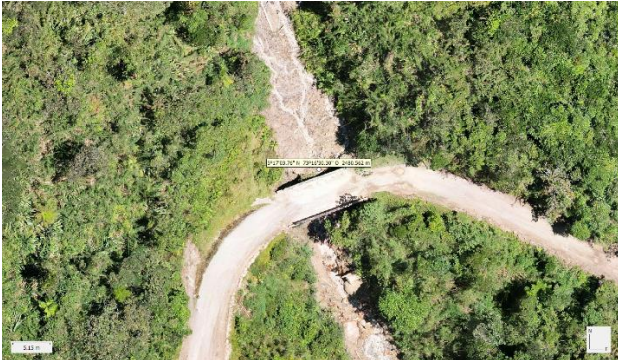
FIGURE 8: Monitoring of the crossing place with UAV's technique. The mass was 0,9m under the plate of the bridge. September 2023. Source: OCENSA.

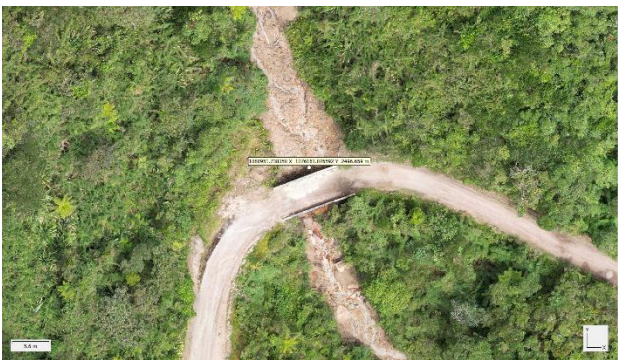
FIGURE 9: Monitoring of the crossing place with UAV's technique, multitemporal analysis. The mass was 2,7m under the plate of the bridge. October 2023. The height of the mass is gradually descending. Source: OCENSA.
